# Mackie Academy Walk Route Safety Review

Review: Mackie Academy Walk Route Assessment

Aberdeenshire Council

23/09/24

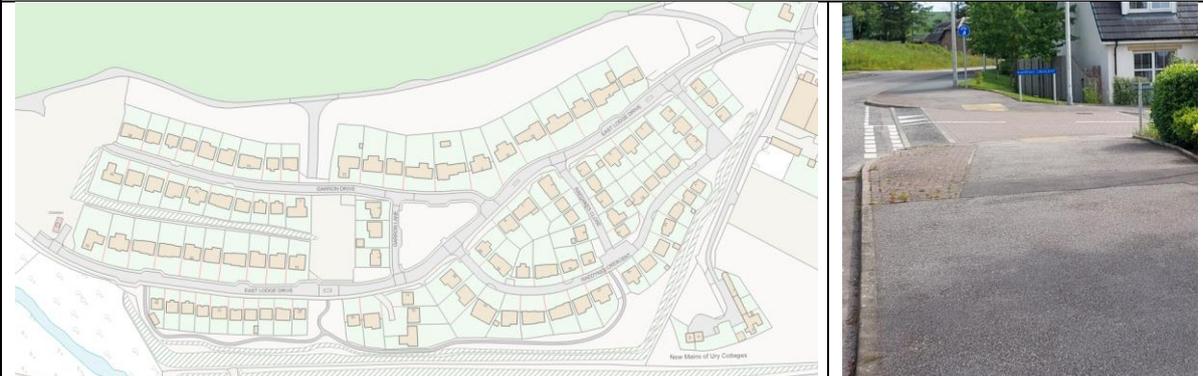
Location: [New Mains of Ury](#)

Observations: This section is within a new housing development with standard footways and footway crossings.

Probability	Risk	Low	Medium	High
High				
Medium				
Low		<b>x</b>

Recommendations: No Recommendations.

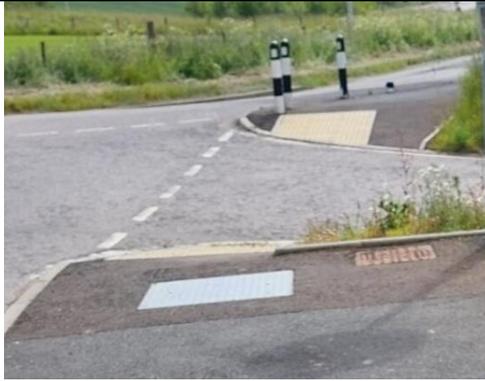
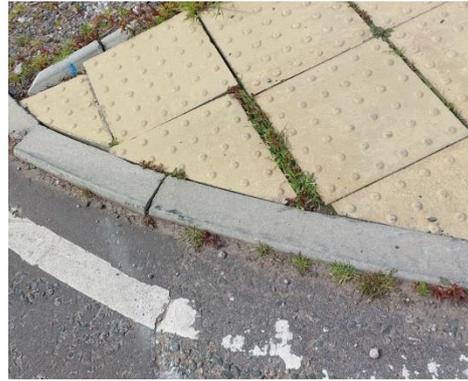
Location: [East Lodge Junction](#)

Observations: The construction of this relatively new pedestrian crossing point is not particularly good. The footway narrows on the west side unnecessarily with a raised heel kerb which creates a trip hazard. The tactile paving slabs are not laid well making them uneven with gaps where weeds are growing through, creating trip and slip hazards. The dropped kerbs are to have an upstand no bigger than 6mm in order for wheelchairs to be able to manoeuvre easily over them. These upstands are higher than 6mm. It can also be seen in the picture above that a hazard marker post highlighting the bend has been damaged.

Probability	Risk	Low	Medium	High
High				
Medium		<b>x</b>		
Low

Recommendations: It is recommended that the School Transport Unit liaise with the Roads Development team and/or the Roads Network Management team to determine who is responsible for maintenance here and find out when the works will be carried out. It may still be the case that the developer is responsible for the repairs as the development is still under construction.

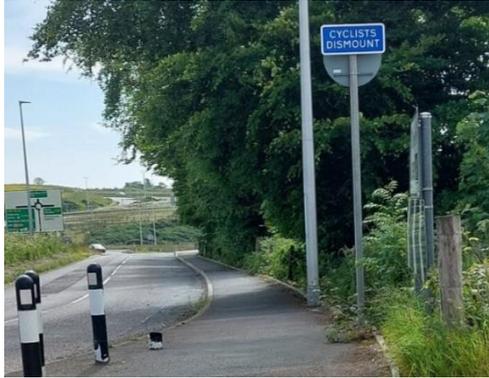
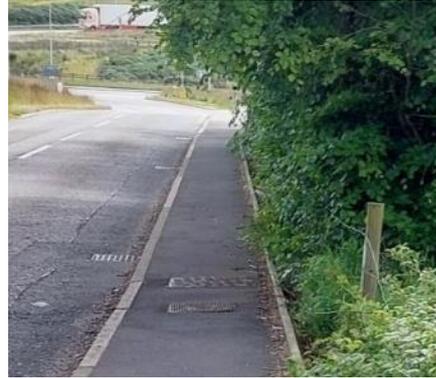
Location: [B979 Housing estate to AWPR roundabout](#)

Observations: The shared surface narrows to a narrow footway for a length of approximately 74m. There are signs indicating cyclists to dismount. The road is straight with good visibility in both directions. There are overhanging trees on the footway and as can be seen a hazard marker post has been damaged, potentially by an overhanging vehicle.

Probability	Risk	Low	Medium	High
High				
Medium		<b>x</b>		
Low

Recommendations: It is recommended that the hazard marker post is replaced and that the overhanging foliage is trimmed back and maintained.

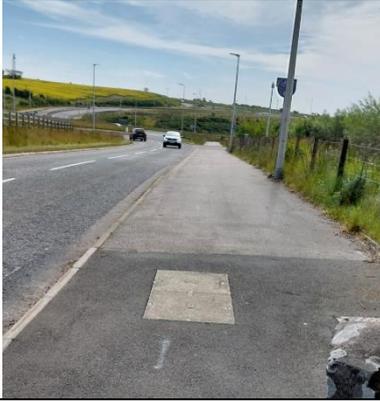
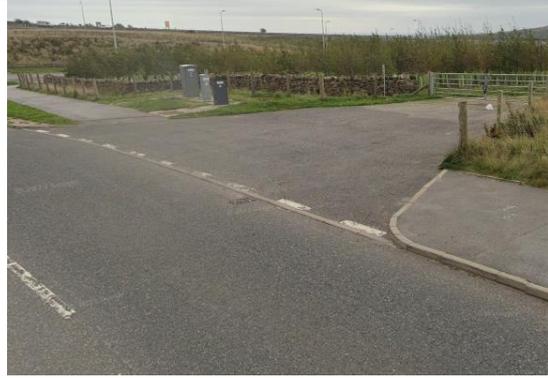
Location: [B979 to AWPR Roundabout](#)

Observations: On this stretch there are two accesses to cross. One a property access and one a maintenance access. The shared surface sign is slightly masked by a lamp column when heading east, although the closer you get to it the more visible it becomes.

Probability	Risk	Low	Medium	High
High				
Medium				
Low		<b>x</b>

Recommendations: No recommendations.

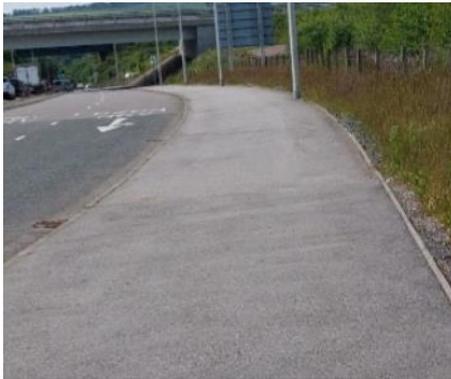
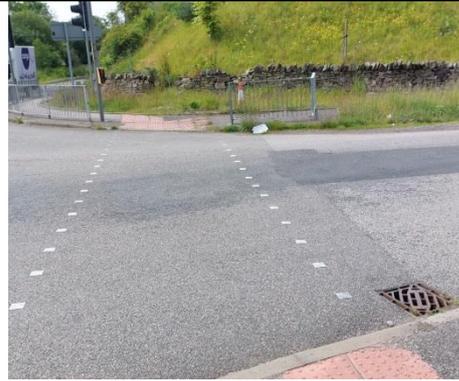
Location: [B979 AWPR Roundabout to A92 Link](#)

Observations: This section has a wide street lit footway and traffic signals with a pedestrian phase to cross the road.

Probability	Risk	Low	Medium	High
High				
Medium				
Low		<b>x</b>

Recommendations: No recommendations.

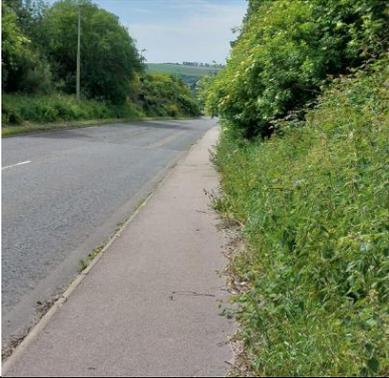
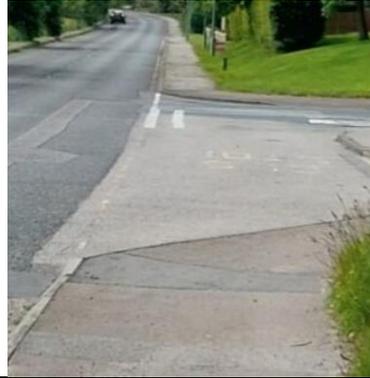
Location: [B979 A92 Link to Baird Park](#)

Observations: This section of footway is narrower, approximately 1.7 to 2.0m in places along the route. The useable footway width is reduced by overgrown foliage in places. There are two accesses to cross, the Glenury Cottages access is particularly wide with some vehicles travelling on a parallel road to the path which may not be visible to pedestrians walking towards Stonehaven. This issue is mitigated by the low number of vehicles using Glenury Cottages and that vehicles will be travelling very slowly approaching the junction. On the north side of Glenury Cottages the speed limit lowers to 30mph, however the 30mph sign on the east side of the road is masked by overgrown foliage which may contribute to some vehicles not adhering to the limit.

Probability	Risk	Low	Medium	High
High				
Medium		<b>x</b>		
Low

Recommendations: We would recommend that the foliage which is encroaching on the footway and masking the speed limit signage is cut back and maintained.

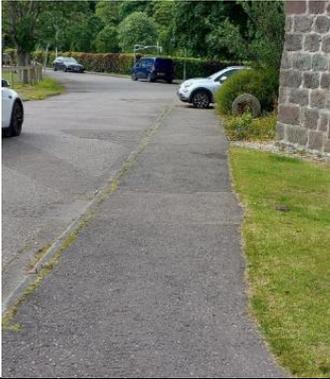
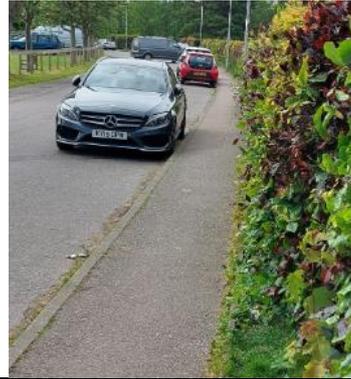
Location: [Netherly Road](#)

Observations: Netherly Road is a quiet Road linking from the B979 to the north to the B979 just north east of Cowie Bridge.

Probability	Risk	Low	Medium	High
High				
Medium				
Low		<b>x</b>

Recommendations: No recommendations

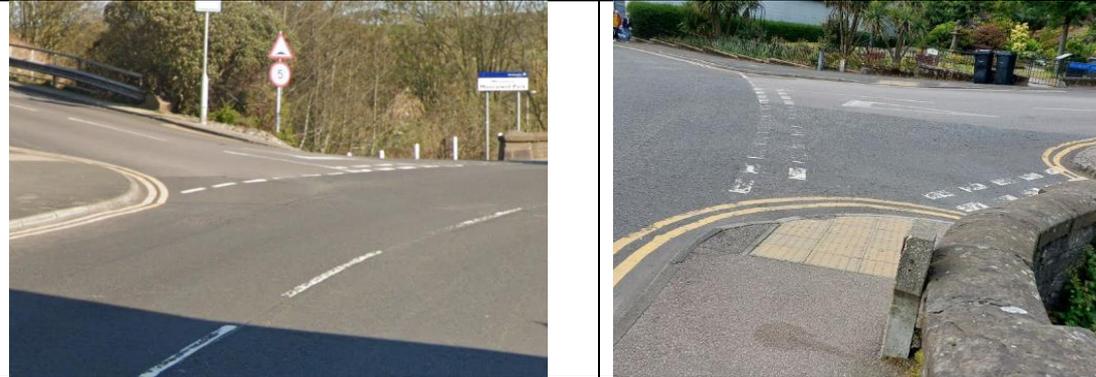
Location: [Belmont Brae](#)

Observations: The Mineral Well Park/B979/Belmont Brae junction is unconventional and may encounter user confusion. Belmont Brae has a very narrow footway up one side with a crossing point at the top with poor visibility. There is currently a Council project in the design/consultation stage that will improve pedestrian facilities in this location.

Probability	Risk	Low	Medium	High
High		<b>x</b>		
Medium				
Low

Recommendations: No recommendations. If pupils and accompanying responsible adult is uncomfortable with this road there is an alternative which involves Barclay Street, Rodney Street and Anne Street which will add an additional 8 minutes walking time, approximately.

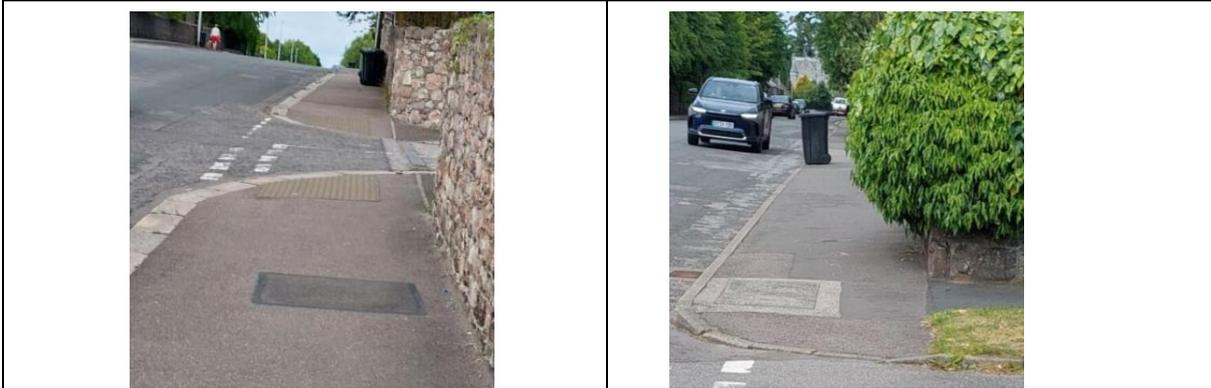
Location: [Bath Street](#)

Observations: Bath Street is street lit with standard widths footways. There is one section with overhanging foliage which reduces the usable footway width slightly. There are several access crossings, some with and some without tactile paving.

Probability	Risk	Low	Medium	High
High				
Medium				
Low		<b>x</b>

Recommendations: No recommendations just now, however, the householder may be required to cut back foliage if it continues to encroach into the footway.

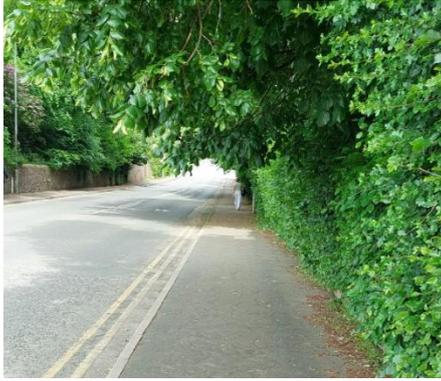
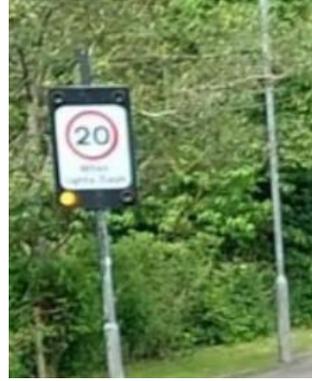
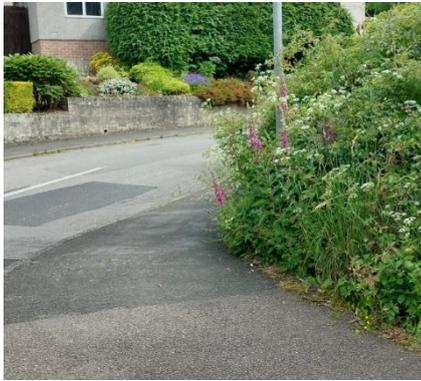
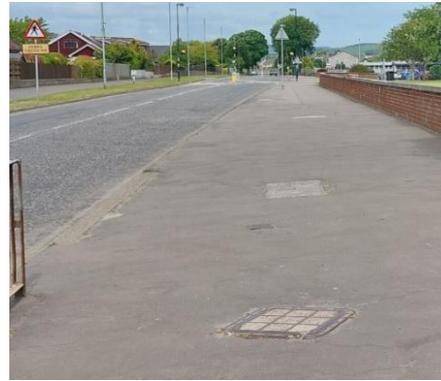
Location: [A957 Slug Road](#)

Observations: There is overhanging foliage reducing the available footway width in places which may result in pedestrians stepping onto the carriageway if passing other people. The southeast corner of East Glebe has overgrown foliage which will mask vehicles exiting East Glebe, potentially resulting in pedestrians being struck by vehicles. The Part Time 20 sign was flashing with diagonal lights at 10:50am.

Probability	Risk	Low	Medium	High
High				
Medium			<b>x</b>	
Low

Recommendations: It is recommended that the foliage is cut back, and the Part Time 20 sign is repaired.
