Carterton and the Surrounding Area Local Cycling and Walking Infrastructure Plan

Audit Report

March 2025

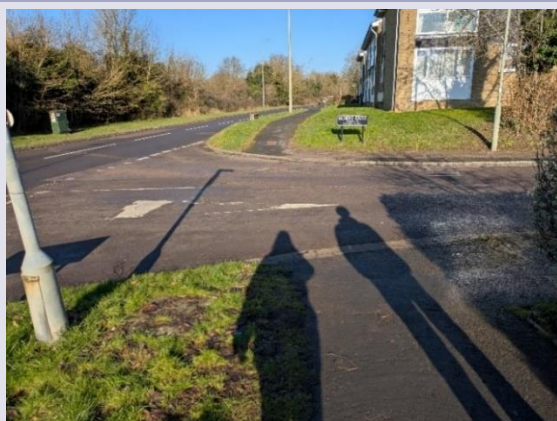
Figure 8: Lack of tactile paving on crossing over side roads of Upavon Way

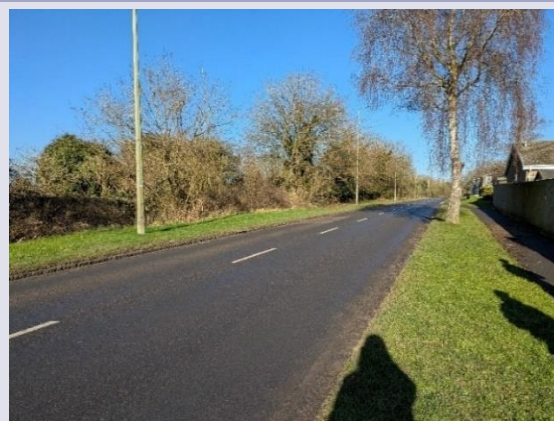
Figure 9: Wide carriageway, with large verges on either side on this section of Upavon Way

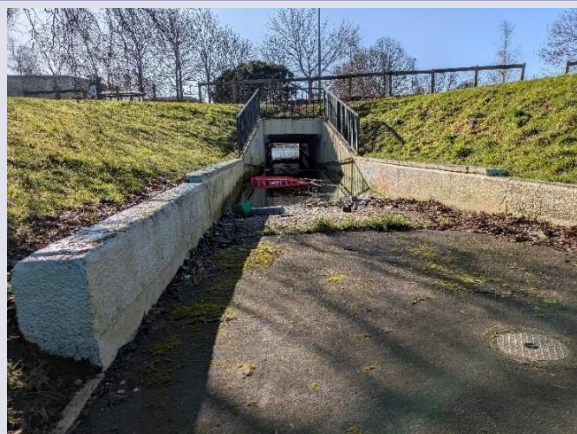
Figure 10: Underpass on eastern section of Upavon Way flooded with litter in standing water

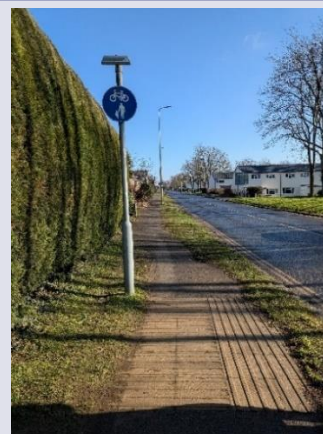
Figure 11: Unclear/ incorrect signage and tactile paving indicating a shared use footway/ cycleway

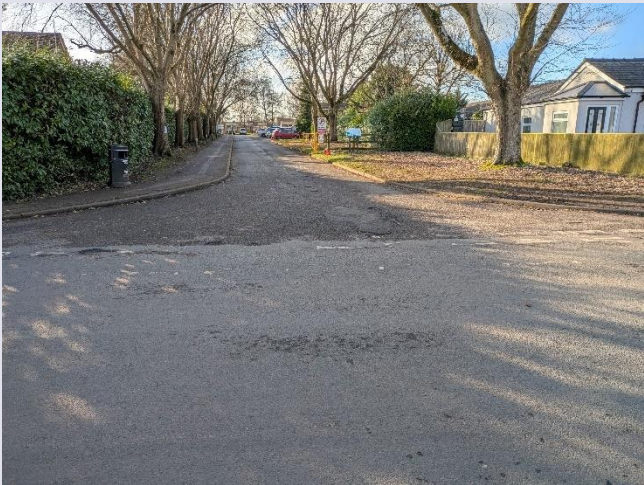
Figure 16: Missing dropped kerbs and tactile paving at side road leading to St Joseph's and Edith Moorhouse Primary Schools						Figure 17: Vehicles parked on both sides of the carriageway

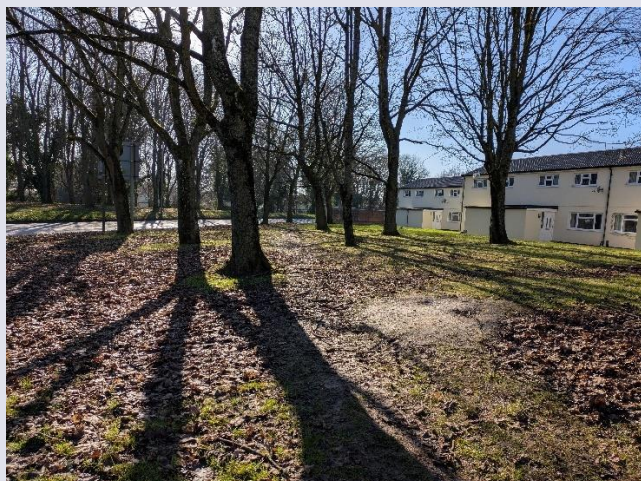
Figure 22: Desire line running south from Upavon Way to join the northern side of the carriageway of Brize Norton Road

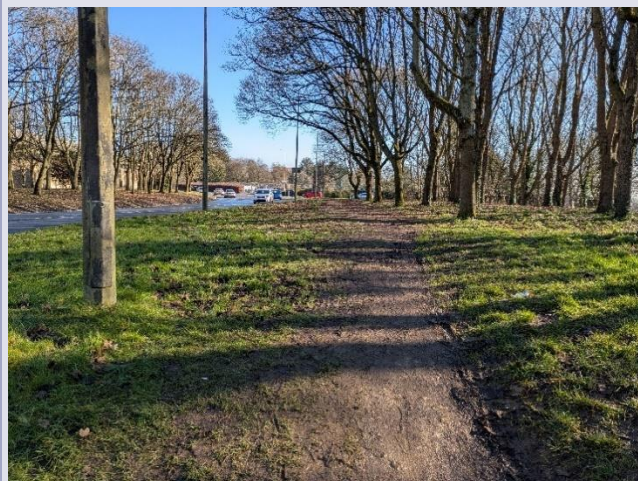
Figure 23: Clear desire line over the verge from the crossing over Brize Norton Road eastbound

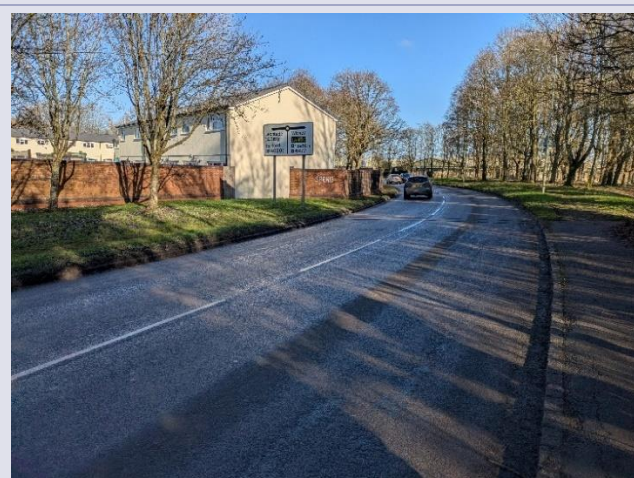
Figure 24: Desire line running parallel to the carriageway on northern side of Brize Norton Road

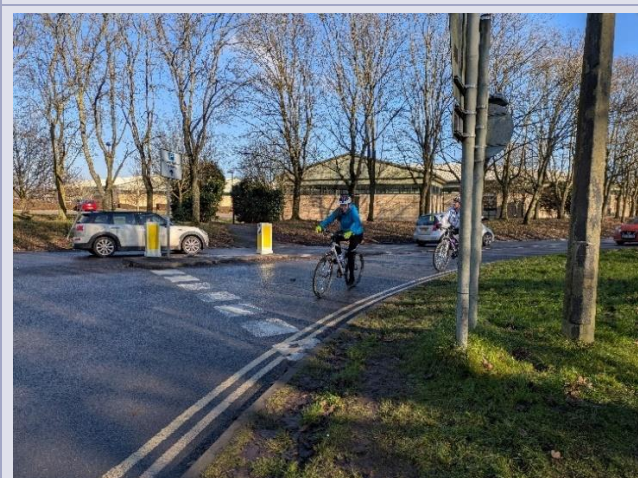
Figure 25: Poor crossing facilities at the mini roundabout connecting Upavon Way, Brize Norton Road and Carterton Road

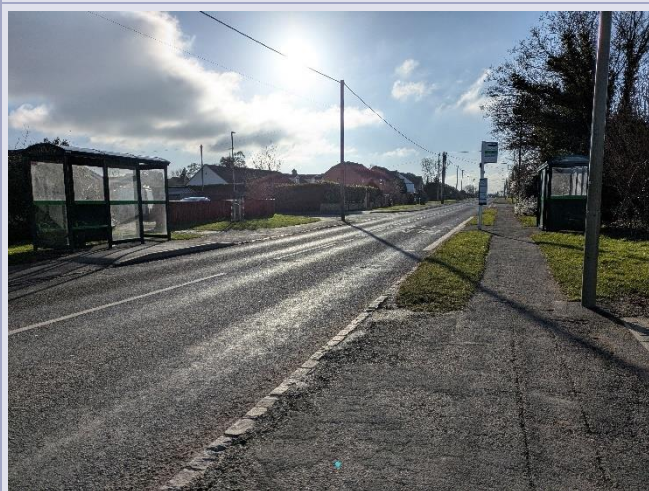
Figure 30: The carriageway of Alvescot Road is very wide, with verges separating the footway and carriageway

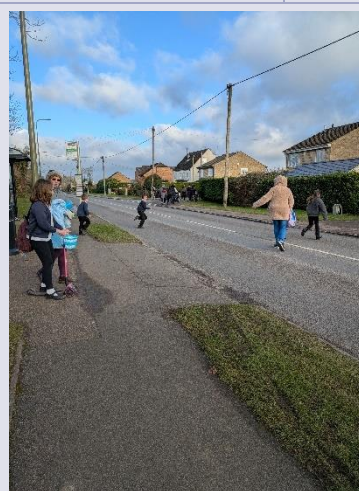
- There is very little crossing provision over Alvescot Road along the length of the road. There is need for crossings, especially at the end of the alley connecting Edith Moorhouse Primary School and Alvescot Road.
- Pedestrian priority is removed when crossing the side roads.
- Due to the width and visibility, vehicles were observed driving at excessive speeds at quiet periods endangering pedestrian safety.

Figure 31: Children run out across Alvescot Road at the end of the alleyway connecting to Edith Moorhouse Primary School

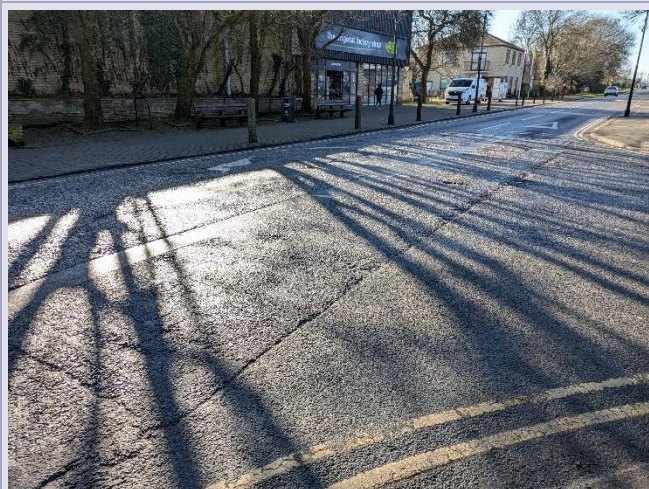
Figure 32: Unclear markings showing the mini roundabout make pedestrian movements difficult and unsafe

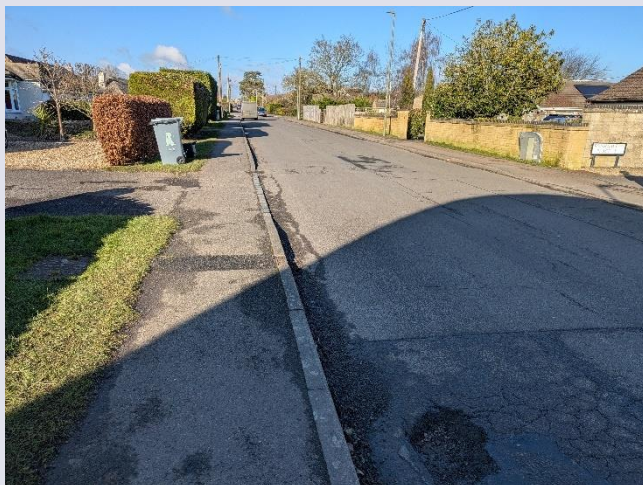
The footways are approximately 1-1.5m in width, with small verges, making passing other users difficult without stepping into the carriageway. The footway surface condition is adequate, with some mis-matched tarmac in places where utilities have been installed.

Figure 34: Swinbrook Road footways are very narrow

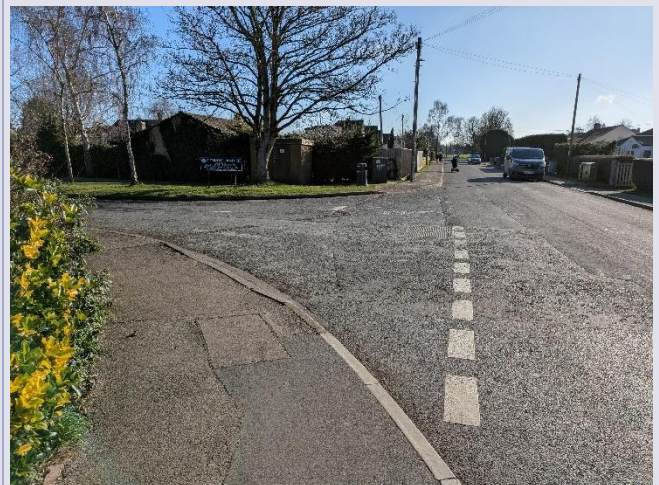
Figure 35: Junction of Swinbrook Road and Glenmore Road very wide and missing tactile paving on dropped kerbs

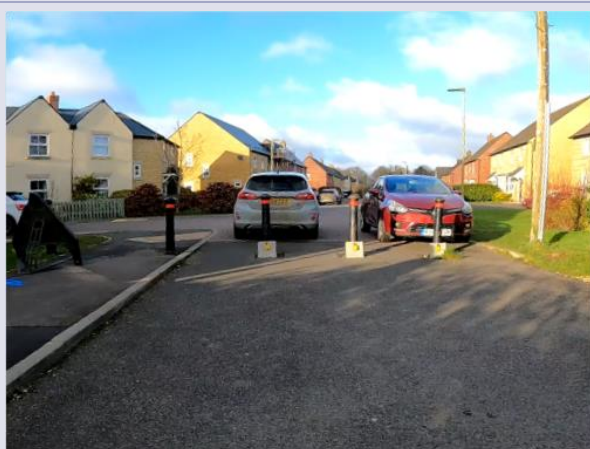
- Beyond Baldwin Mews, the footway on the eastern side of the carriageway stops, with no provisions to cross onto the opposite side.
- Dropped kerbs and tactile paving at side roads are not up to standard, with wide junction mouths at Glenmore Road.
- An existing modal filter north of Manor Road has been observed to be utilised as an area for parking (Figure 36) which restricts pedestrian and cycle movements through the filter.

Figure 36: Modal filter at the northern end of Swinbrook Road

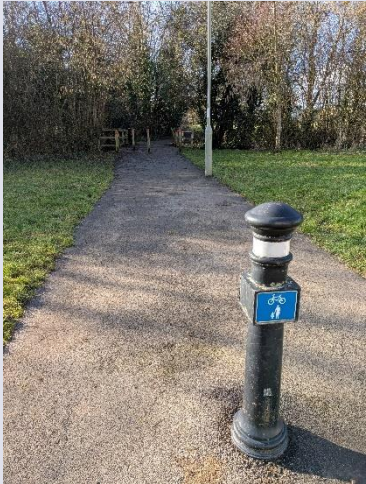
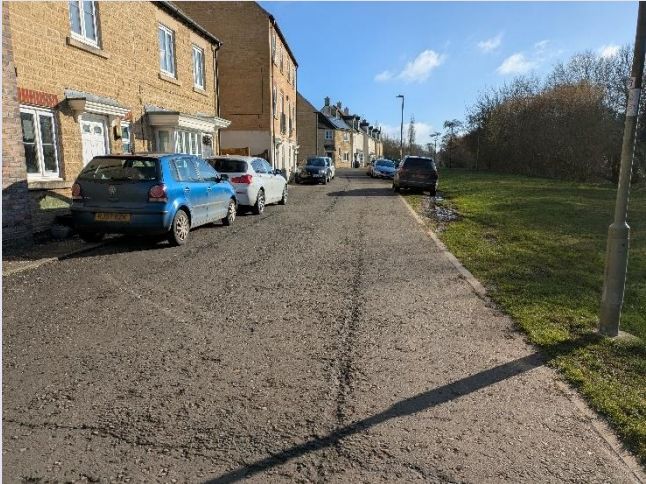
Figure 37: Marked route on small bridges over the brook to access Swinbrook Road and Boundary Lane			Figure 38: Trodden and popular walking route along Boundary Lane where pedestrians must use the carriageway

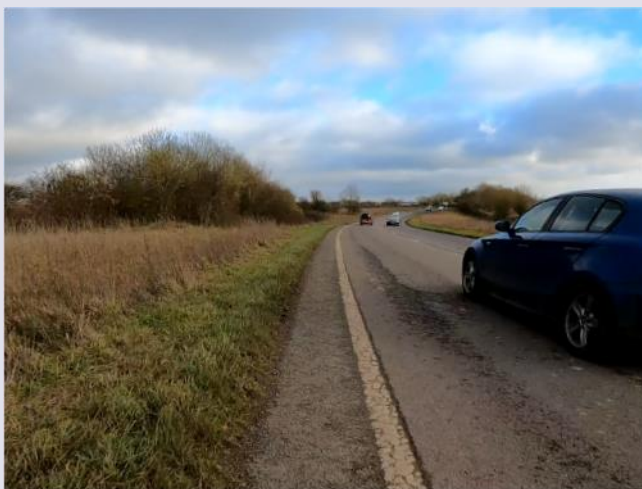
- Currently, cyclists have the option to cycle in a small verge, with vehicles passing at a very close distance.

Figure 46: Cyclists have to use the small gutter verge, whilst the carriageway is very wide meaning cars travel at high speeds

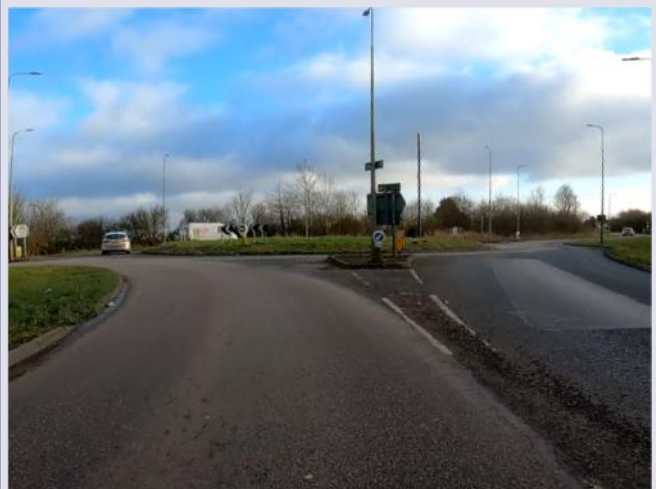
Figure 47: At present, cyclists must navigate a large roundabout with high speeds which could be unsafe

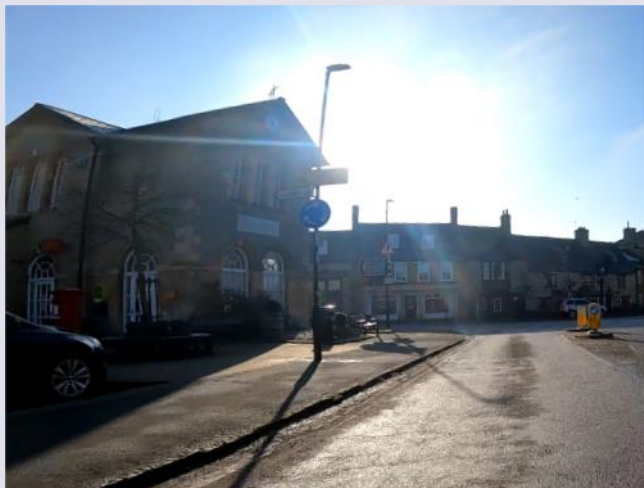
Figure 59: No clear cycle parking in the busy hub in the centre of Clanfield

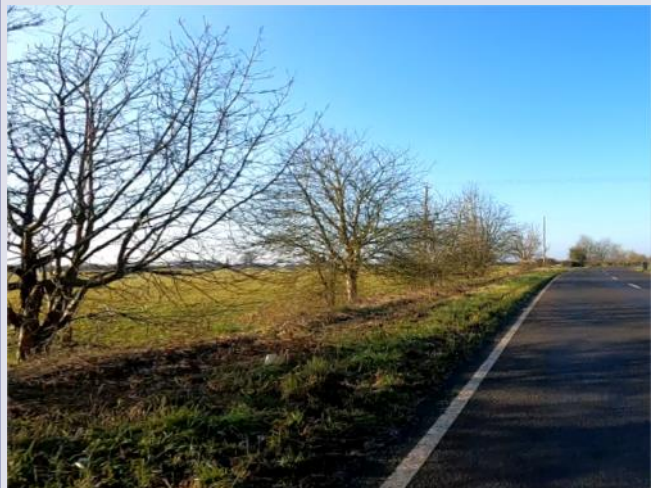
Figure 60: Ditches line the southern verge of the carriageway, with a large levels difference

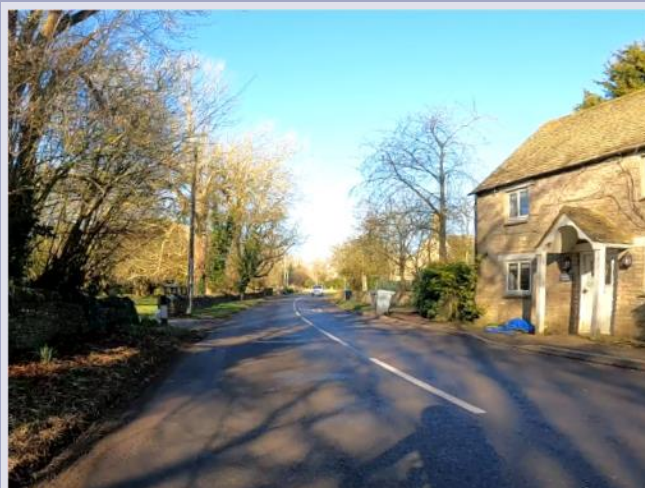
Figure 61: The carriageway and footways narrow in Alvescot where historical buildings and boundaries limit

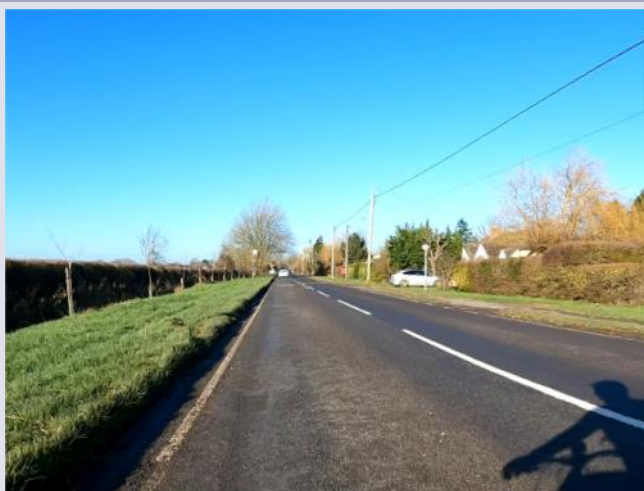
Figure 63: Wide carriageway and verges on connection between Alvescot and Black Bourton

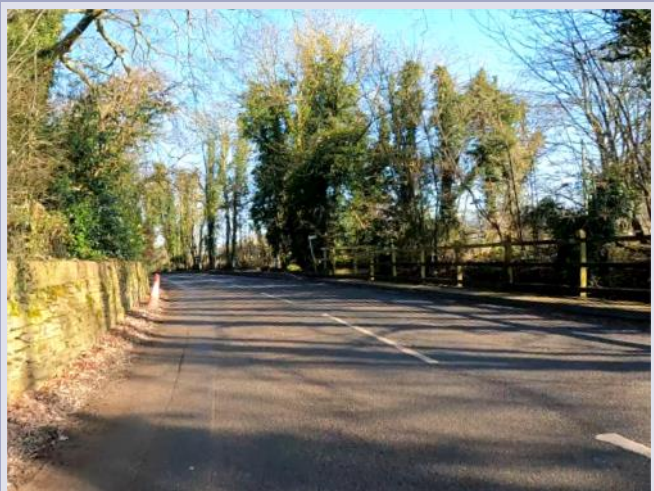
Figure 64: Carriageway narrows on entrance to Clanfield

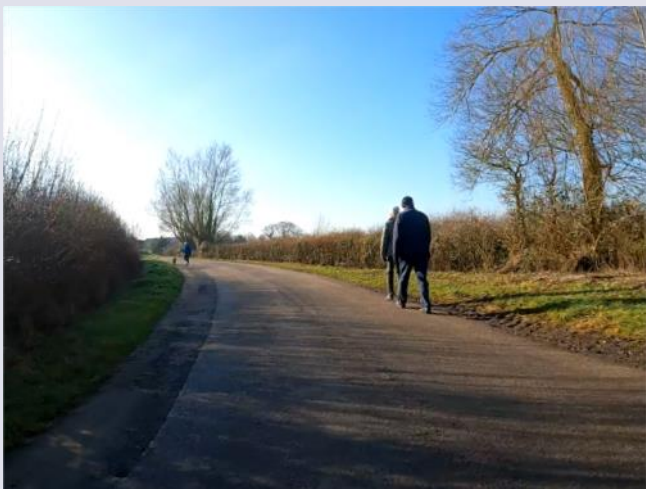
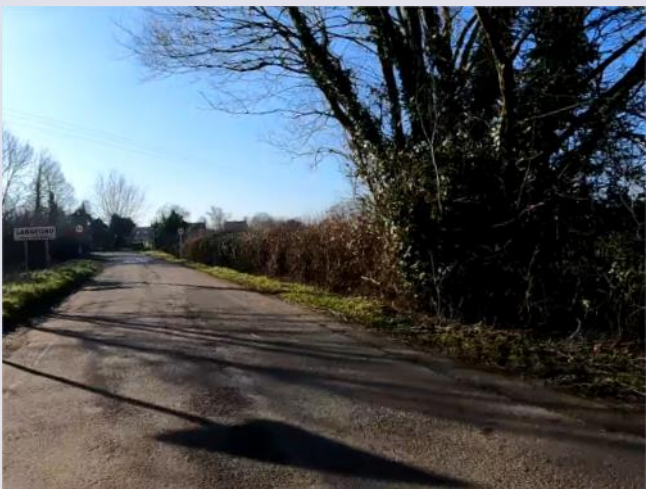
<div> Figure 65: Due to the nature of the road, pedestrians walk in the carriageway </div>	<div> Figure 66: Ditches line the western verge in sections on approach to Langford </div>

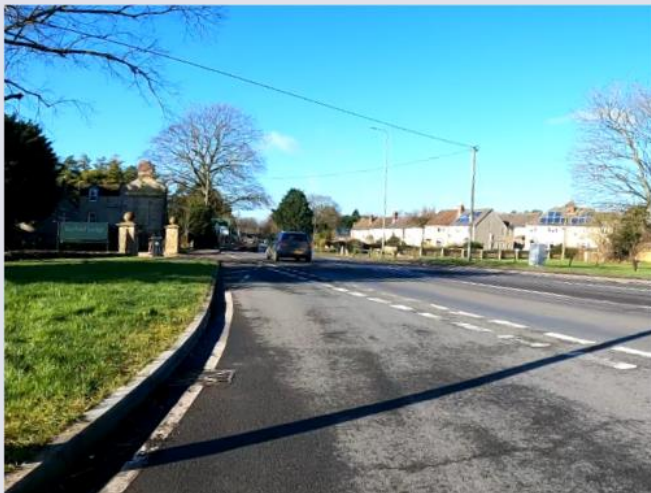
Figure 67: Poor cycle facilities to navigate the Shilton Road/ A40 junction where traffic flows are much higher

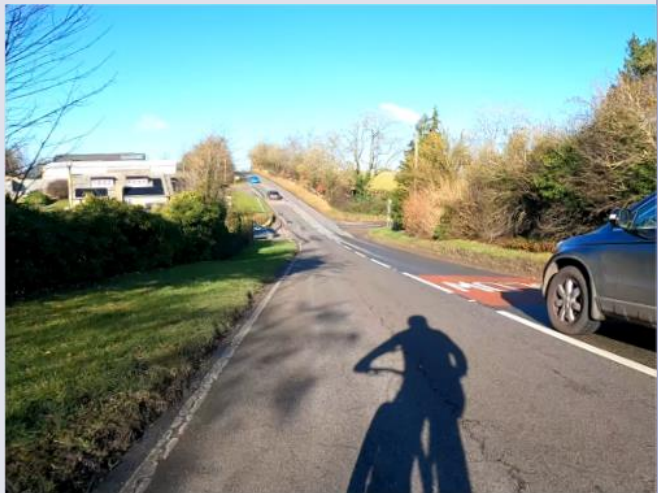
Figure 68: Sections of steep gradient may deter some cyclists from using this route
