Walks & Talks 2026

North Swanage - 1 of 5 UK locations chosen to participate in the Environment Agency's Coastal Transition Accelerator Programme, chosen for their unique features and strong, engaged communities.

Today's walk will take us along Cliff Behaviour Units (CBU) 1-6 Map Section 1 looking at distinct segments of the cliff system, characterised by similar physical form, geology composition and cliff behaviour.

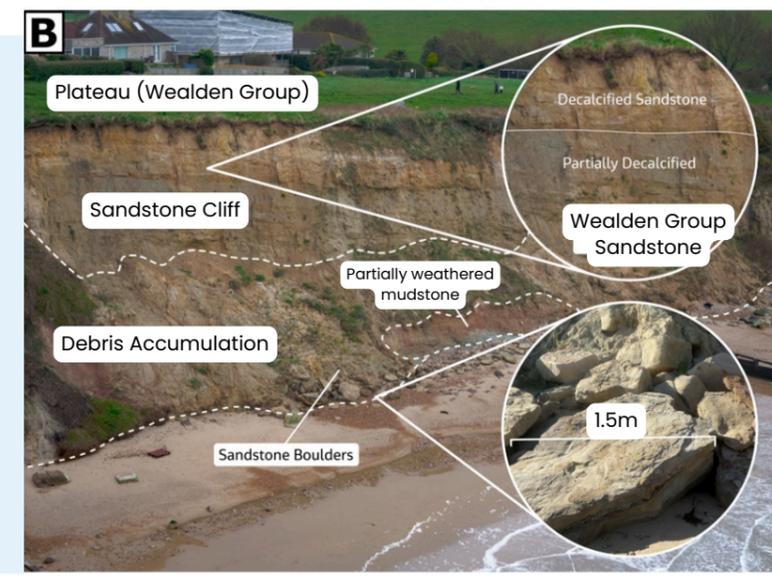
Sandstone instability process

- Sandstone: Relatively resistant to erosion, forms steep vertical cliffs. Rockfall failures possible but not susceptible to deep seated landslides or mudslides
- Cliff retreat in regular small increments
- Deep drainage and vegetation stabilisation likely ineffective.
- Surface water control beneficial
- With seawall in place cliff instability and recession will gradually reduce
- Barrier system needed to protect beach users below cliff

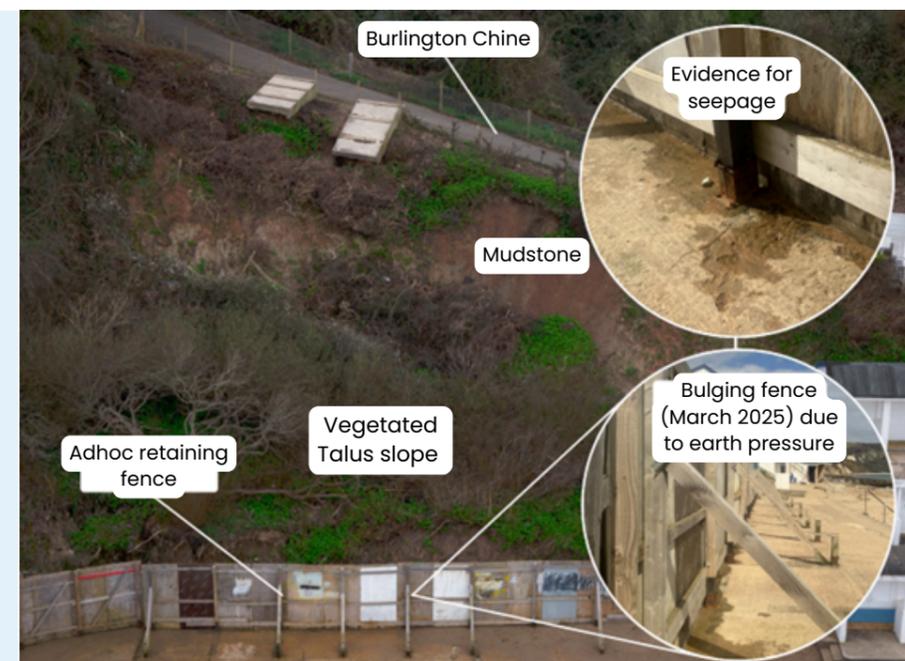
Mudstone instability process

- Mudstone: Relatively erodible and susceptible to deep seated landslides and mudslides when weathered and influenced by ground / surface water
- Cliff retreat can be in 10 m chunks (e.g. Pines Hotel 2012/13)
- Climate change (increased winter rainfall) will continue to cause instability and cliff recession
- Drainage potentially effective in places
- Vegetation stabilisation potentially effective in places

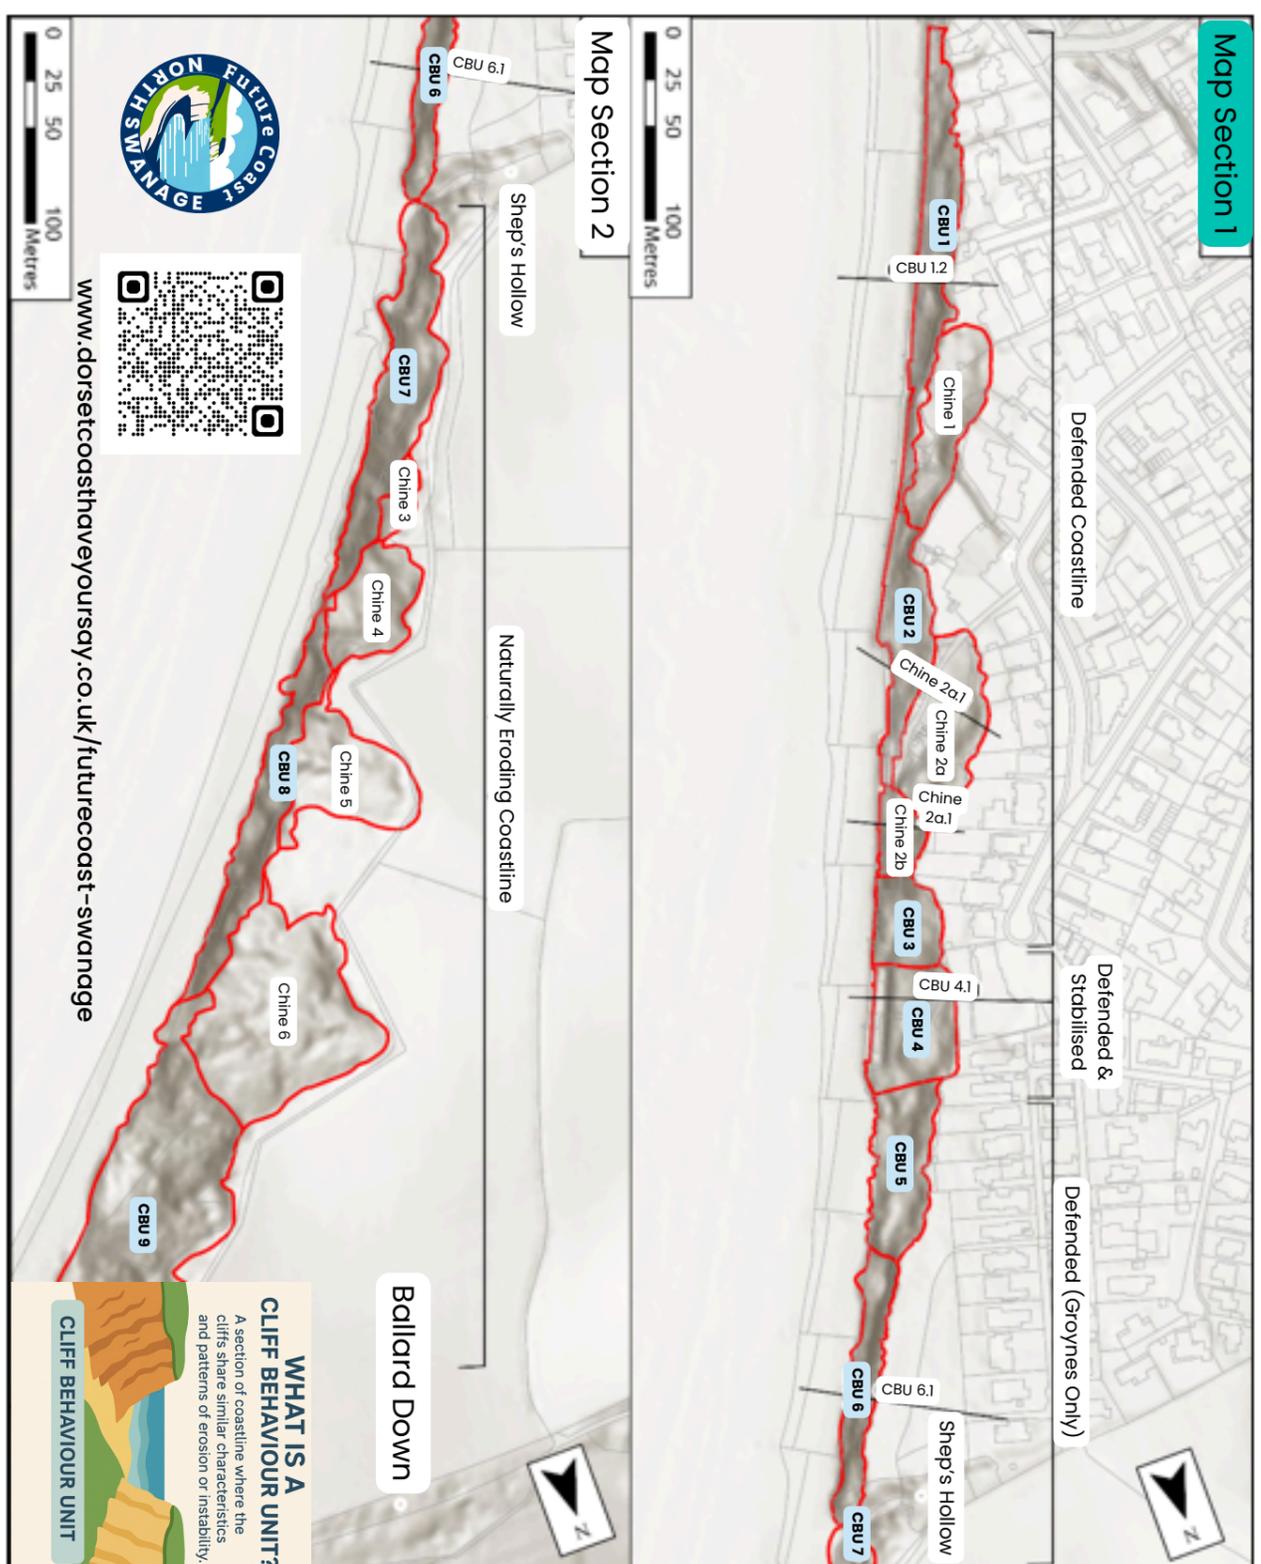
Cliff and Chine Behaviour Units

What are they: Distinct segments of cliff system, characterised by similar physical form, geology composition, and cliff behaviour

Why have they been defined: Enable definition of changing hazards along frontage and related appropriate adaptations

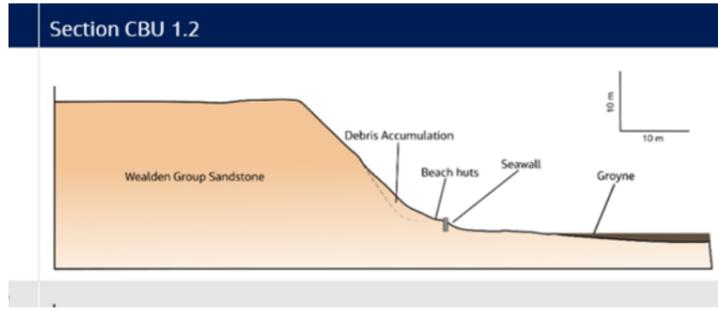
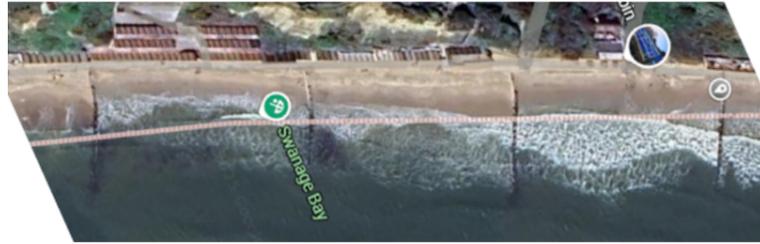
CBU1 Sandstone beds dipping north

CBU1 starts roughly in line with first wooden beach huts - south of first timber groyne
 Scenario 2025: steep (30-60 degree) weathered sandstone cliffs, well-vegetated cliff face, rockfall scars evident on cliff face from historical failures, accumulation of talus at cliff base, loading at cliff top, surface water runoff over cliff edge

CBU1 ends in line with 4th timber groyne

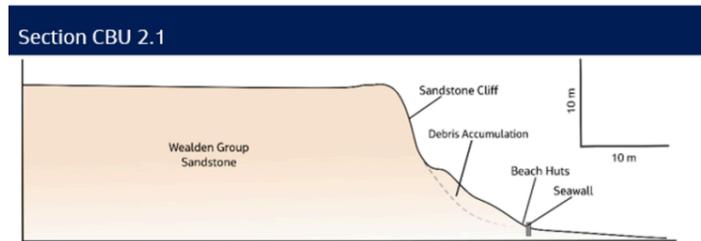
CBU2 Sandstone beds Wealden Group

CBU2 starts at 4th timber groyne by the coloured huts after Chine to Burlington
 Scenario 2025: steep (40 degree+) to near vertical weathered sandstone cliffs, debris accumulation at cliff top with bulging and seepage evident, well-vegetated talus slope

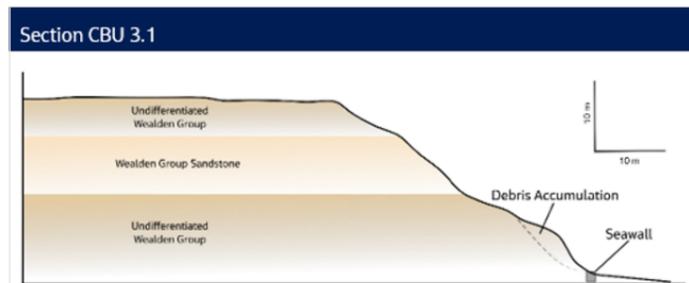
CBU3 layers of Mudstone & Sandstone

CBU3 starts after the Burlington huts and includes the stone apron (recently repaired by homeowner)
 Scenario 2025: densely vegetated steep slopes (20-40 degree) of undifferentiated Wealden Group mudstone and sandstone with a central band of sandstone, talus and landslide debris material remains slumped over the top of dilapidated structures at cliff toe from historical failures

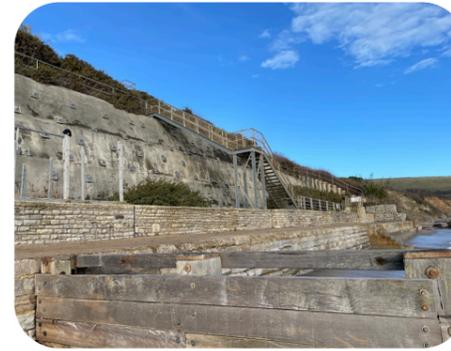
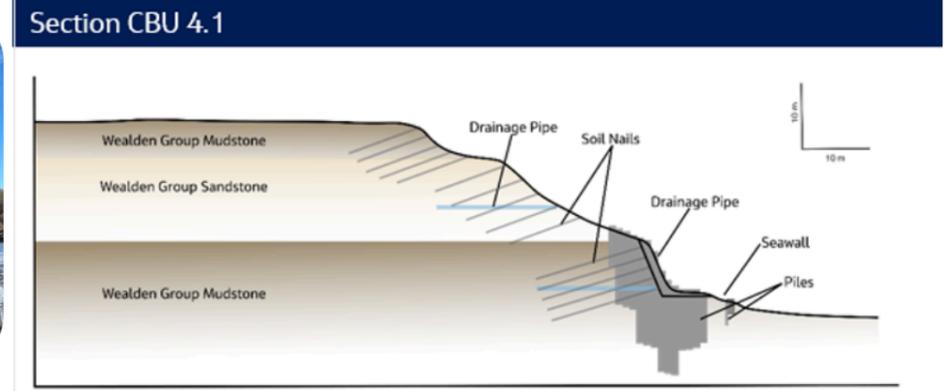
CBU4 layers of Mudstone & Sandstone - Pines Hotel scheme

CBU4 Scenario 2025: cliff stabilisation scheme completed in 2017 comprising concrete retaining wall with soil anchors and piling, slope drainage and soil nailing on upper cliff. Scheme is designed to stabilise the cliff in front of the Pines Hotel through 2055. North of the retaining wall, shallow slumping of accumulated debris may continue to occur due to saturation or loading

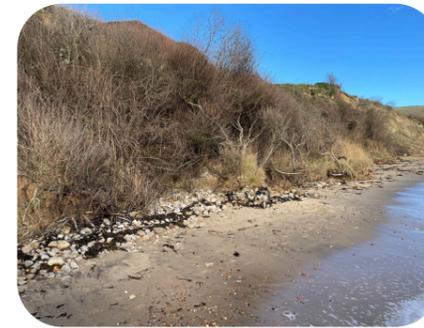
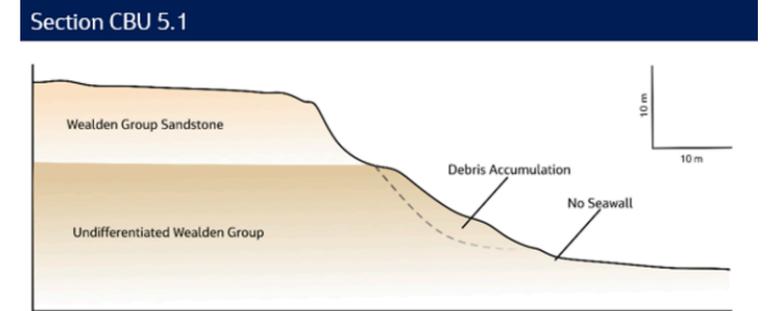
CBU5 Sandstone layer on top of Wealden Group

CBU5 starts after Pines scheme and seawall ends covers approximately 1 groyne bay and **finishes** just beyond next timber groyne. Section in front of Ballard Estate undefended. Scenario 2025: active erosion of the cliff face and debris, and recent failure scars evident. Vegetated wide landslide debris benches at mudstone dominant cliffs, and unvegetated talus and boulders at sandstone dominant cliffs

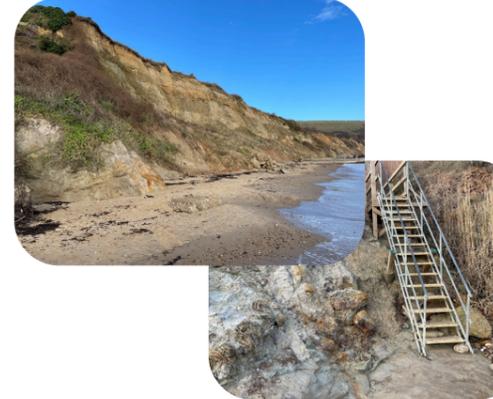
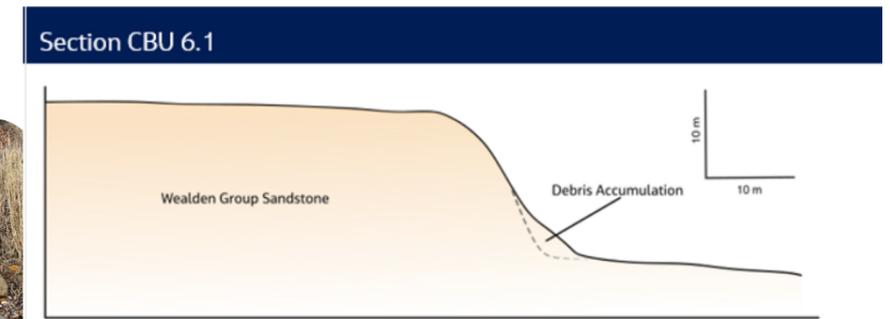
CBU6 layers of Sandstone

CBU6 starts just after 2nd timber groyne beyond seawall, continues to Sheps Hollow. Scenario 2025: steep to near vertical sandstone cliffs without protection of a sea wall, unvegetated cliff face exposed to surface weathering. Large sandstone blocks present along beach, with concrete blocks locally scattered below the cliffs which may provide some protection to the cliff toe from marine erosion. Valley incision at Sheps Hollow
