Spring Bank Conservation Area  
Character Appraisal

Draft for Public Consultation Feb 2024

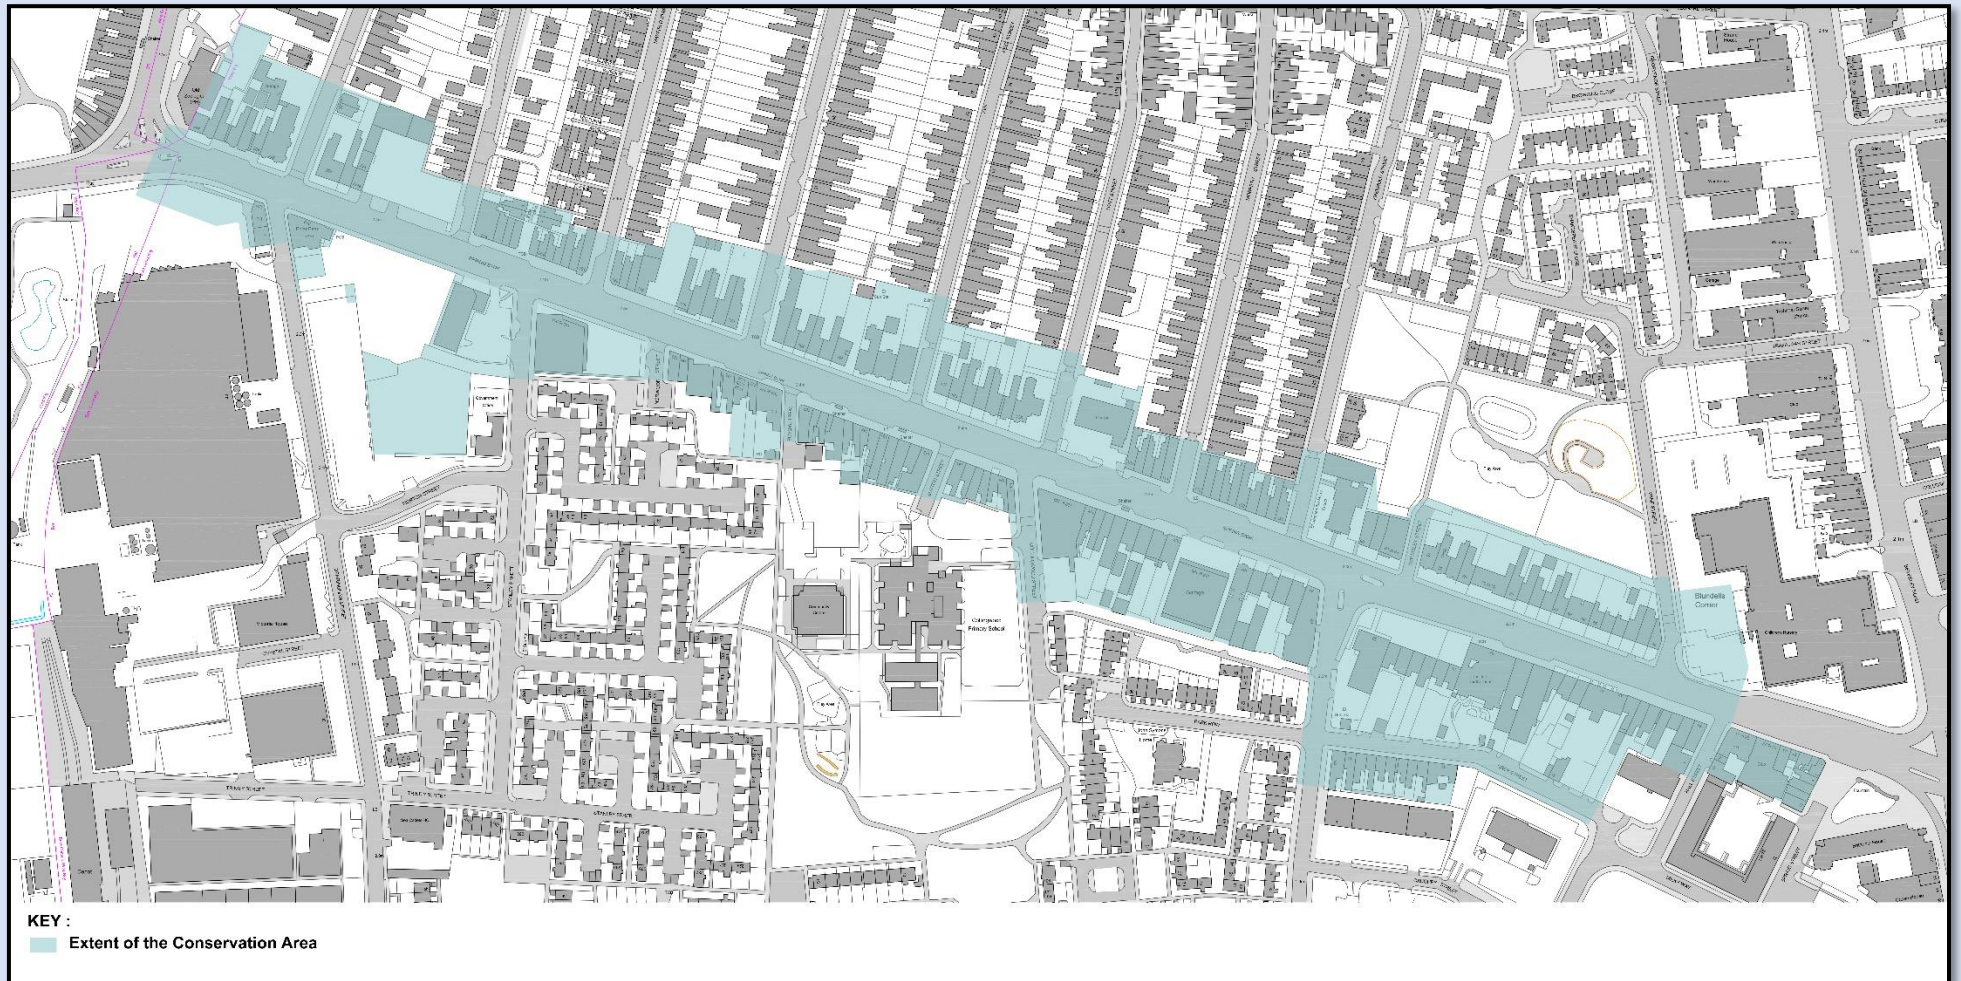
Figure 14 – Plan showing the extent of the Conservation Area Boundary  
Prepared by Seven based on Ordnance Survey © Crown Copyright 2023. All rights reserved. Licence number 100022432. (Author, 2023)

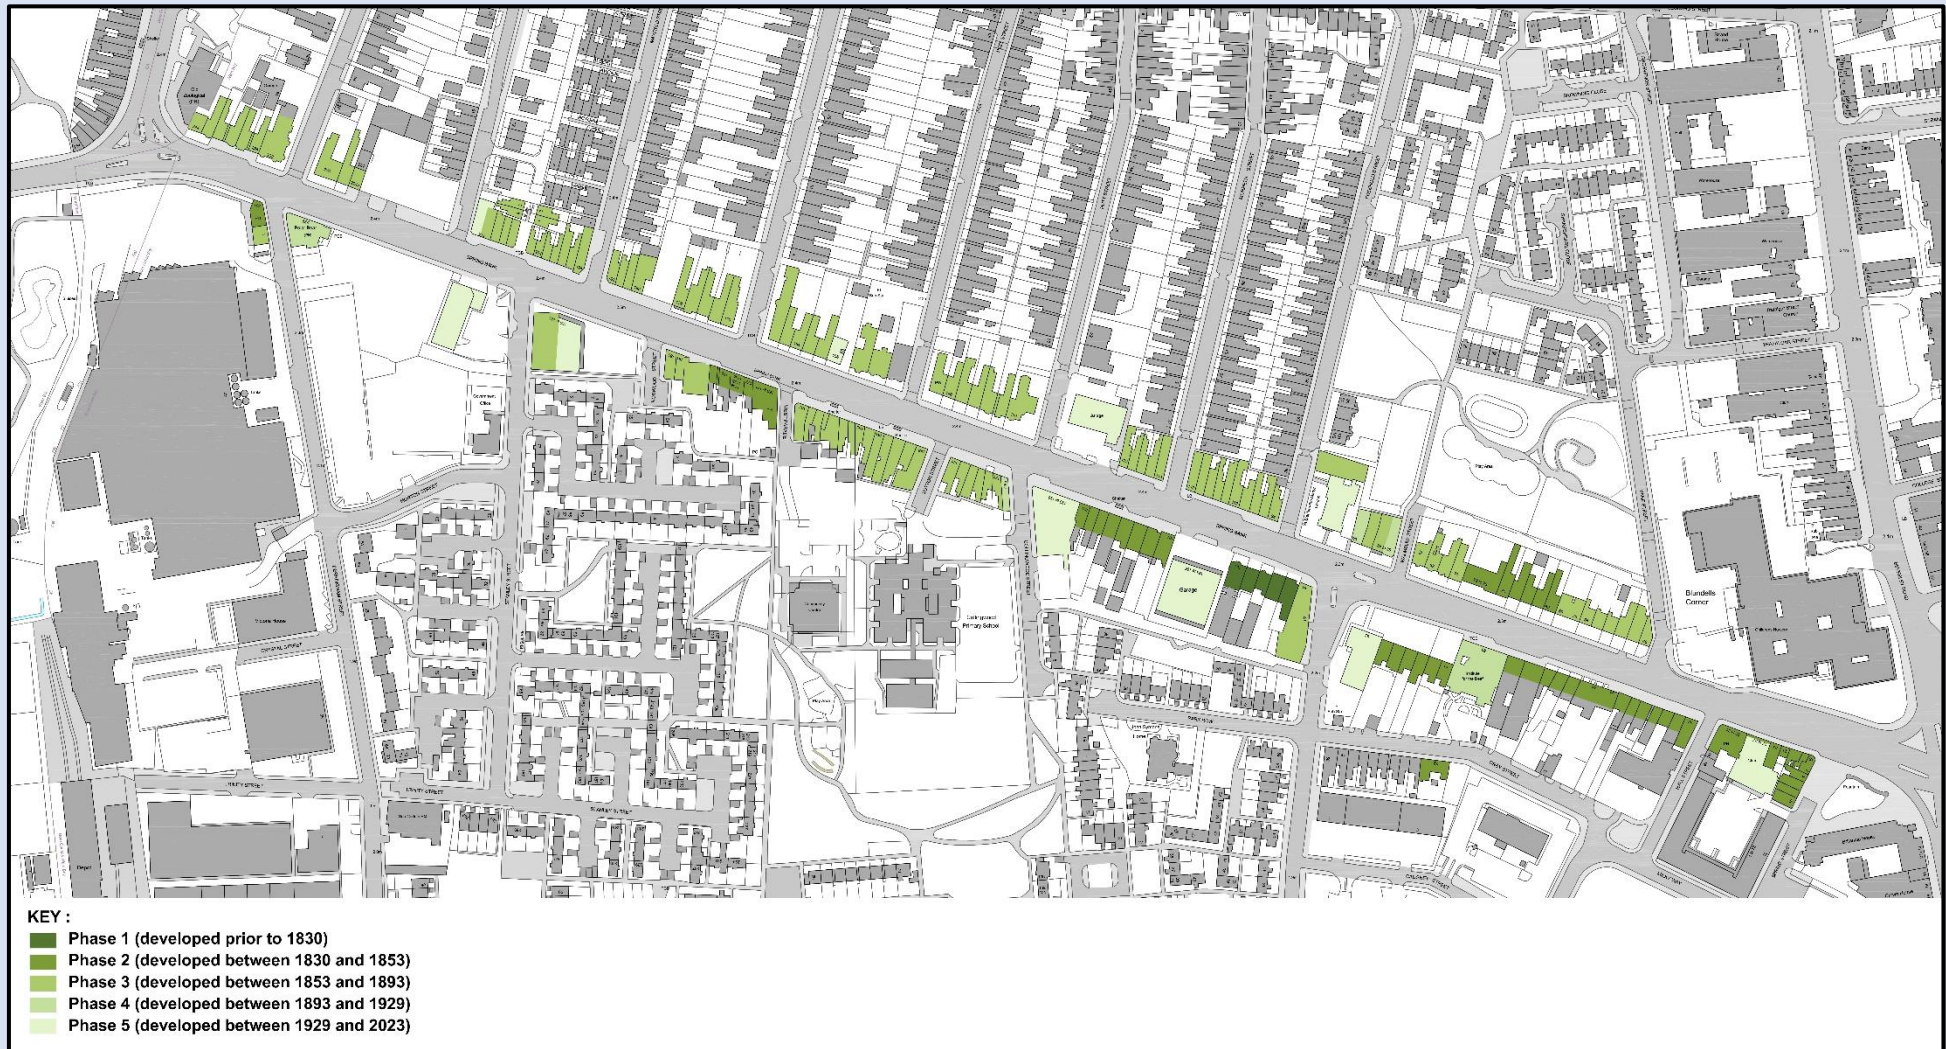
Figure 18 - Map showing the phased development of Spring Bank - Prepared by Seven based on Ordnance Survey © Crown Copyright 2023. All rights reserved. Licence number 100022432 (Author, 2023)

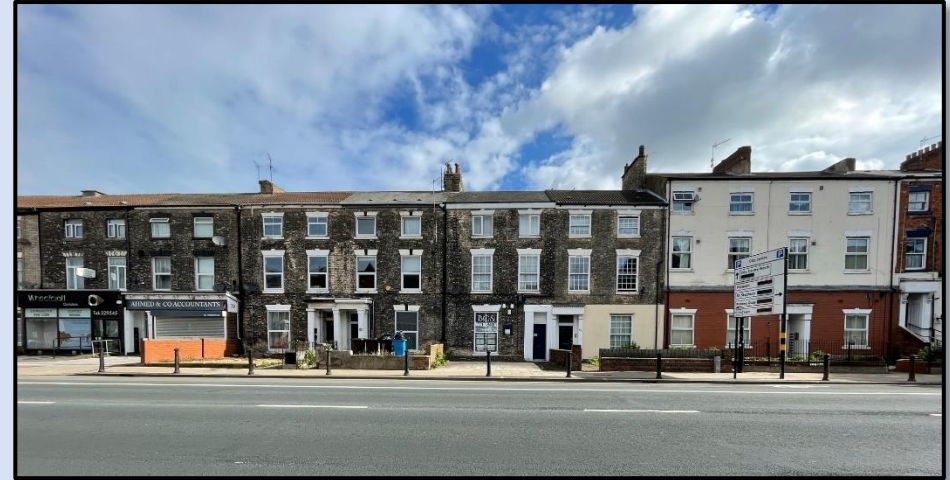
The character of buildings changes in zone 2 with buildings that are much taller in scale at three-four stories in height. This increase in height and the vertical proportions of the building, creates a proportion that successfully holds the width of the street. The predominant use in this area of the street is residential use with elevated ground floor levels with steps and cast iron railings creating a threshold space to the properties. These buildings were some of the earliest buildings constructed between early 1800's and 1893 and depict the Georgian style of architecture with vertically proportion and simple, elegant detailing.

Figure 21 - Photograph of 58 to 72 Spring Bank (north side) (Author, 2023)

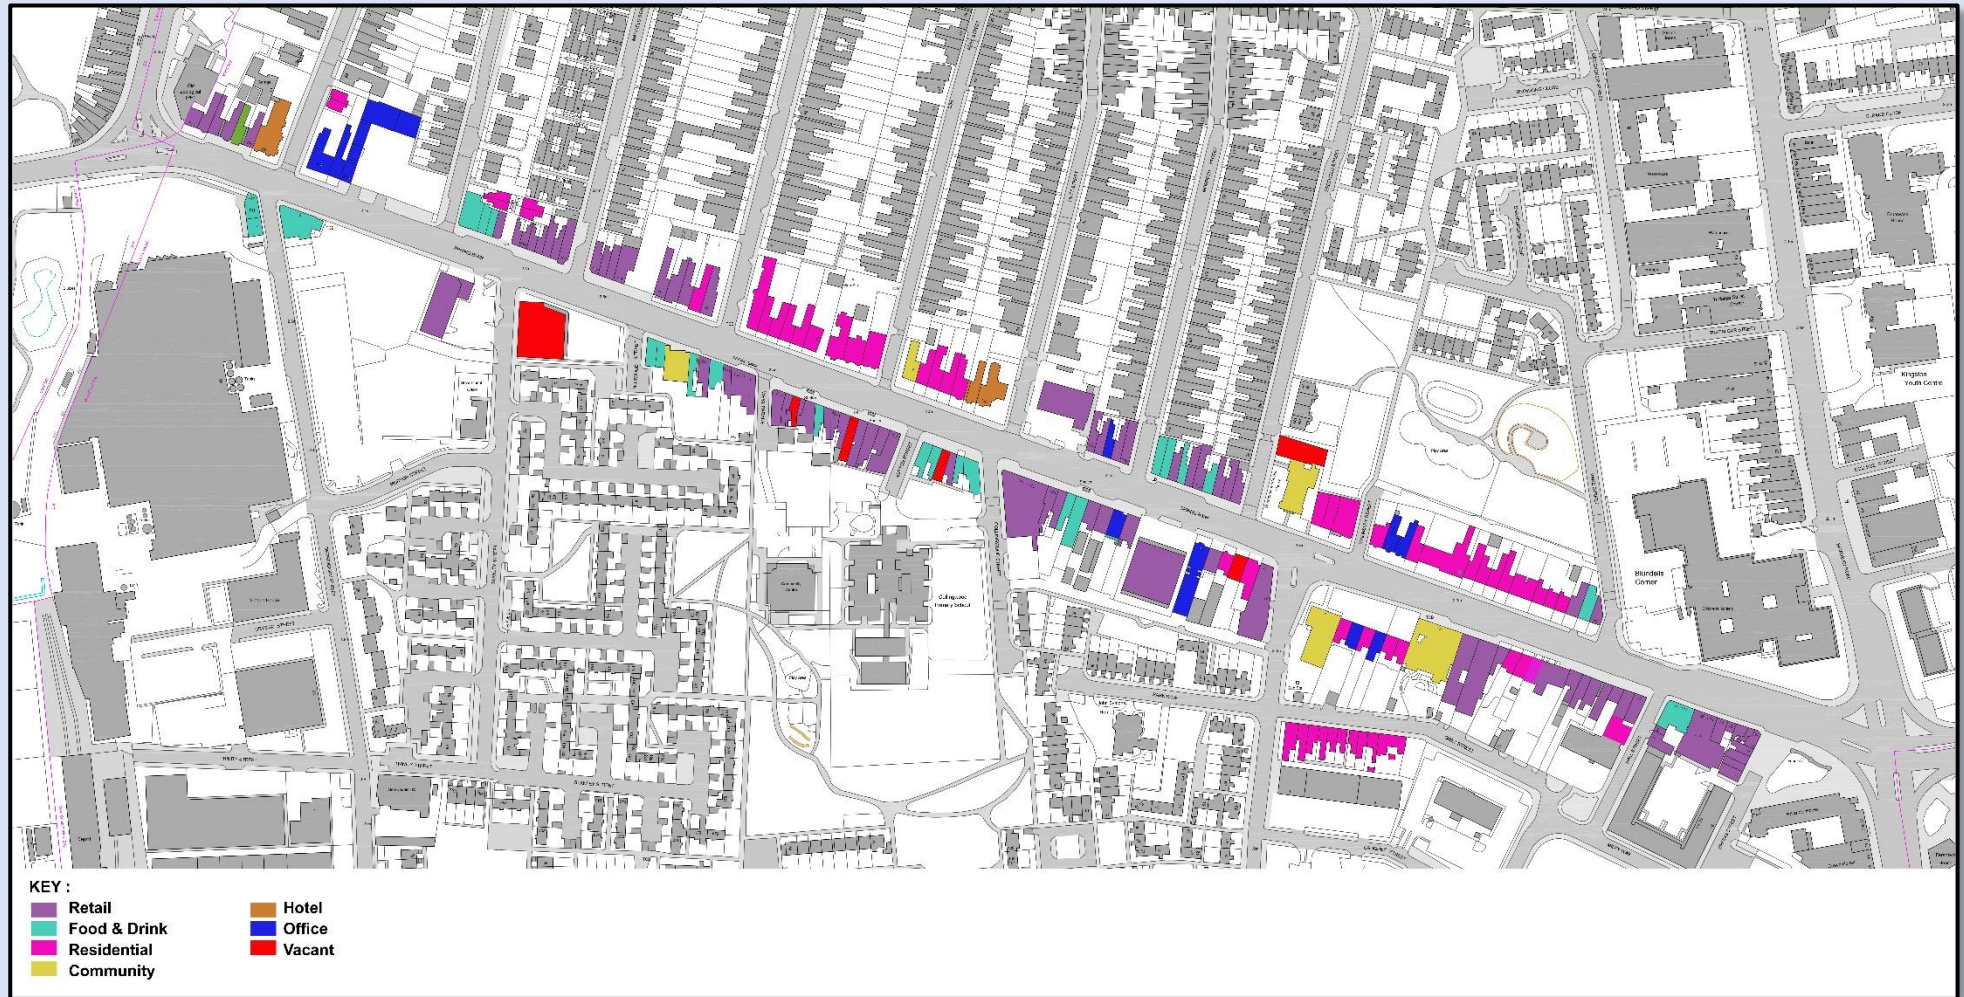
Figure 36 - Map showing the existing ground floor uses on Spring Bank (Source : Prepared by Seven based on Ordnance Survey © Crown Copyright 2023. All rights reserved. Licence number 100022432)

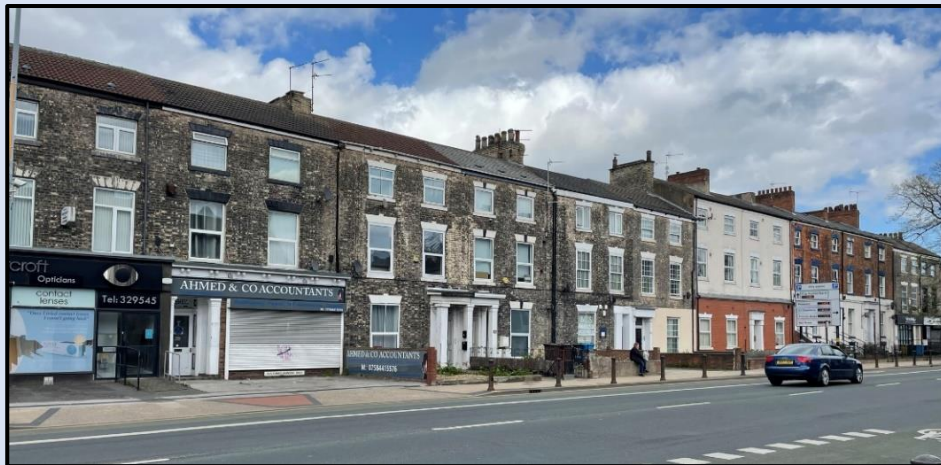
These townhouses date from 1830-1893 and are located towards the eastern section of Spring Bank. These are defined by elevated ground floor levels with stepped access, elaborate entrance porticos and pilasters and vertically proportioned windows.

Figure 39 - Photograph of 46 - 72 Spring Bank (north) (Author, 2023)

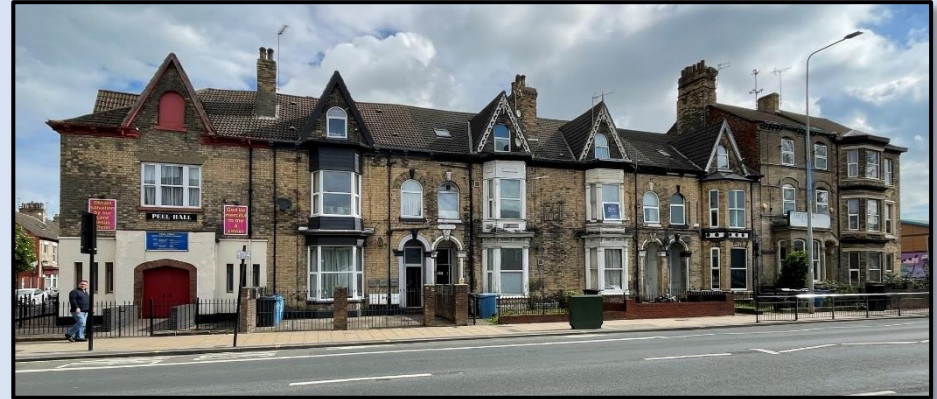
To the north side of Spring Bank are groups of Victorian villas that are all similar in character and detail. Generally three storey in height with the second floor within the roof space, these villas are defined by the use of buff brickwork, projecting two storey bay windows, decorative gables at roof level and decorative arched brick or stone detailing to doors and windows. Although historically designed as grand residential villas, a number have been converted to retail/food use at ground floor level with residential use above.

Figure 43 - Photograph of 136 to 148 Spring Bank (north) (Author, 2023)

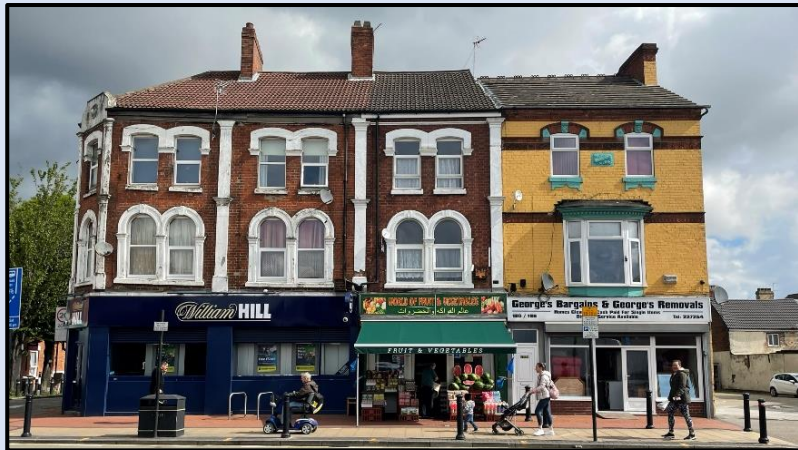
To the north side, groups of three storey buildings with residential units above and ground floor retail/food use are located along Spring Bank. Generally of buff/red brickwork construction, they include various details to bring visual interest and to maximise daylight to the upper floor levels including projecting bay windows double arched windows and projecting gable details at roof level. The retail historically was clustered within these groups, creating focal points for activity along Spring Bank.

Figure 46 - Photograph of 186-190 Spring Bank (north) (Author, 2023)

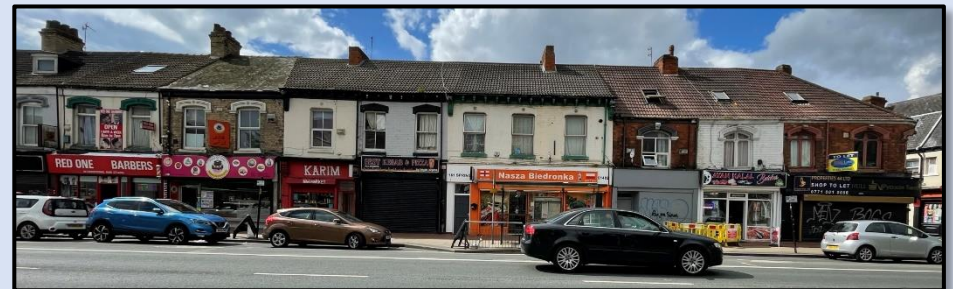
To the south side of Spring Bank, the Victorian retail units are generally limited to two storey in height with residential or back-of-house accommodation at first floor level. These are defined by predominantly brickwork facades at first floor level, often with projecting bay window features and decorative stonework arched windows and brickwork detailing.

Figure 48 - Photograph towards 147-167 Spring Bank (south) (Author, 2023)

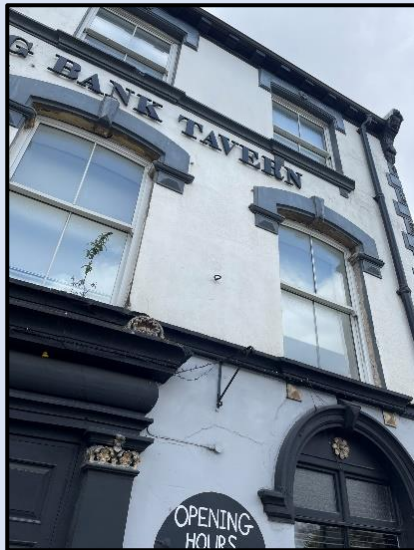
Figure 50 - Photograph showing historic details on the Spring Bank Tavern (Author, 2023)

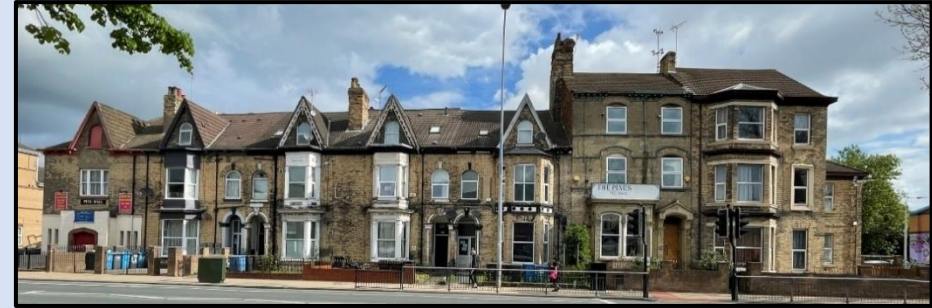
Figure 55 - Photograph towards 136-148 Spring Bank (north) (Author, 2023)

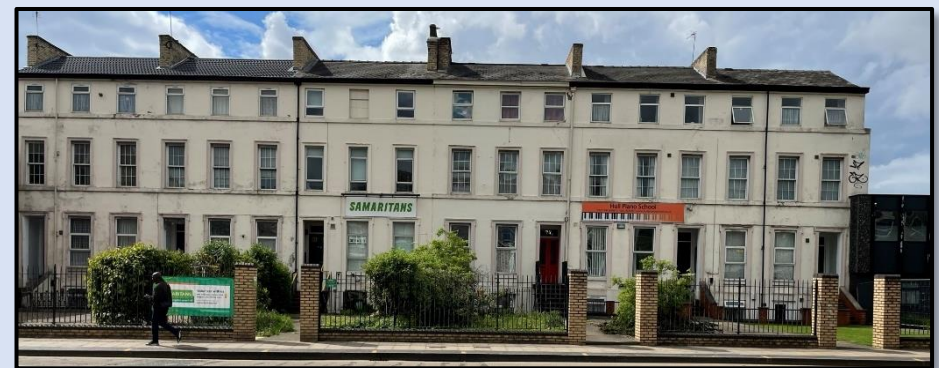
Figure 56 - Photograph towards 69-79 Spring Bank (south) (Author, 2023)

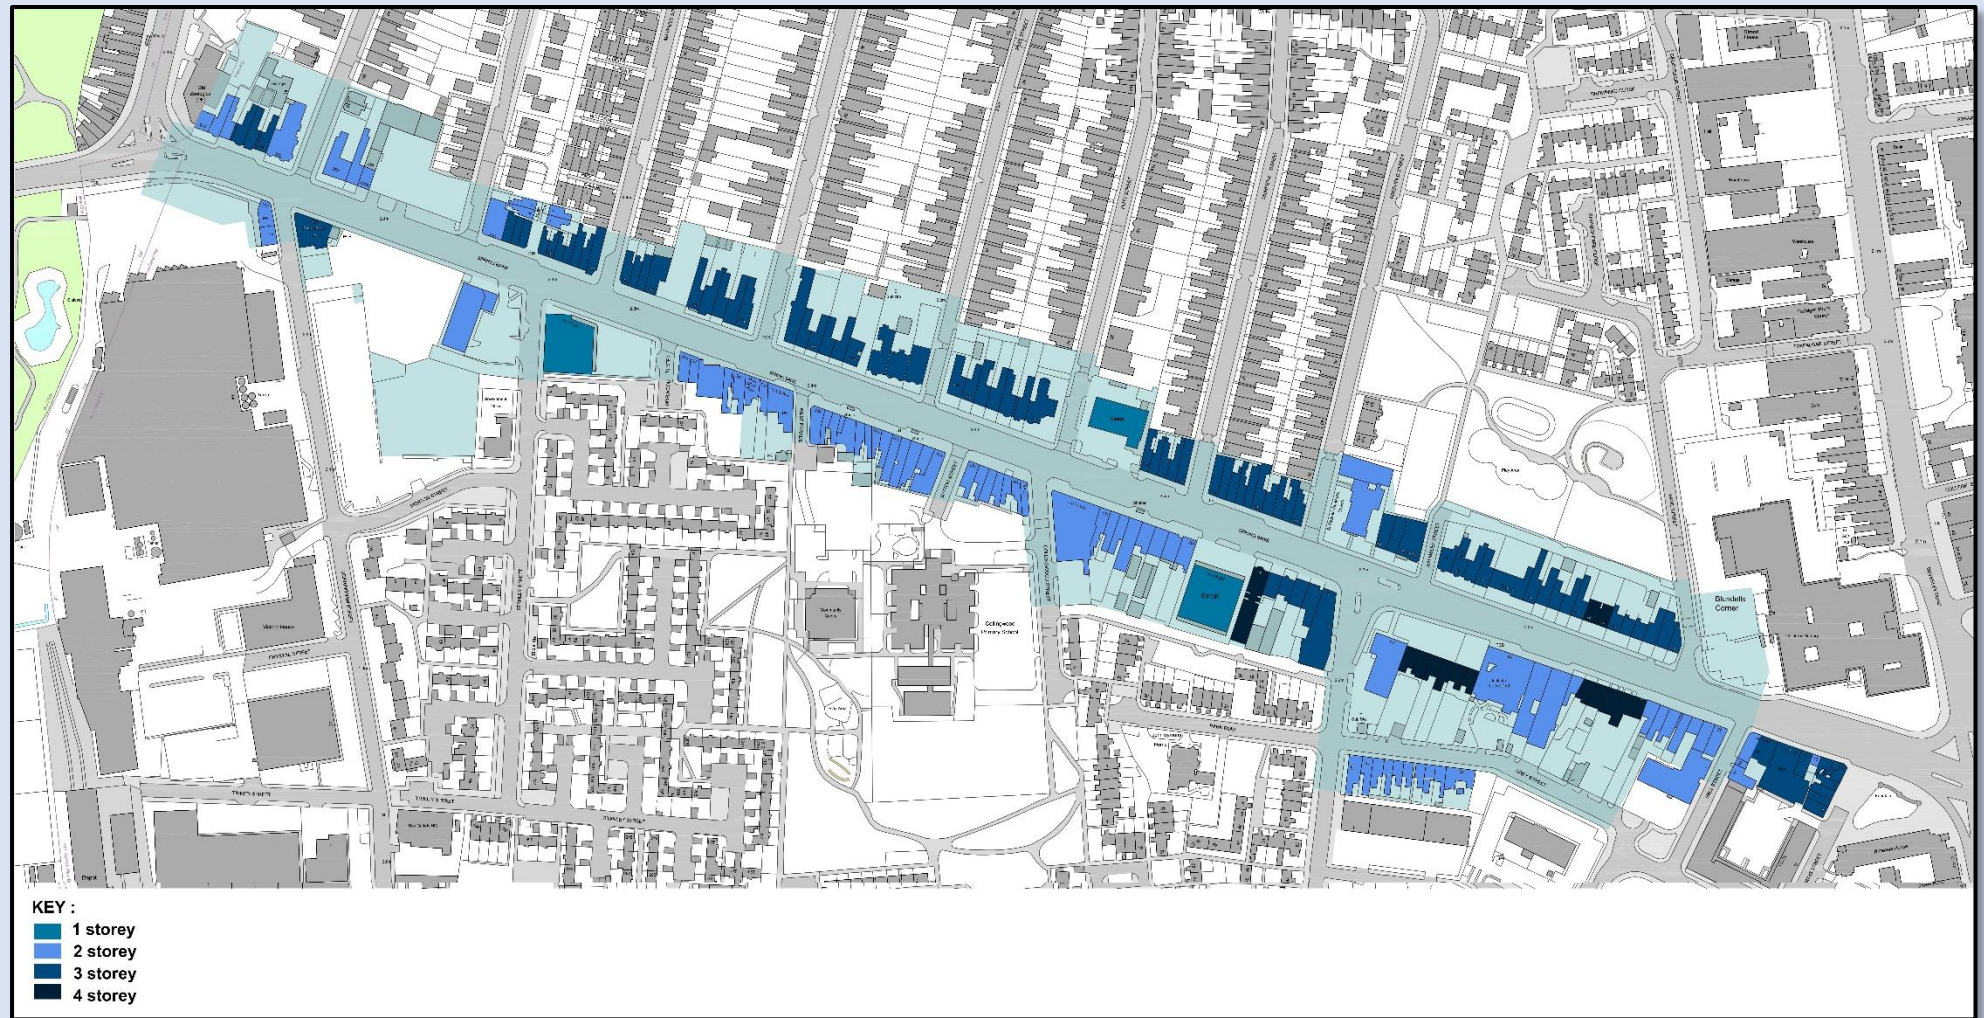
The map on Figure 46 illustrates the scale of buildings along Spring Bank. The north side of the street is predominantly three storeys in height which helps to give a good sense of enclosure to the street and clearly defines the edge of the urban blocks. The scale and vertical proportions of the buildings are broken up by details including projecting bay windows, feature gables and dormer windows that help to punctuate the eaves level and create visual interest to the street.

Figure 59 - Map showing the scale of buildings on Spring Bank Prepared by Seven based on Ordnance Survey © Crown Copyright 2023. All rights reserved. Licence number 100022432) (Author, 2023)

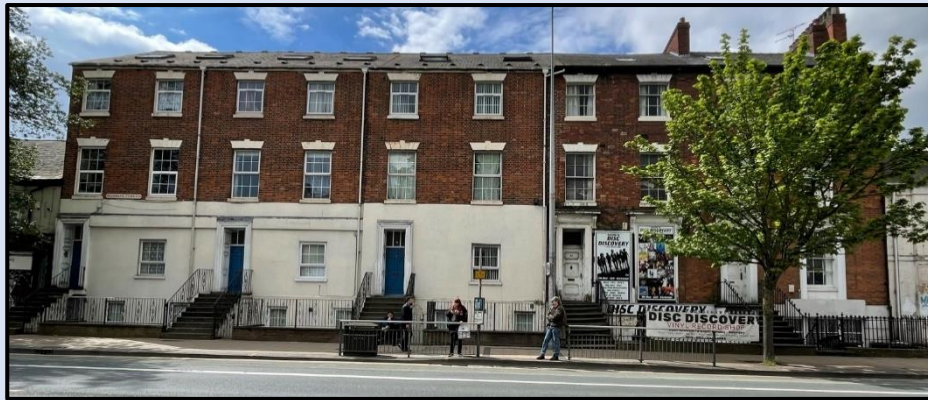
To former residential developments, front gardens were formed with wrought iron railings and low stone or brick plinths to provide formal front gardens that created a threshold to the pavement with stone steps leading up to the elevated front door.

Figure 63 - Photograph of 43-55 Spring Bank showing the railings to the site boundary (south) (Author, 2023)

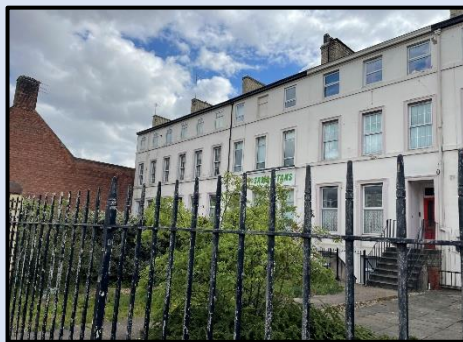
Figure 65 - Photograph of 69-79 Spring Bank showing the low brick wall and piers with iron railings between (Author, 2023)

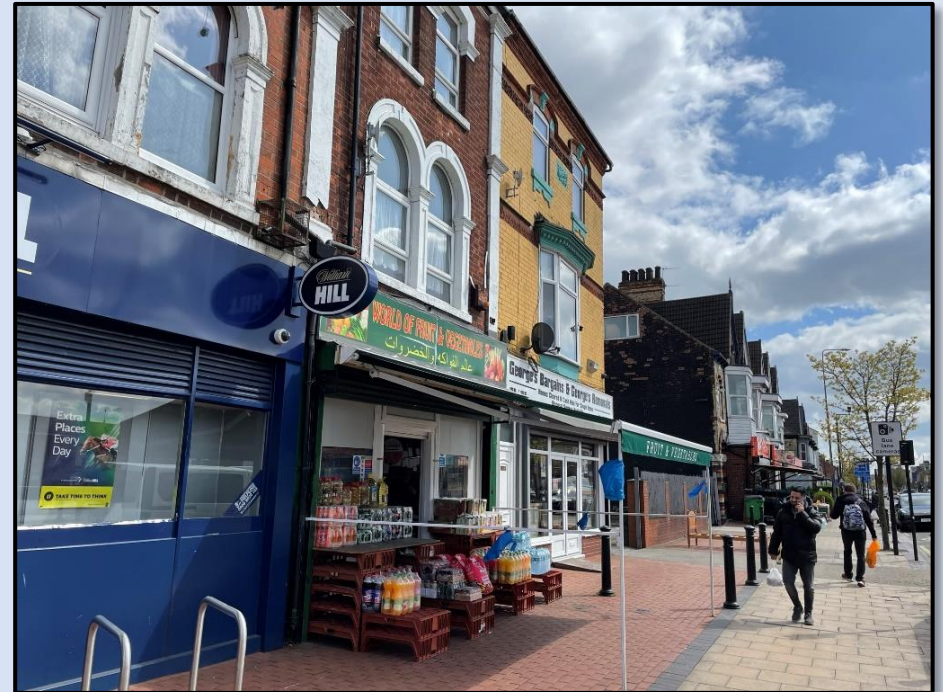
To retail units, generous pavements outside allow produce or seating to be located on the street, which create a vibrancy to the street and encourage activity throughout the day. Awnings were historically used to provide shelter to the external areas and to minimise overheating within the shopfront, particularly to the north side of the street.

Figure 66 - Photograph of 186-188 Spring Bank showing the generous extent of external areas to some retail units (Author, 2023)

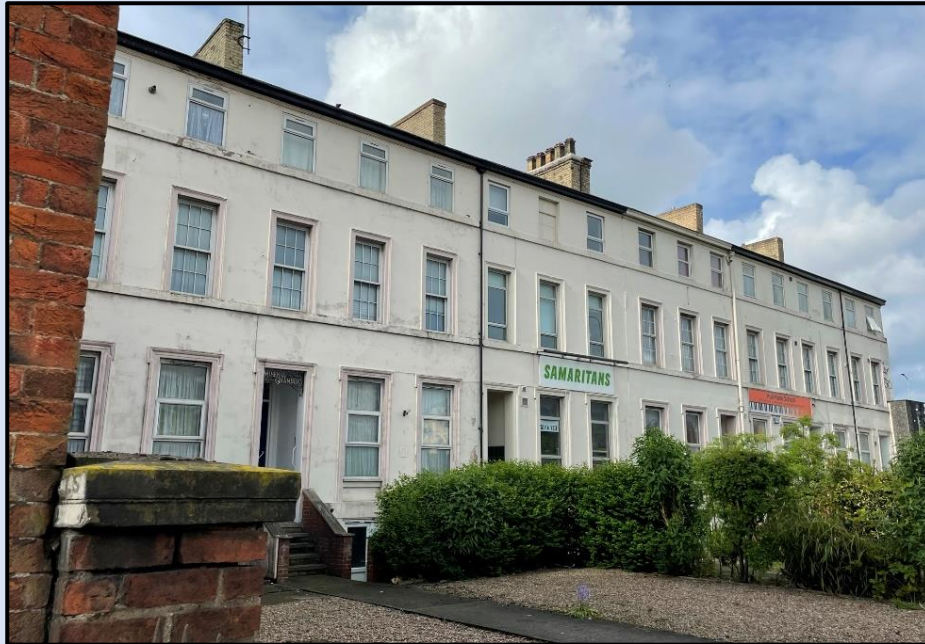
Figure 67 - Photograph of 69-79 Spring Bank which is substantially set back from the dominant building line (Author, 2023)

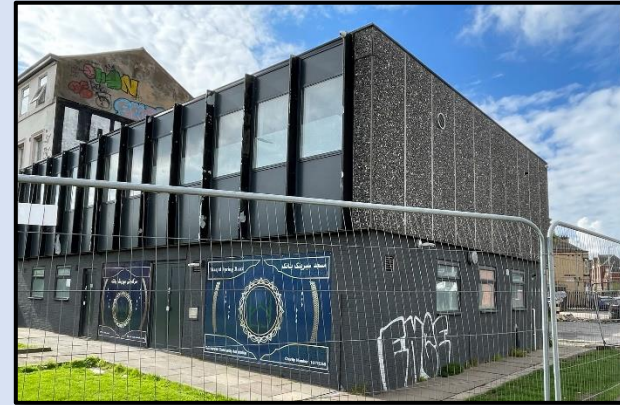
Figure 70 - No 79 Spring Bank which adjoins 79 Spring Bank which is set back from the dominant building line (Author, 2023)

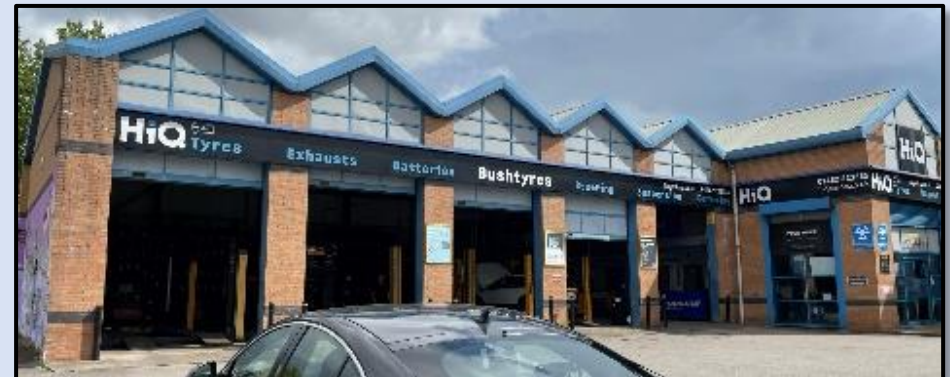
More recent developments dating from the 1960's-1990 do not adhere to the consistent building line and are incongruous with the character of the street. These include the 1960's two storey bank on Park Street, the Seventh Day Adventist Church, the Kwik Fit and Hi-Q Garages and the former Iceland store are set back from the predominant building line which diminishes the sense of enclosure to the street.

Figure 68 - The Hi-Q garage to the north side of Spring Bank which is set back from the dominant building line to provide sufficient turning areas for vehicles (Author, 2023)

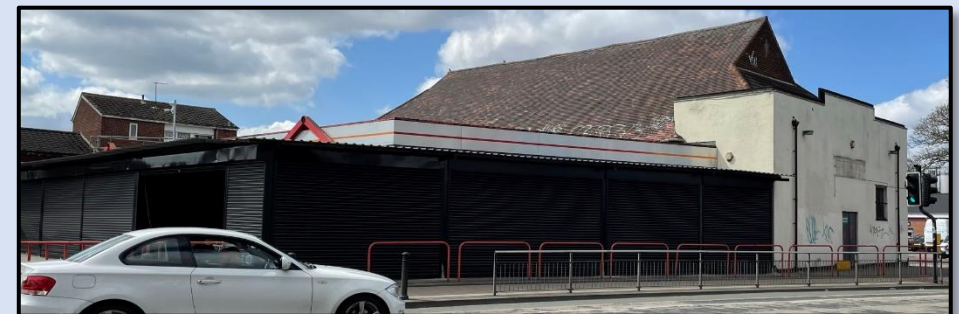
Figure 69 - No 185 Spring Bank which comprises of the former Church Hall to St Jude's Church and a later 1980's extension which fronts the adjacent car park, breaking the building line and massing (Author, 2023)

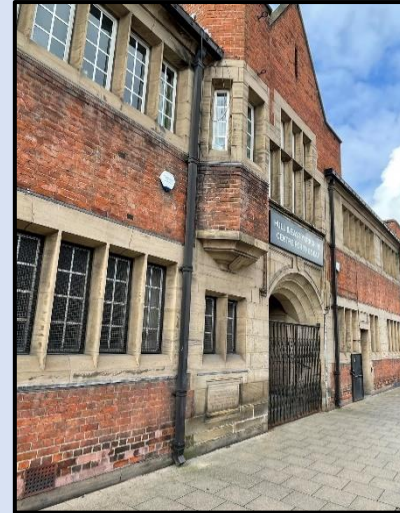
Figure 72 - The use of terracotta brickwork to the Deaf Institute built in the 1920's. (Author, 2023)

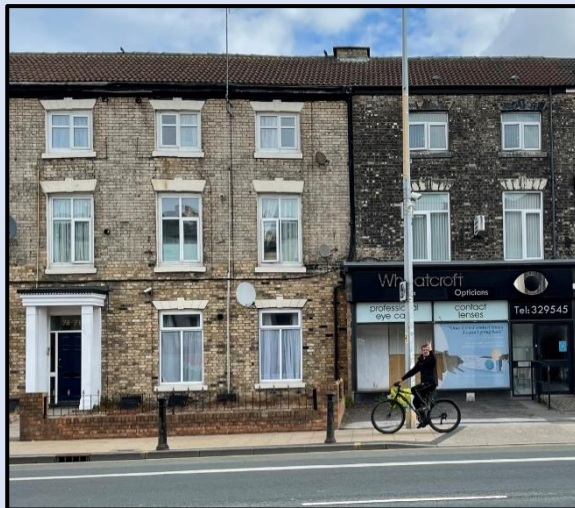
Figure 73 - The use of buff brickwork to the Georgian buildings dating from pre 1830. (Author, 2023)

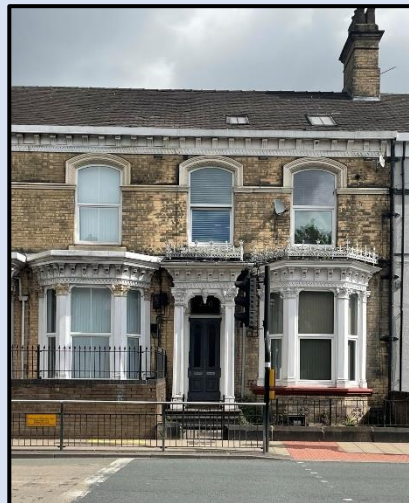
Figure 75 - The use of buff brickwork to the Late Victorian buildings towards the west of Spring Bank. (Author, 2023)

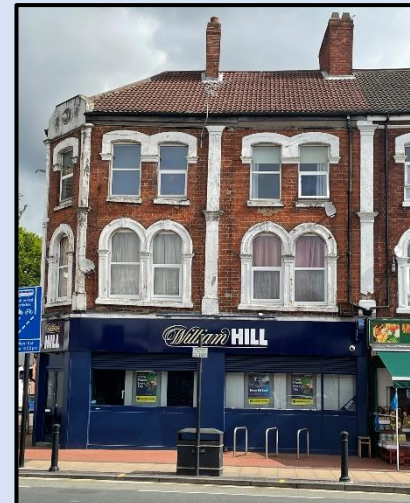
Figure 74 - The use of terracotta brickwork to the Late Victorian buildings towards the west of Spring Bank. (Author, 2023)

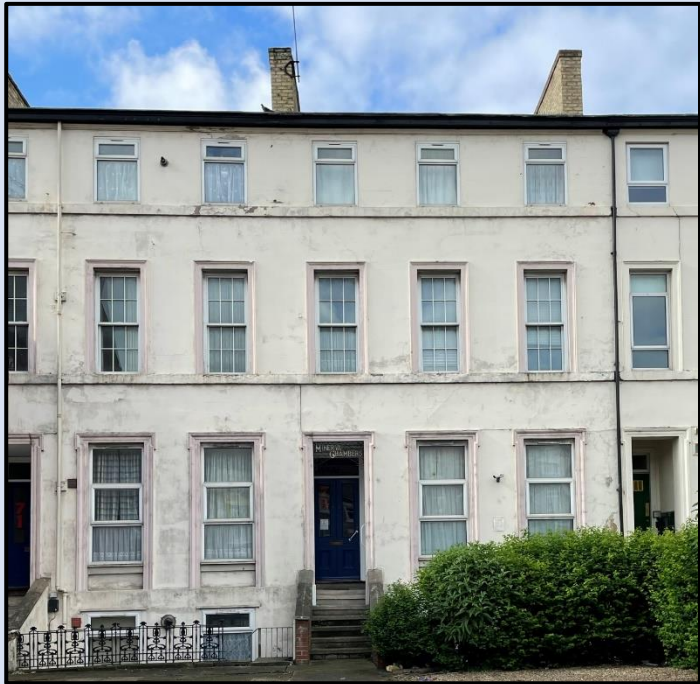
Figure 79 - The use of render to 75-79 Spring Bank (south)  
(Author, 2023)

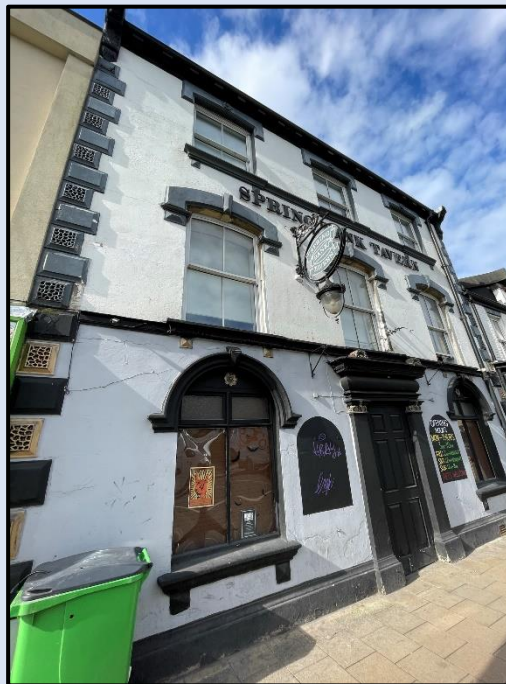
Figure 77 - Render utilised to the external walls of the Spring Bank Tavern (Author, 2023)

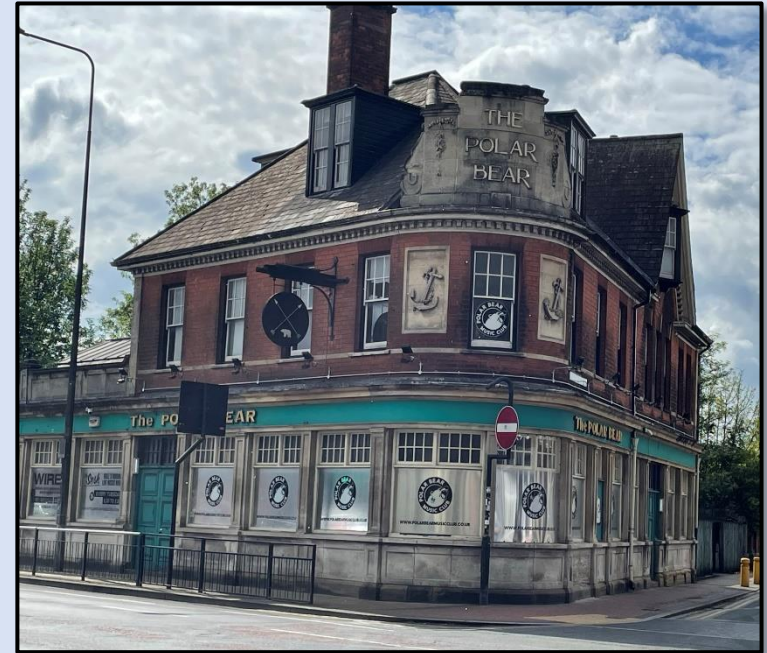
Figure 80 - The roof form of the Polar Bear which curves at the corner, allowing the buildings form to turn the corner. (Author, 2023)

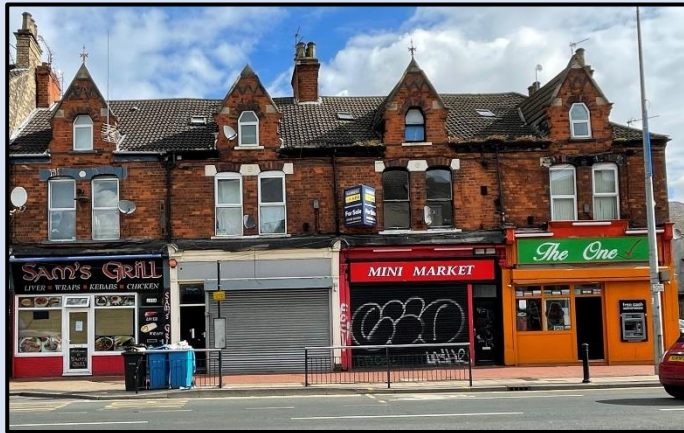
Figure 83 - Pitched roof forms with decorative dormer windows creating visual interest at roof level. (Author, 2023)

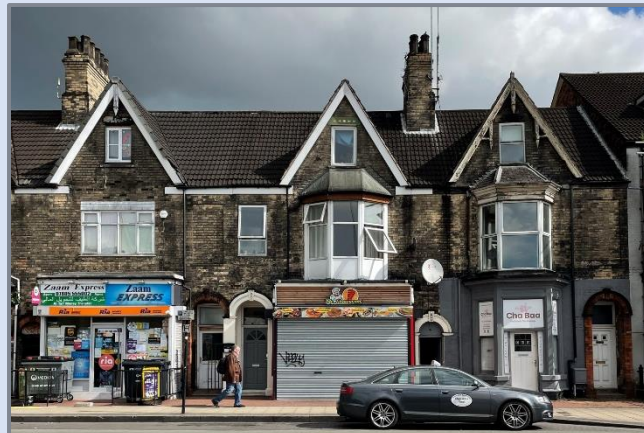
Figure 81 - Victorian Villas with projecting gables and bay windows, creating depth and visual interest to the facade. (Author, 2023)

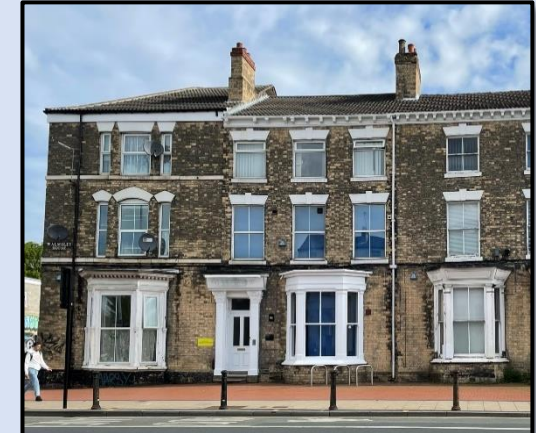
Figure 82 - Pitched roof with limited detail at roof level with the exception of the timber gutter supports. (Author, 2023)

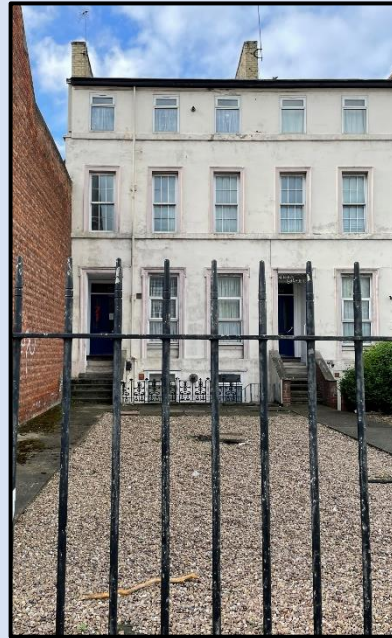
Figure 85- Modern railings installed in the 1980's to form the boundary of 69-79 Spring Bank (Author, 2023)

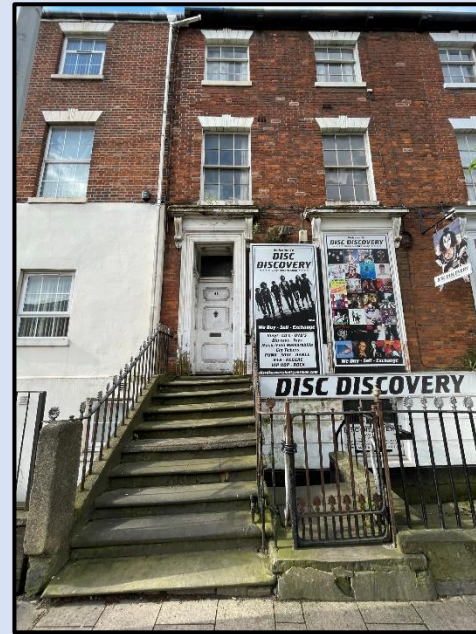
Figure 84 - Stone steps leading to the elevated ground floor residential entrance providing privacy to the primary living space. (Author, 2023)

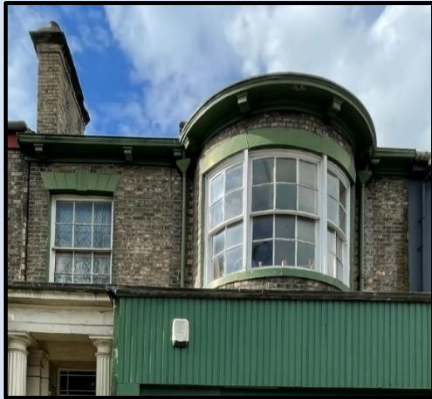
Figure 89 - Original timber sliding sash windows retained (Author, 2023)

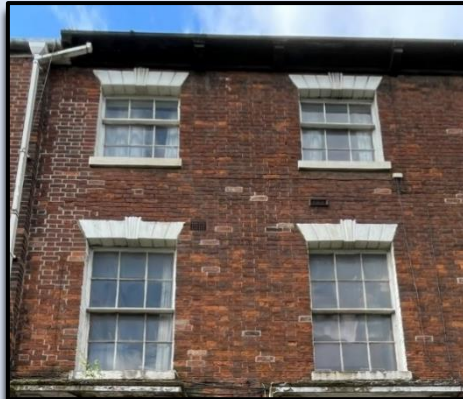
Figure 90 - Original timber sliding sash windows retained (Author, 2023)

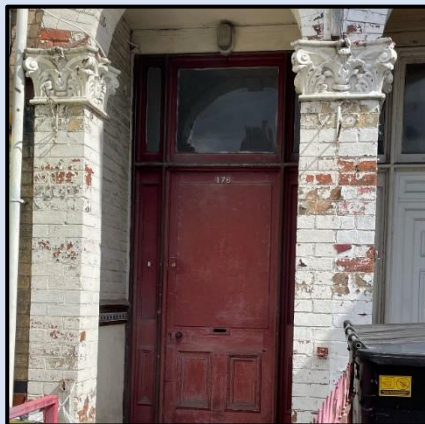
Figure 92 - Retained feature doorway with Corinthian heads to brick piers (Author, 2023)

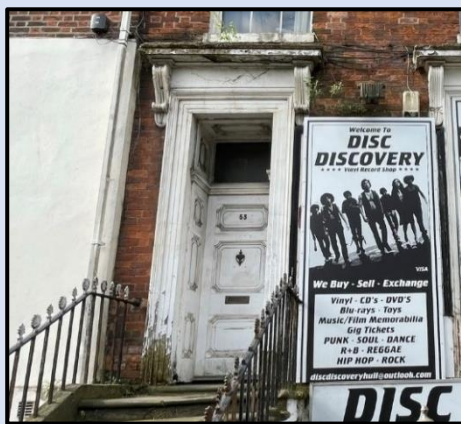
Figure 93 - Original doorway entrance and portico with scroll details and plaster surround (Author, 2023)

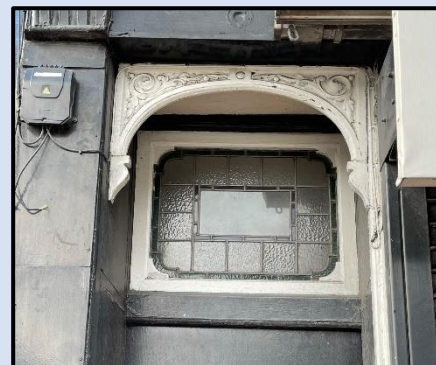
Figure 79 - Cast iron arched doorway detail and decorative fanlight retained (Author, 2023)

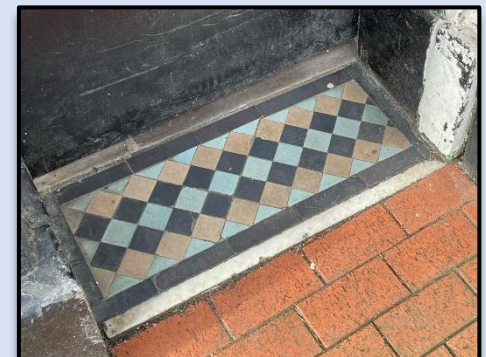
Figure 91 - Retained tiled threshold detail (Author, 2023)

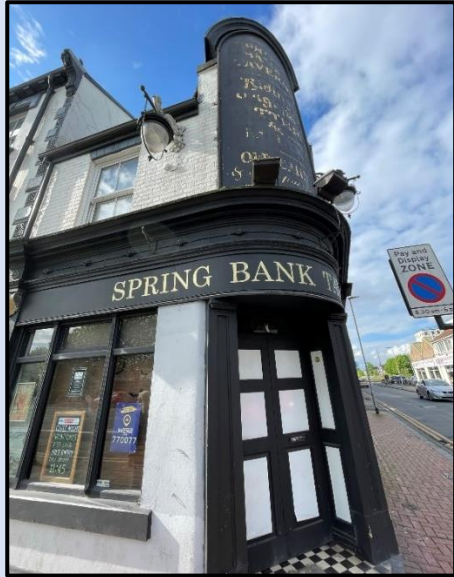
Figure 96 -The original cornice and fascia shop frontage at the Spring Bank Tavern (Author, 2023)

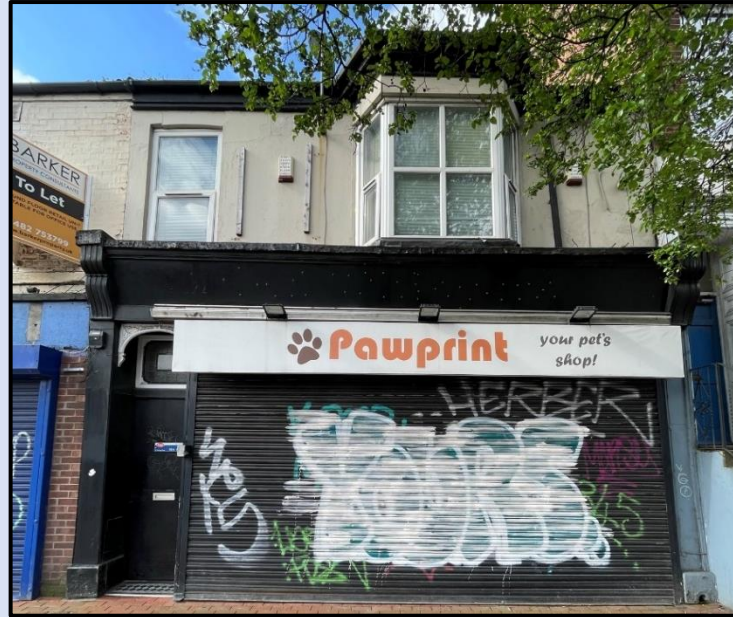
Figure 95 - Pawprints unit which has retained its original cornice, fascia, pilasters and doorway details. (Author, 2023)

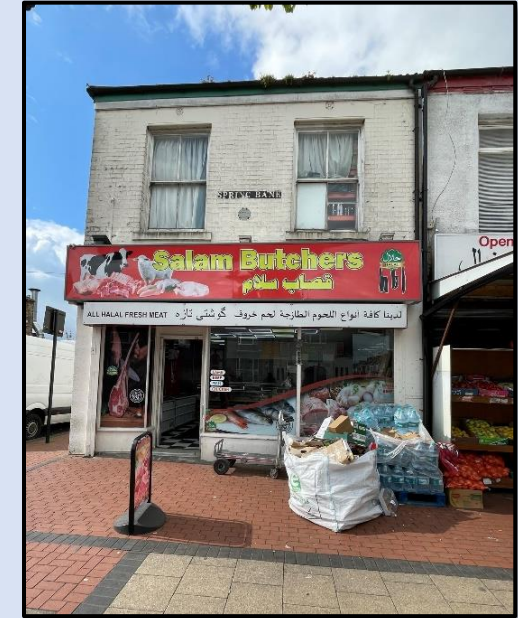
Figure 94 - Salam Butchers (143) has retained its original shopfront from late 1800's. (Author, 2023)

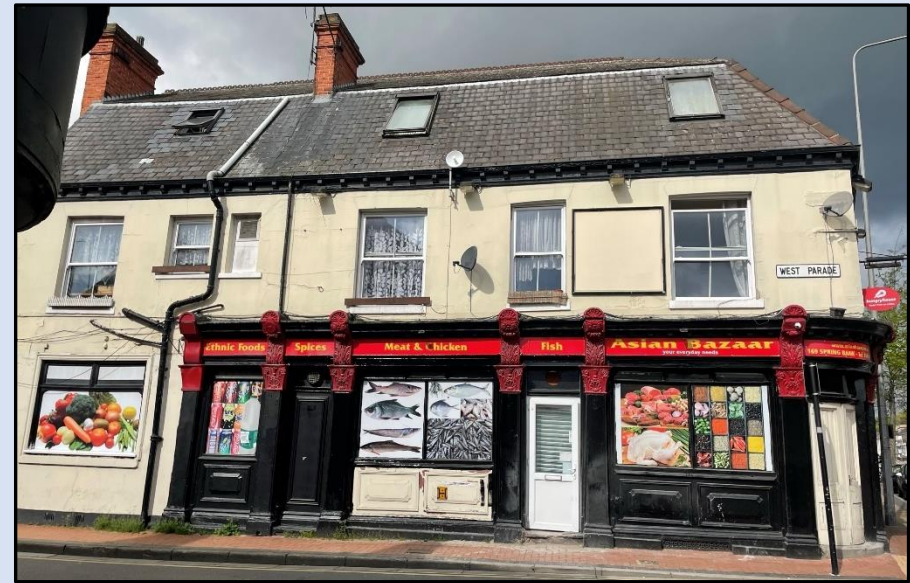
Figure 99 - The former Tap & Spile frontage has been retained but has suffered from inappropriate signage, colour scheme and fit-out that has had a negative impact on its quality. (Author, 2023)

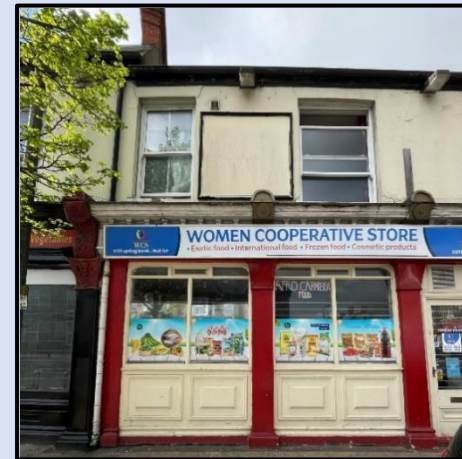
Figure 101 - 171 Spring Bank has retained its historic shopfront but has suffered from intrusive signage and loss of decorative corbels. (Author, 2023)

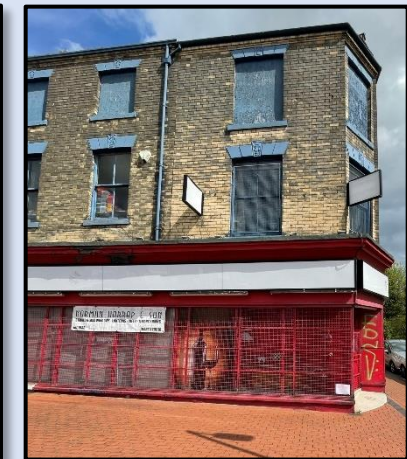
Figure 100 - No 84-86 Spring Bank has retained some remnants of the original shopfront but requires some work to enhance the quality. (Author, 2023)

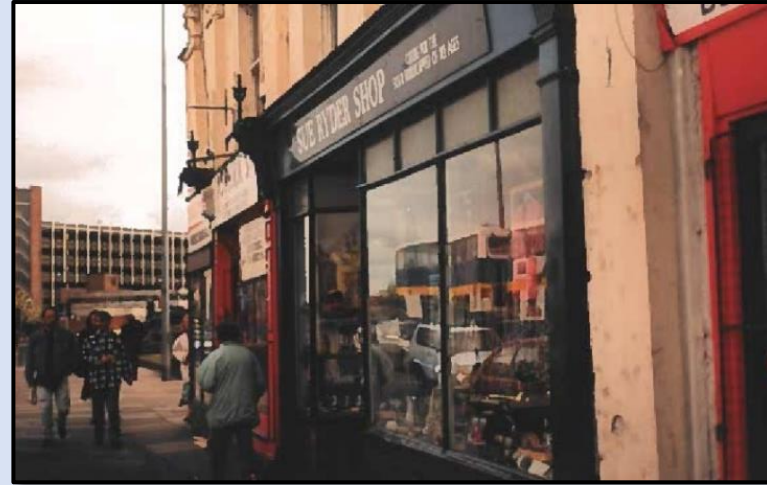
Figure 102 - 19 Spring Bank in 1995 shortly before Conservation Area Designation with the traditional shopfront retained including the recessed door and fanlights (Hampel, 1995)
