Spring Bank Conservation Area  
Character Appraisal

Draft for Public Consultation Feb 2024

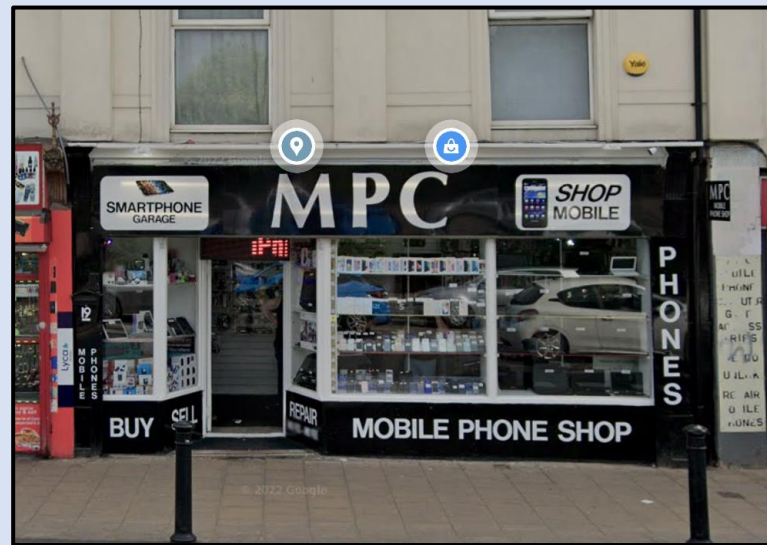
Figure 103 - 19 Spring Bank in 2022 (after designation) with later changes including extensive signage and concealment of the fanlights that has a negative impact on the quality of the shopfront. (google maps, 2022)

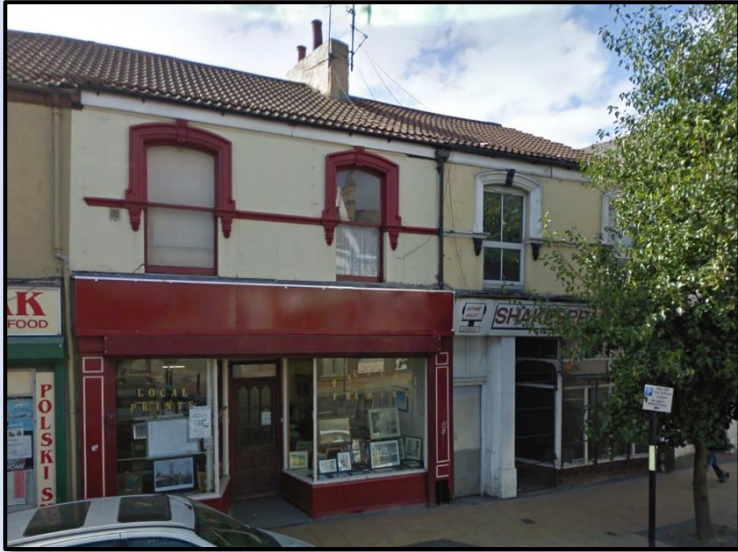
Figure 104 - 173-175 Spring Bank in 2009 (after designation) with the original shopfronts still in-situ with the recessed central/side entrances (the pilasters and corbel details to No 173 are a later addition and the fanlights have been concealed). (Google Maps, 2009)

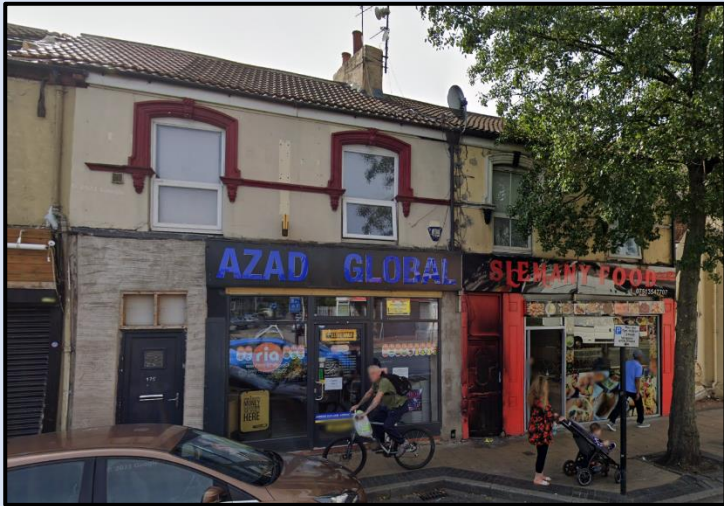
Figure 105 - All of the original shopfront has been removed and replaced with new metal framed shopfronts and low quality side doors to upper floor residential. (Google Maps, 2009)

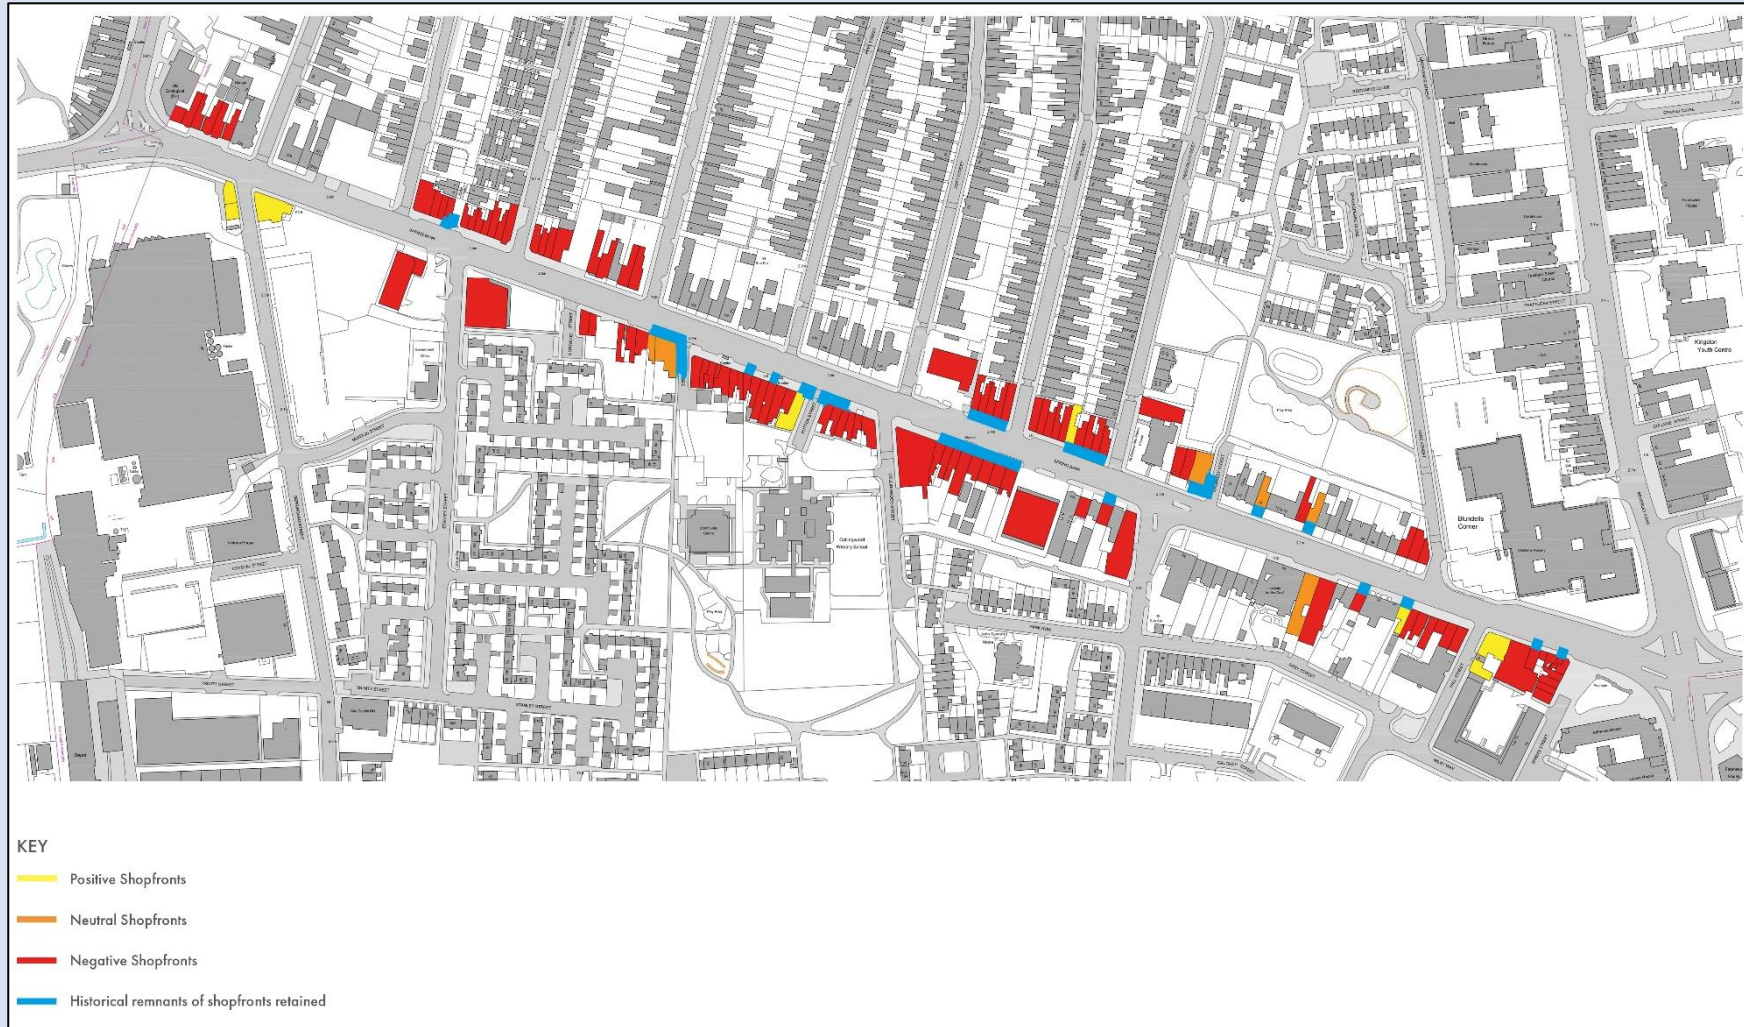
Figure 92 (to follow) illustrates the positive, neutral and negative shopfronts along Spring Bank as well as identifying where historic remnants of fascias, pilasters, corbels and cornices that have been retained, despite replacement of the original shopfront.

Figure 106 - Map showing the positive / neutral / negative shopfronts and historic retained remnants - Prepared by Seven based on Ordnance Survey © Crown Copyright 2023.  
All rights reserved. Licence number 100022432) (Author, 2023)

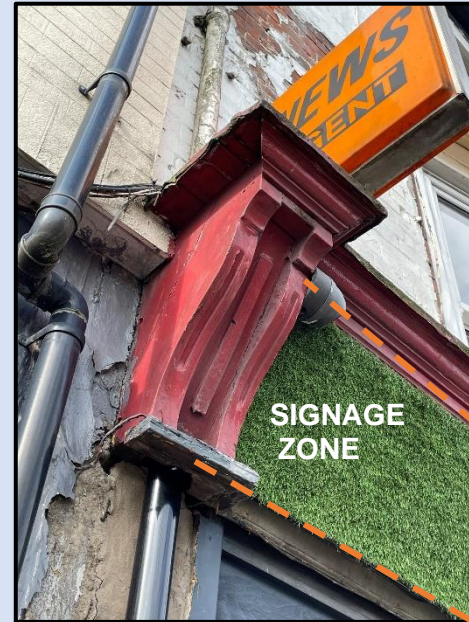
Figure 108 - 21 Spring Bank with the original corbels, cornice and fascia sign board retained (Author, 2023)

Steps should be made with any forthcoming Advertisement Consent applications to reduce the depth of fascia signage and revert back to the original signage zone and to avoid the use of internally illuminated signage. In many cases, the original corbel details have been retained to one of the shopfront in the group that can be used to determine the earlier height/location of the fascia.

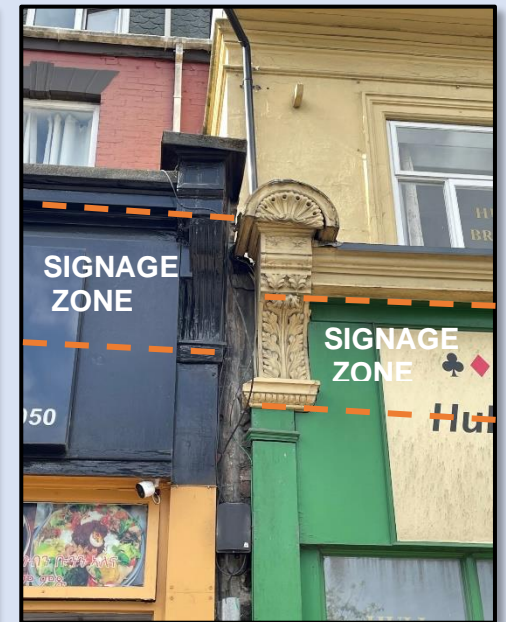
A lack of control over signage has led to the extensive use of large scale, brightly coloured and internally illuminated signage that is inappropriate for the Conservation Area.

Figure 107 - 115-117 Spring Bank showing how the depth of the signage has increased beyond the original signage zone (Author, 2023)

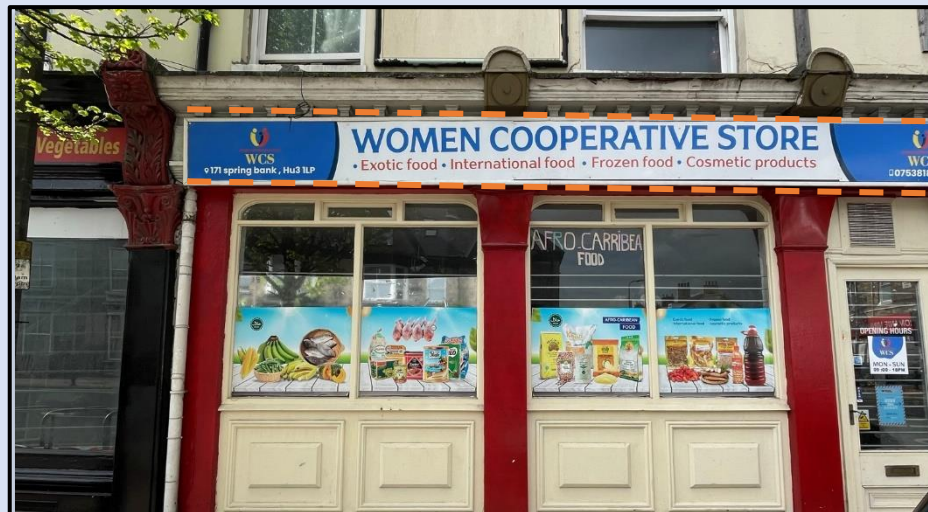
Figure 110 171 Spring Bank showing how the fascia sign is the correct depth but extends over the corbel detail (Author, 2023)

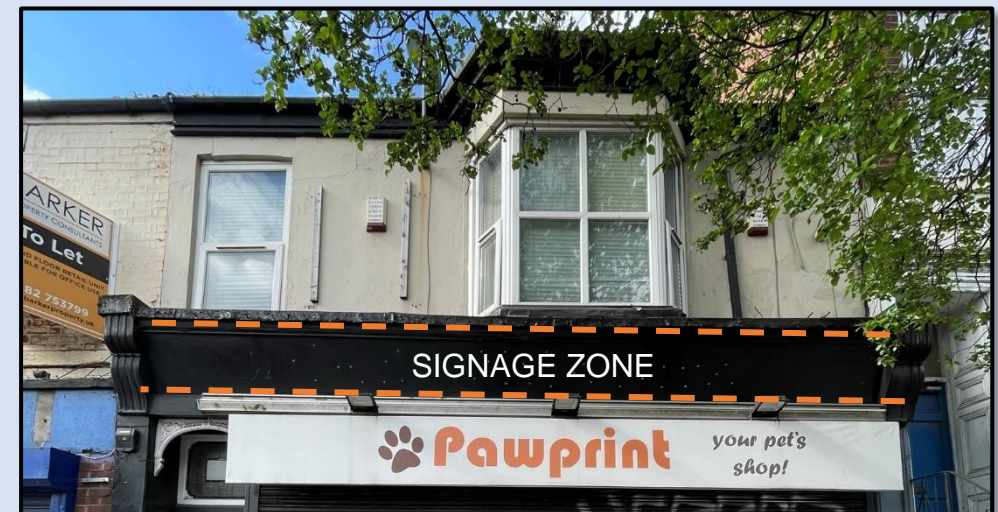
Figure 109 - 45 Spring Bank has retained its original fascia, cornice and corbels but the signage is positioned below the signage zone (Author, 2023)

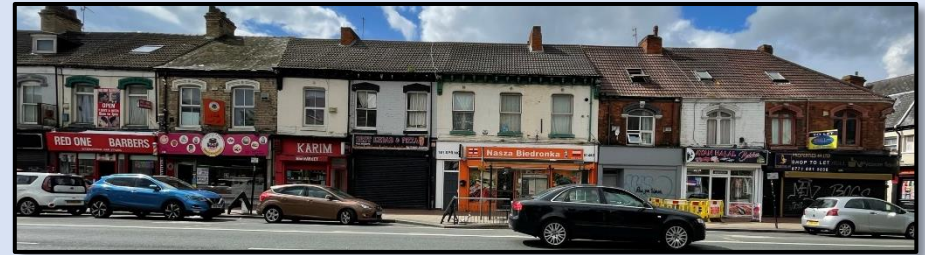
Figure 128 - 147-165 Spring Bank showing the lack of care in the shopfront design and general maintenance that reduces the quality of the buildings from positive to neutral buildings (Author, 2023)

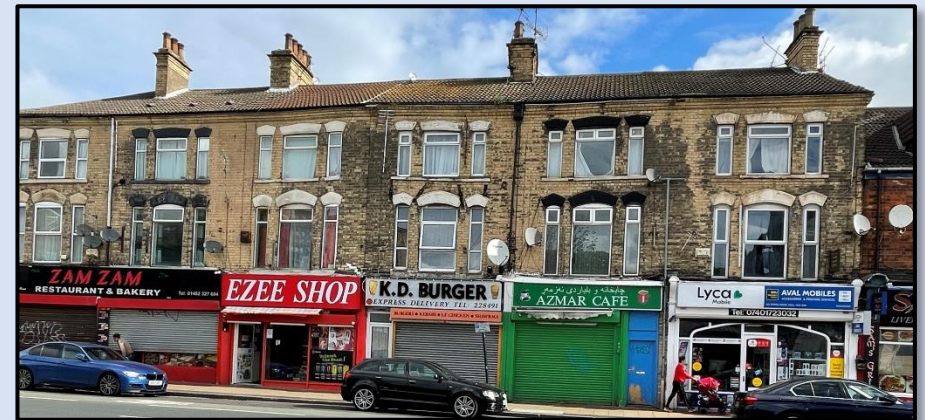
Figure 127 - 104-110 Spring Bank showing the lack of care in the shopfront design and general maintenance that reduces the quality of the buildings from positive to neutral buildings (Author, 2023)

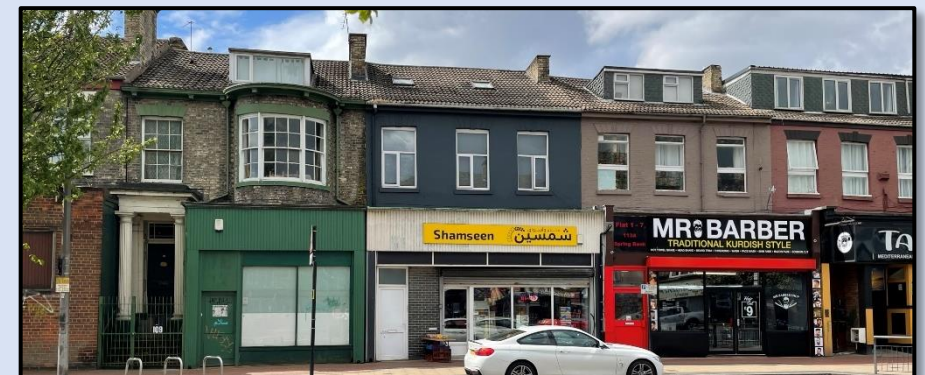
Figure 126 - 109-113 Spring Bank showing how later addition shopfronts and uPVC windows have reduced the quality (Author, 2023)

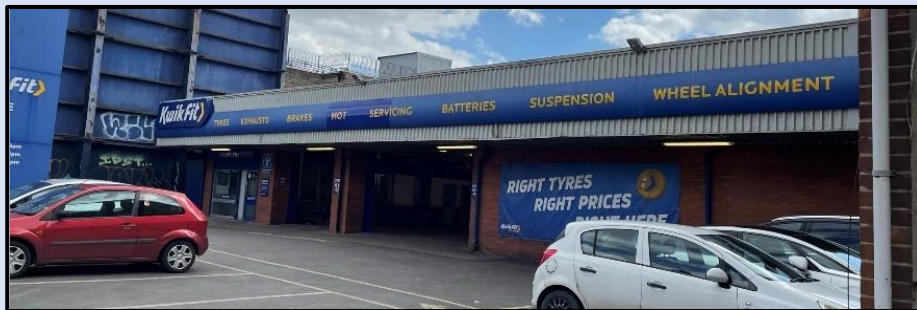
Figure 132 - Kwik Fit garage built on the site of a former Chapel (Author, 2023)

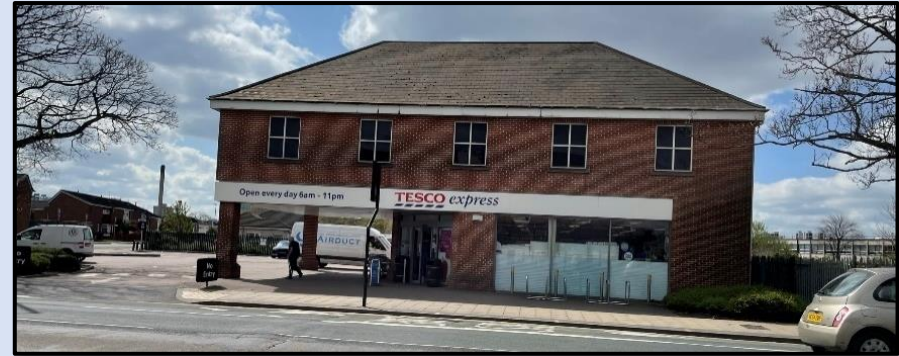
Figure 129 - Tesco store built in the 1990's does not contribute positively to the character of the street. (Author, 2023)

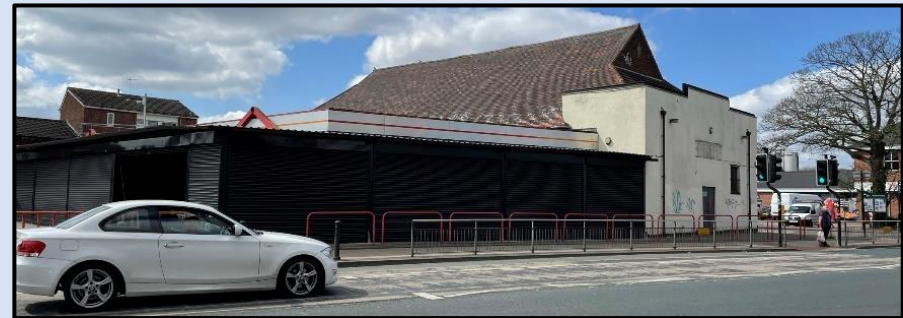
Figure 130 -Retail unit that extended the former Church Hall to St Jude's Church creates a negative frontage and lacks quality (Author, 2023)

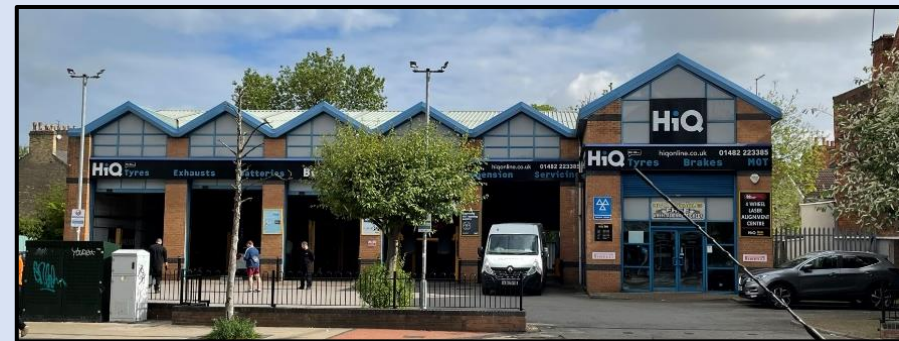
Figure 131 - Hi-Q Garage built on the former green space (Author, 2023)

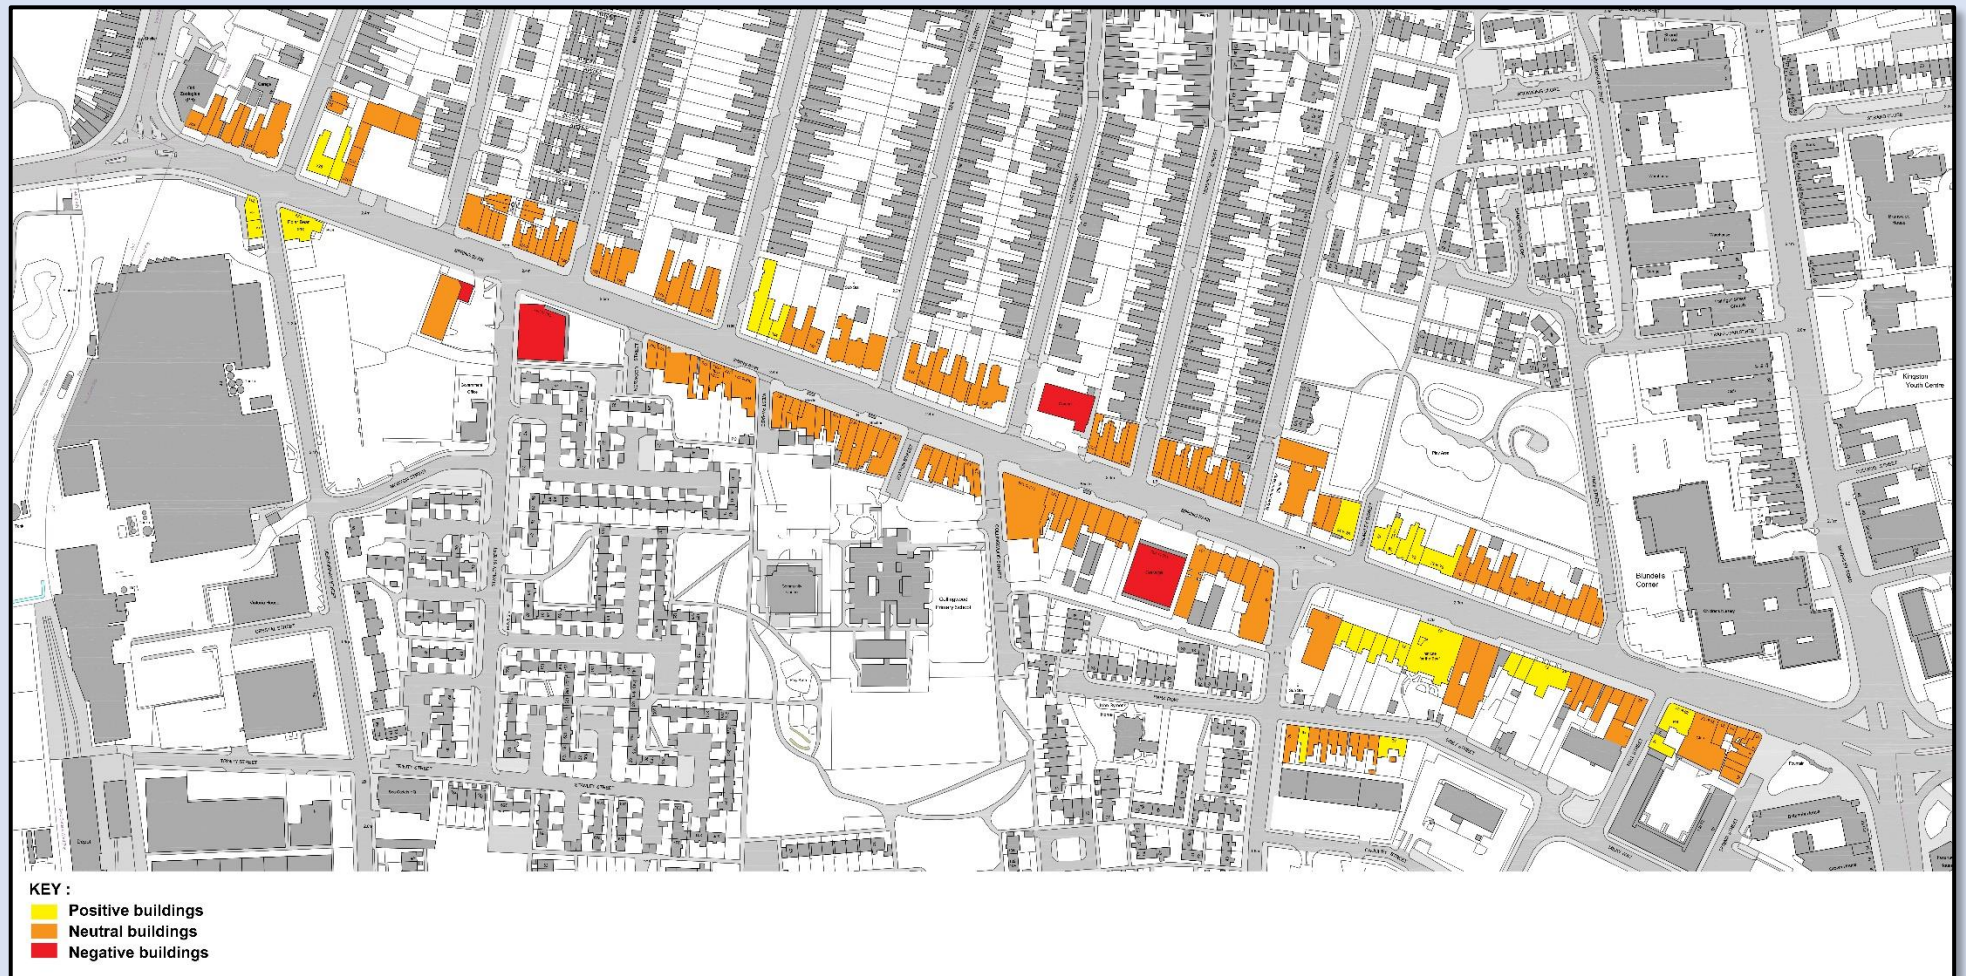
Figure 133 -Map showing the positive / neutral / negative buildings on Spring Bank as of 2023 Prepared by Seven based on Ordnance Survey © Crown Copyright 2023 (Author, 2023)

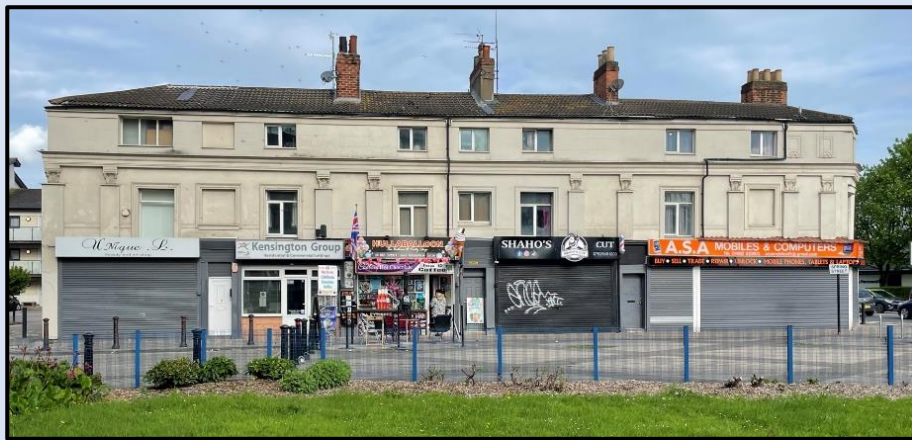
**No 2-10 (even) Spring Street and 15-19 (odd) Spring Bank -** Originally designed as a formal promenade of shop units with residential above, 2-10 Spring Street and 15-19 Spring Bank forms an important gateway building into the Conservation Area from the city centre/Ferensway approach. The adjacent image shows the building in Victorian times, formerly known as 'Stone Boy House'. The building today has suffered from a lack of careful maintenance, the loss of timber framed sash windows and introduction of inappropriate UPVC windows, additional rain water goods, poor quality and visually incohesive shopfronts/signage and replacement of the slate roof with concrete pan tile roof tiles.

Figure 134 - Stone Boy House facing Spring Street (Author, 2023)

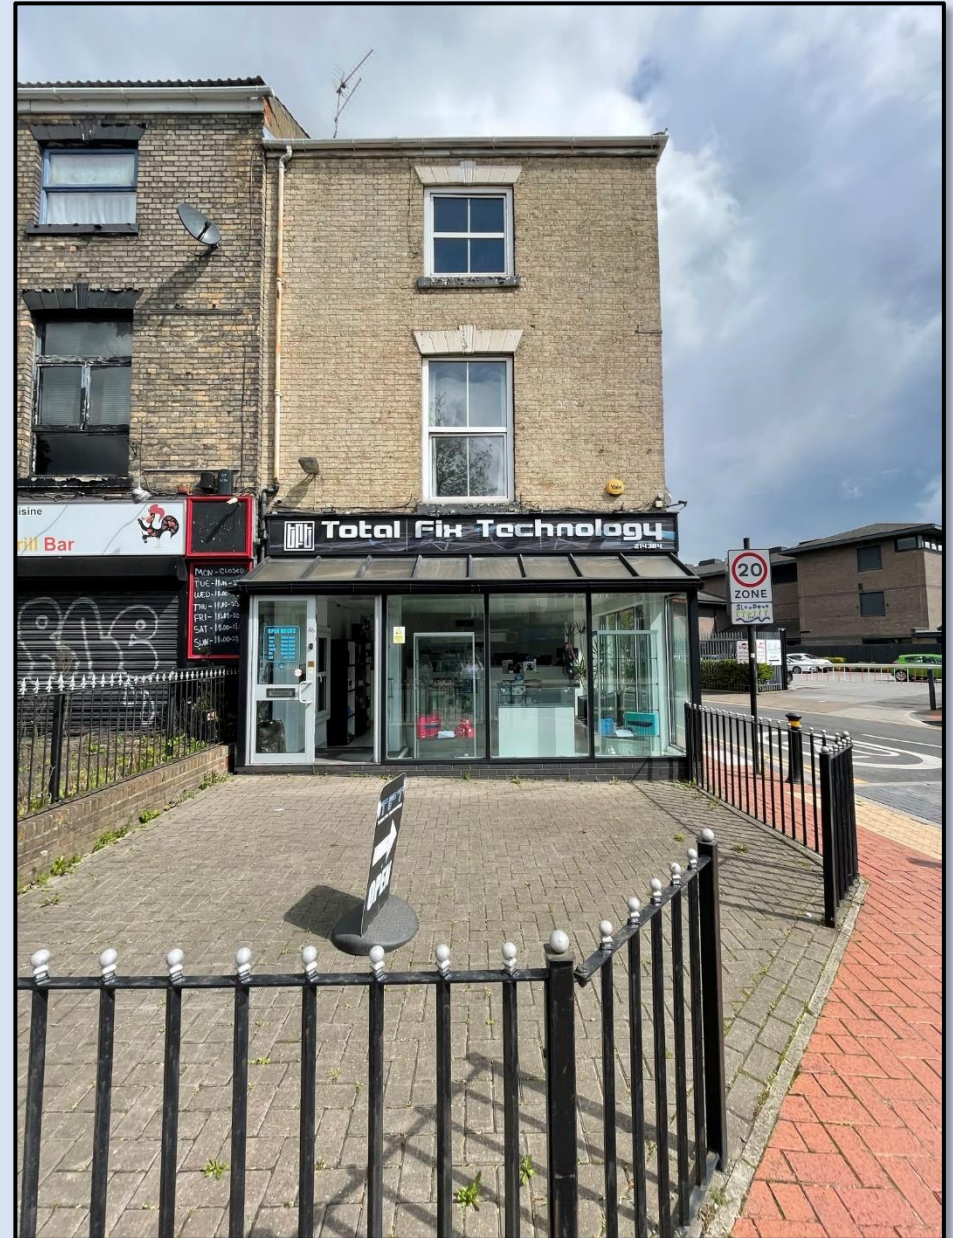
Although some of the historical features have been retained, the replacement of the windows to the side elevation and the introduction of a fully glazed modern metal framed extension to the front façade is considered inappropriate within the Conservation Area and brings the building line forward from the historical building line.

Figure 136 - The Spring Bank frontage to 46 Spring Bank (Author, 2023)

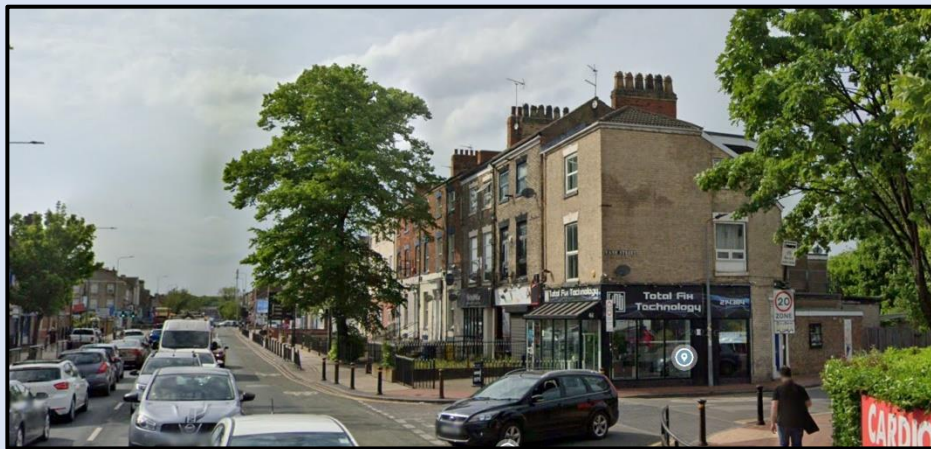
Figure 137 - 46 Spring Bank from the Ferensway approach (Author, 2023)

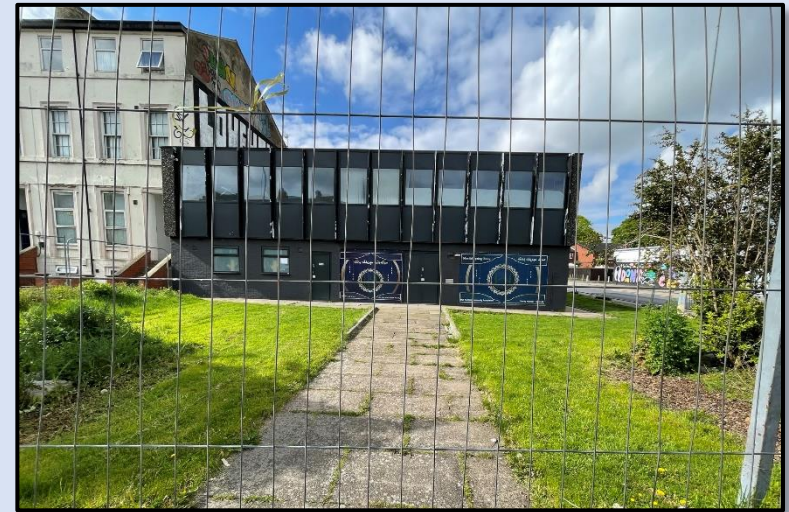
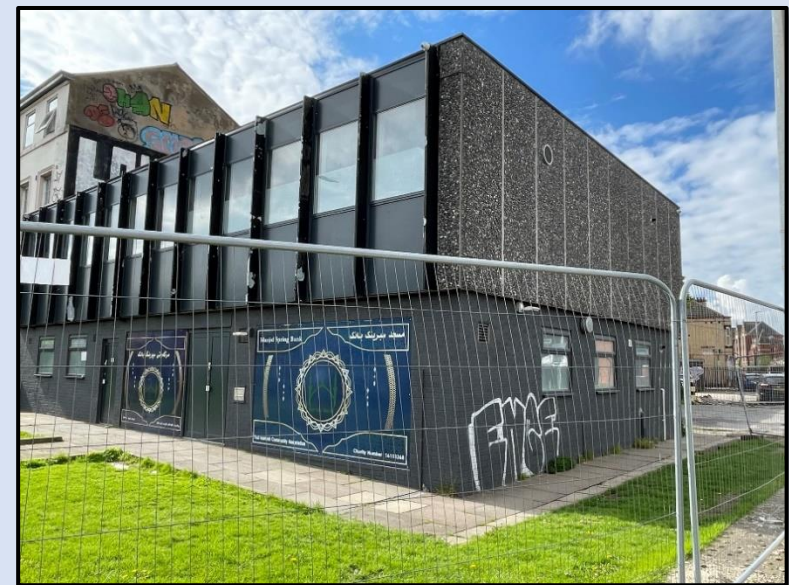
**No 83 Spring Bank on the corner with Park Street** - No 83 Spring Bank dates from the 1960's and is a modernist style building that encapsulates typical features of its time. A dark grey brick plinth creates a solidity to the base of the building and curtain walling, a modern material of its time, is used to create a transparent floating 'box' in contrast to the solid brick base. The end elevation is pre-cast concrete panels. Although a modern building, the building does play an important role on a key vista into Spring Bank from Park Street. Its character and setting therefore need to be considered in the wider context of the Conservation Area.

Figure 138 - The frontage of 83 Spring Bank from Spring Bank (Author, 2023)

Figure 139 - 83 Spring Bank from the corner of Spring Bank and Park Street (Author, 2023)

The building has had limited external works undertaken as part of this recent conversion. The building would however benefit from further works to enhance the aesthetic quality including the painting of the vertical exposed external fins and more appropriate treatment of the ground floor with the removal of the large vinyl signs. The Herris fencing has also been retained to the perimeter of the building, assumed to provide security when not in use. This fencing does, however, look unsightly and should be removed and a new permanent fence provided that suits the modernist character of the building.

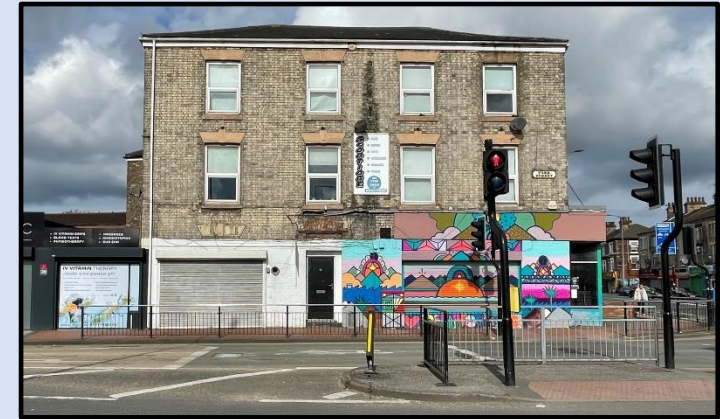
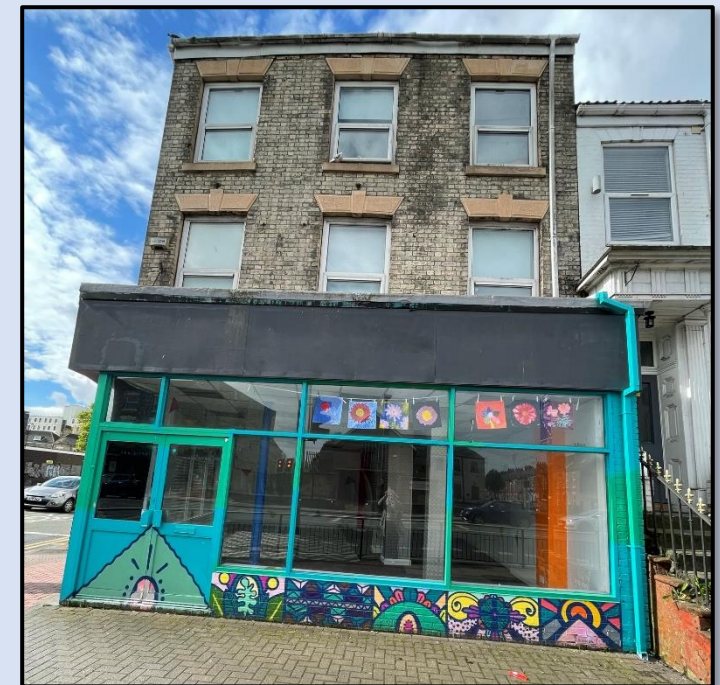
The building was constructed between 1830 -1893 and would have originally have featured timber sash windows and a timber framed shopfront. Although the building today retains features including the feature stonework lintels and cills, replacement UPVC windows, poor quality shopfront and fascia signage and the introduction of street art to enliven the shopfront have created a somewhat incoherent appearance that does not contribute positively to the area.

Figure 140 - 91-93 Spring Bank from Park Street (Author, 2023)

Figure 141 - Spring Bank frontage of 91-93. (Author, 2023)

The building would benefit from replacement of the UPVC windows with timber sash windows (as the original design) and a more appropriately detailed shopfront due to its prominent corner position.

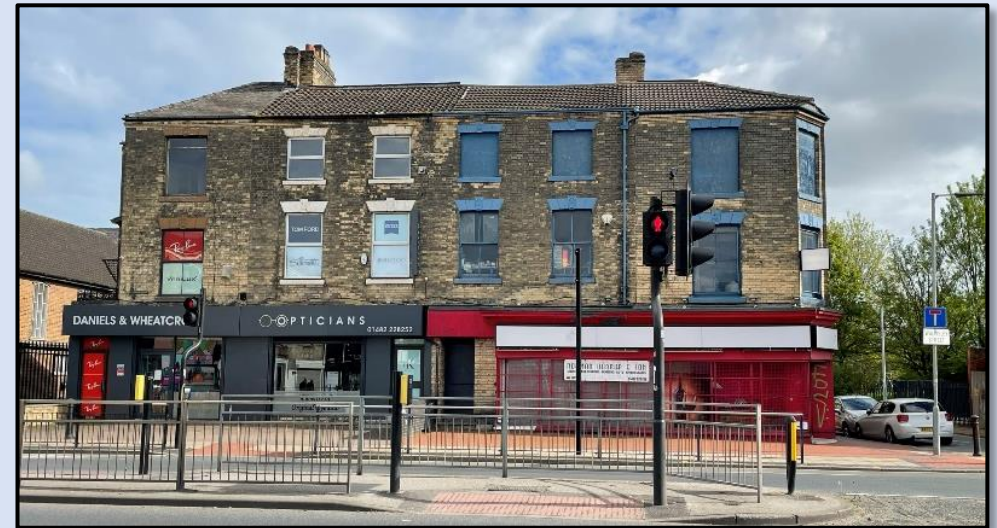
The buildings have retained some original features including some timber sash windows, stonework detailing with decorative window lintels and cills and the timber framed bay window to the west elevation of the later No 90. Some windows to No 84 and 86 have been boarded over and may still retain the original windows behind. No 88 and 90 however, has had a number of windows replaced with UPVC windows.

The shopfront to No 86 has retained some of its original details dating from the early 1900's when the units were extended, with the fascia board appearing intact behind the existing signage board. The shopfront to No 88 and 90 has, however, lost its original shopfront and fascia and has been replaced with a modern metal framed shopfront. No 84 has also had a rear extension built, visible from Walmsley Street, that is detrimental to the Conservation Area.

Figure 142 - Spring Bank elevation of 84-90 Spring Bank from the Park Street approach (Author, 2023)

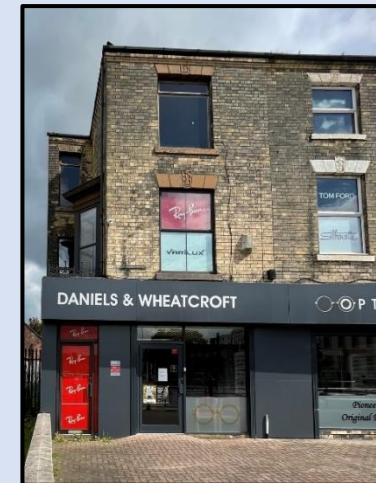
Figure 144 - 88-90 Spring Bank (Author, 2023)

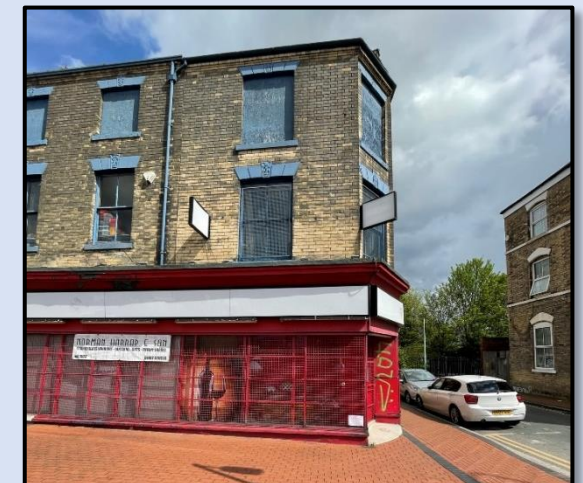
Figure 143 - 84-86 Spring Bank (Author, 2023)

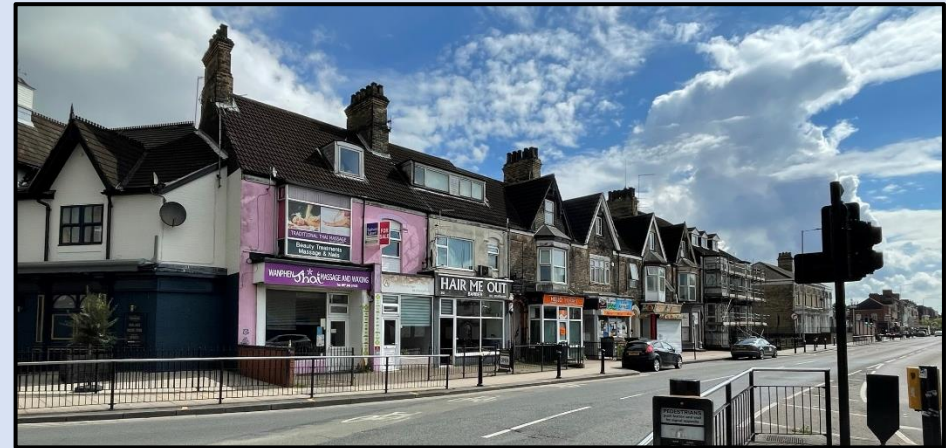
Nos 234-240 comprise of four buildings originally built between 1830-1893 as residential Villas similar to those found further along Spring Bank. These are characterised by a double height bay window with a feature gable at roof level. The ground floor level to each former dwelling has since been converted to retail use which has resulted in the loss of the ground floor of the bay window to all but one unit. The original bay window to No 234 is still in place, albeit the main central window has had a door inserted and the cill partially removed. No 238 has lost its bay window completely at ground and first floor level and has been replaced with a horizontal window that is incongruous to the style of the original building which is vertical in proportion.

Figure 145 - 234-244 Spring Bank from the junction with Princes Avenue/Spring Bank West (Author, 2023)

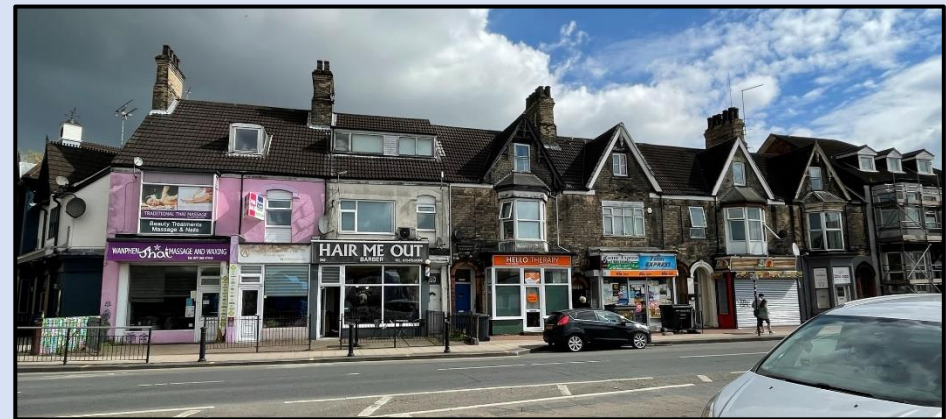
Figure 146 - View towards 234-244 from Spring Bank (Author, 2023)
