# A469 Troedrhiwfuwch

## The Nature of the Landslide and Proposed Remedial Works

# The Nature of the Landslide

# The Proposed Remedial Works

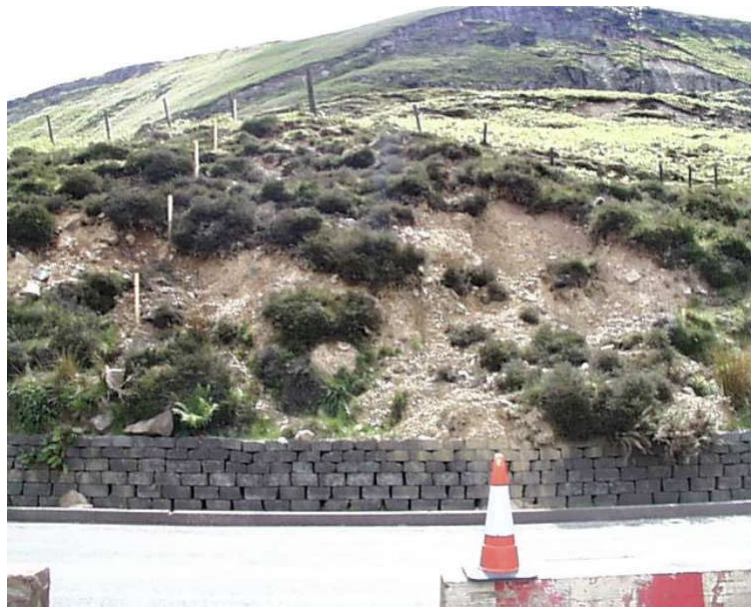
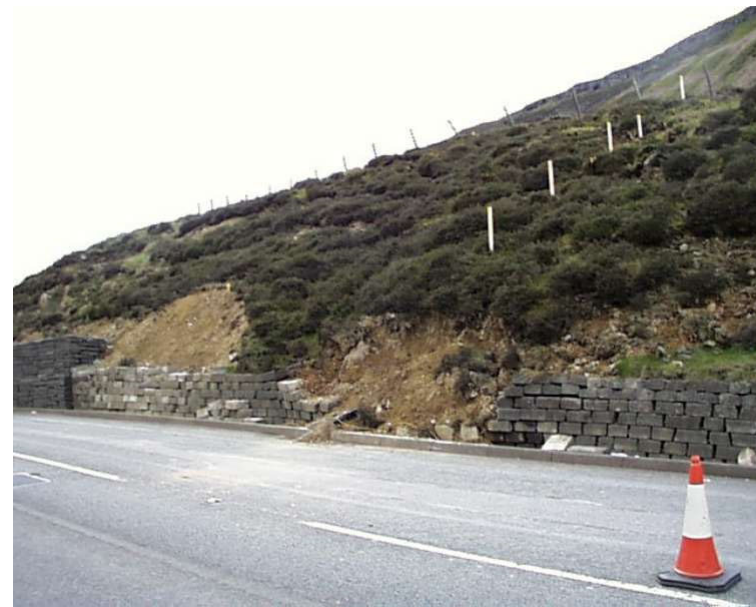
## Overtopping of retaining wall 2001

In 2001 there was a partial road closure for replacement of a retaining wall that had been overtopped by a landslip.

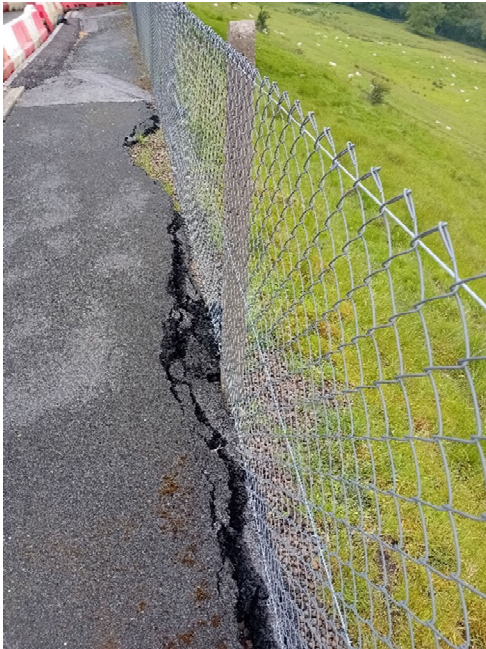
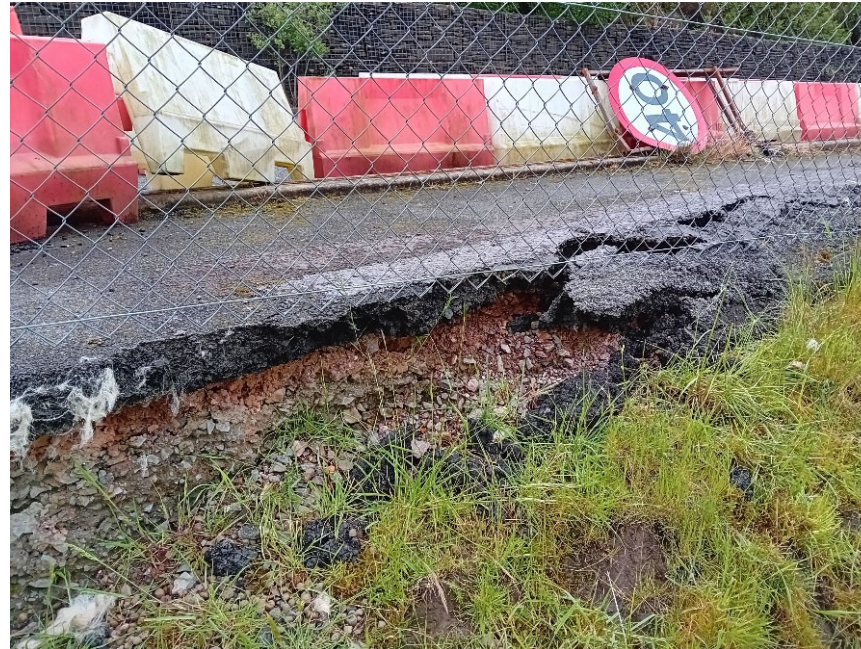
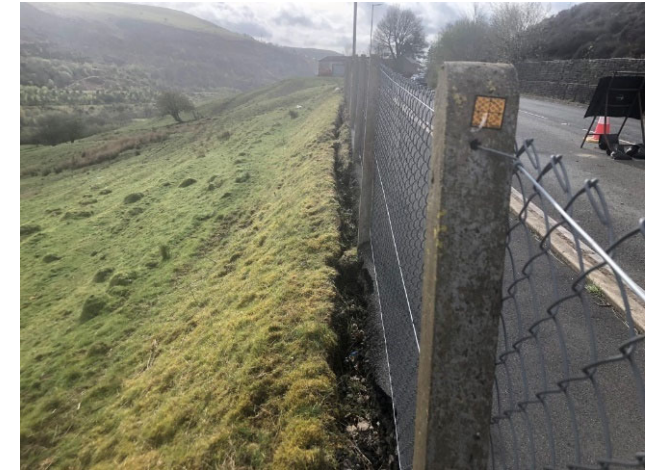
Example of ground loss adjacent to footway

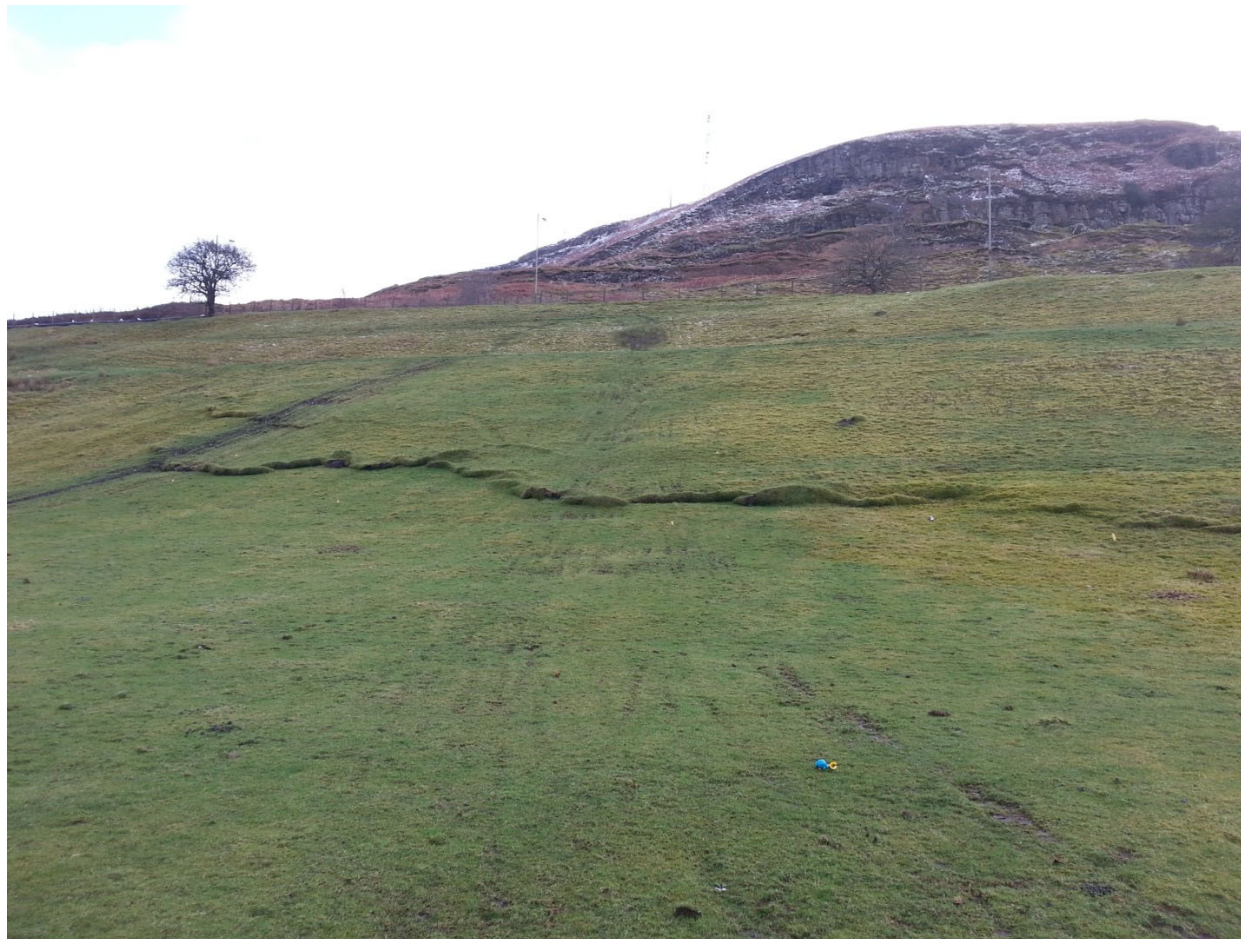
Example of toe bulge

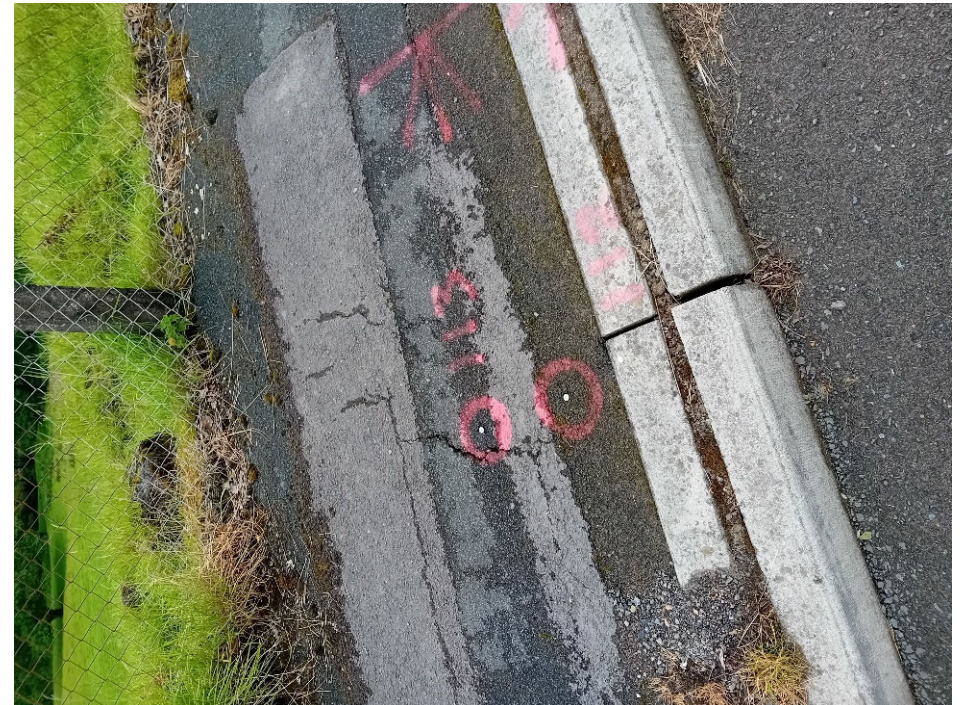
Road pin monitoring

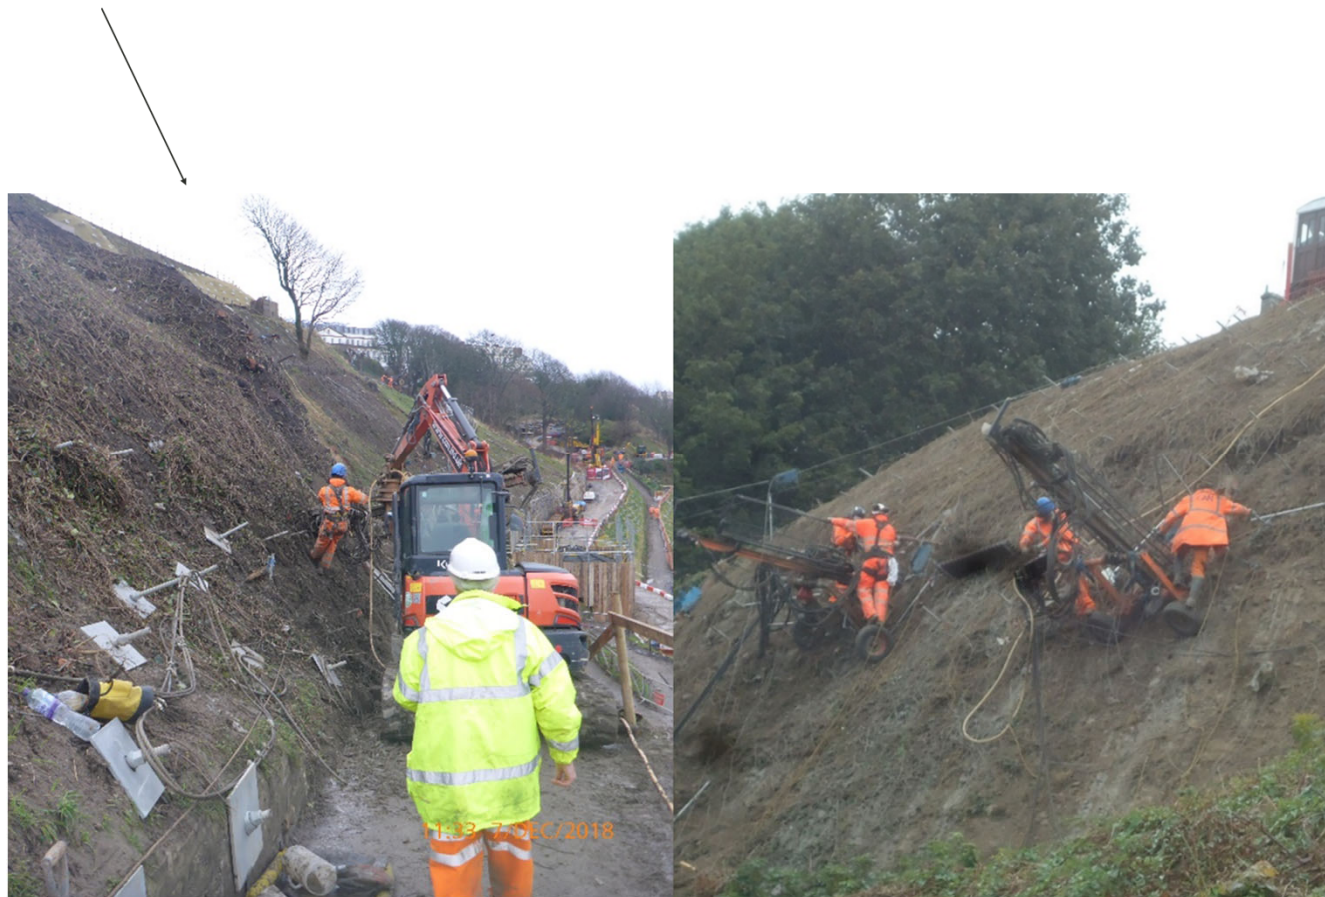
**Soil nails** can be installed using drills mounted on an excavator arm or suspended from a secure place above.

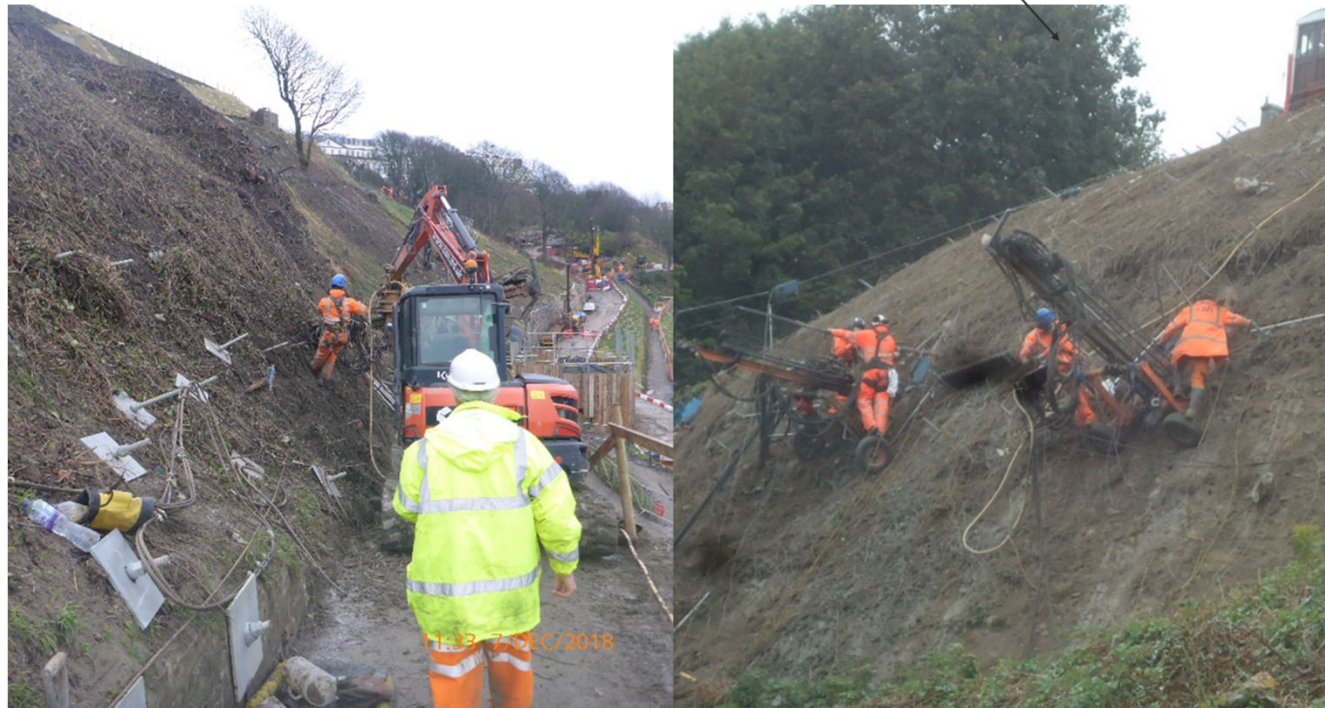
**Soil nails** can be installed using drills mounted on an excavator arm or suspended from a secure place above.

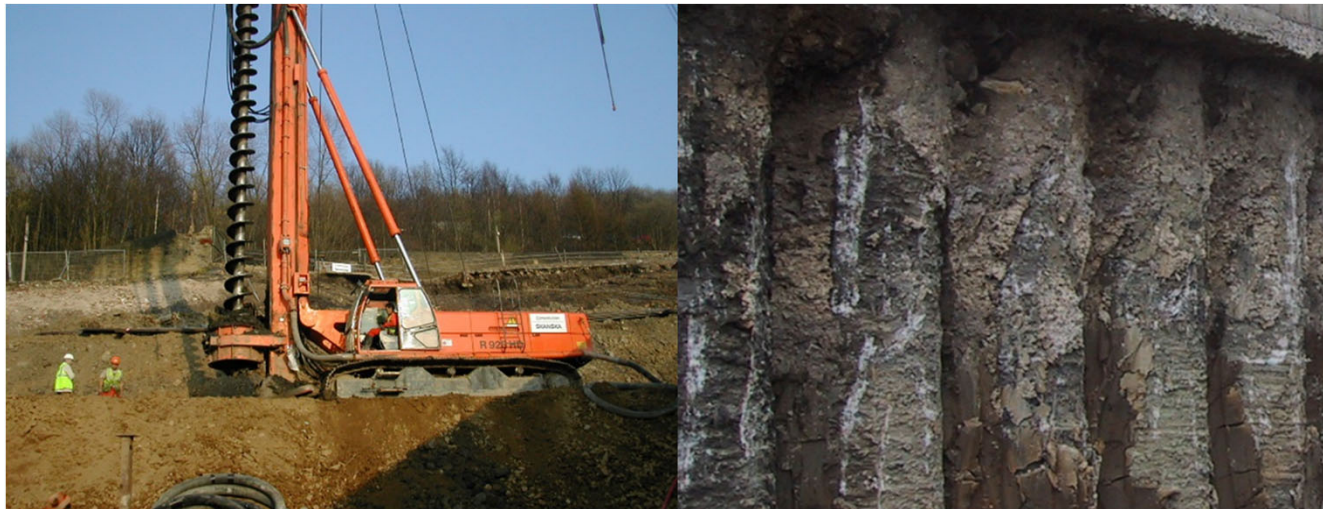
A **contiguous pile wall** contiguous pile wall consists of reinforced concrete columns bored into the ground at close spacings.

The small gaps between the piles allow groundwater to flow past while retaining the ground behind.

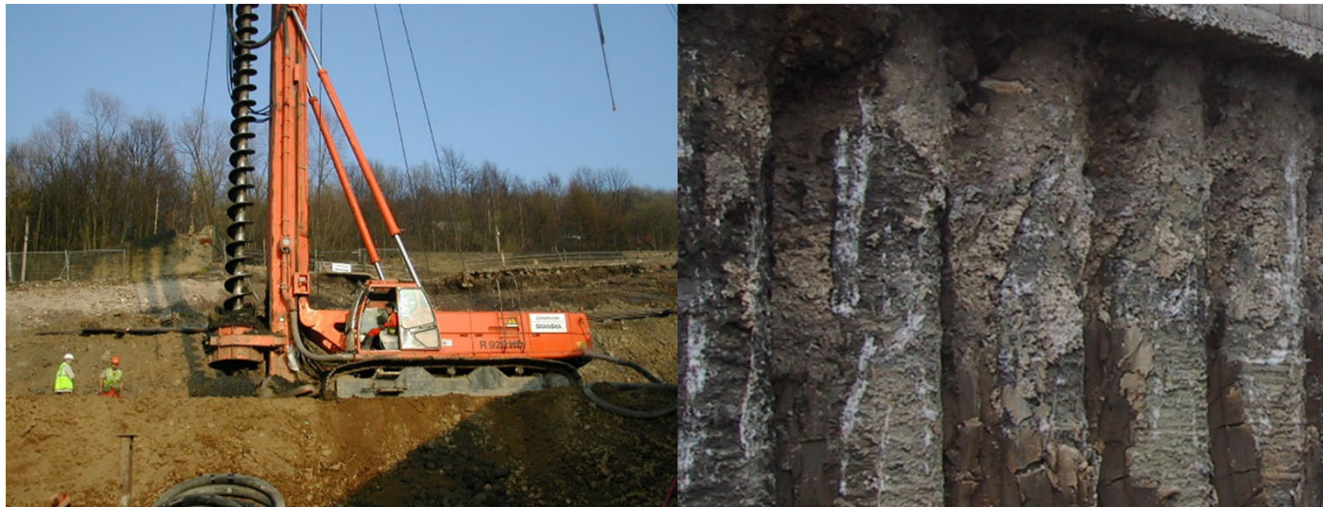
The concrete piles will be along the edge of the road and will initially be buried by the slope below.

They may become exposed as material on the slope below continues to move.

The wall will be designed to accommodate up to 4m of ground loss in front of the piles.
