# Mackie Academy Walk Route Safety Review

Review: Mackie Academy Walk Route Assessment

Aberdeenshire Council

23/09/24

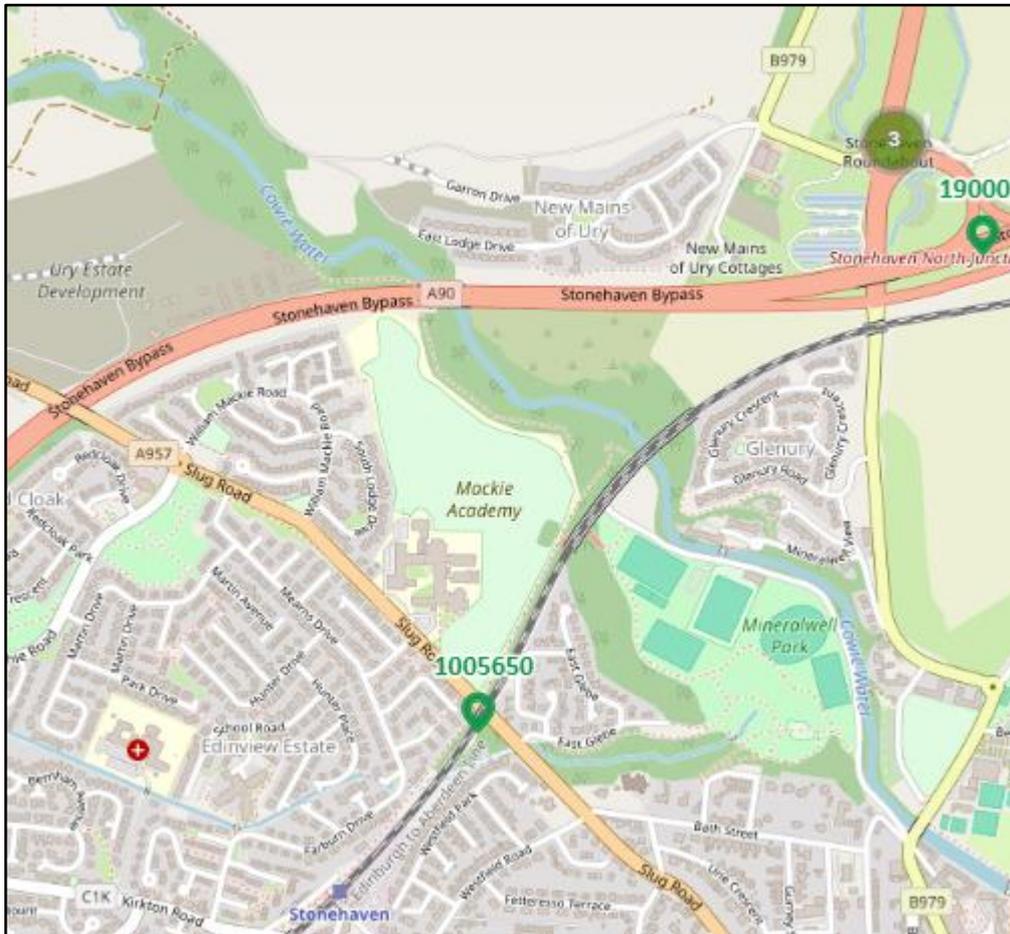
- Slight injury collision, reference number 1005650 occurred on 16 November 2020 at 08:30 am. An 11-year-old male ran across the road without due care and attention and was clipped by the wing mirror of a car, which had tried to avoid the pupil.

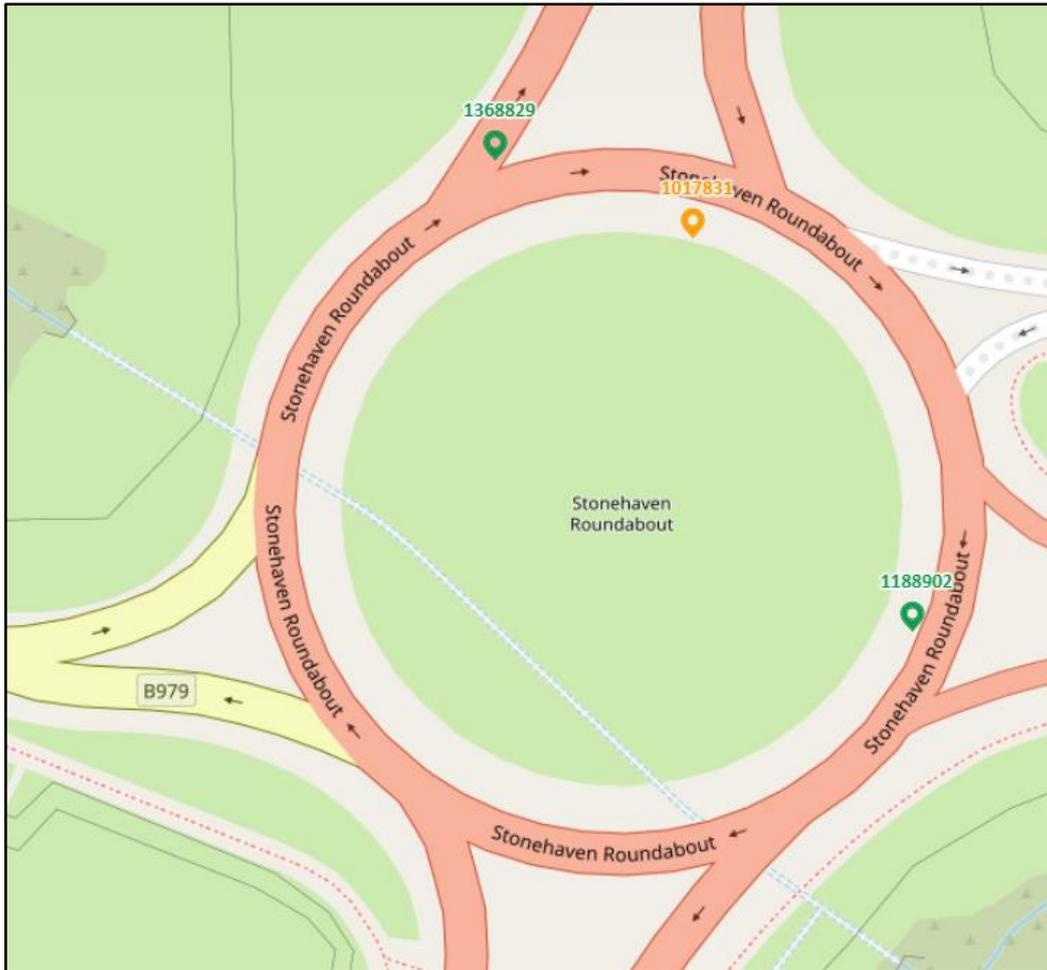
- These collisions occurred on the opposite side of the roundabout to where pedestrians would be walking. One involved vehicle brakes failing, one involved a driver exceeding the speed limit and disobeying the give way markings and the third was the result of a vehicle changing lane and colliding with another car when exiting the roundabout.
