Carterton and the Surrounding Area Local Cycling and Walking Infrastructure Plan

Audit Report

March 2025

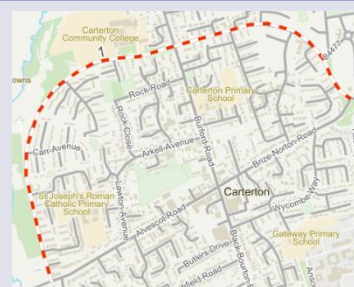
- There is no tactile paving on most of the side-road junctions, making crossing the road more difficult, unsafe, and inaccessible.
- Mini roundabouts are sometimes unnecessary for traffic flow levels and make cycling unsafe.
- The road is generally very wide, with very few traffic calming measures, meaning vehicles speeds increase above 30mph regularly, meaning walking and wheeling can feel very unsafe due to the proximity with carriageway.
- The underpass on the eastern side of Upavon Way is regularly flooded which forces users to cross at road level. At road level there are no controlled crossings despite being a popular through route.

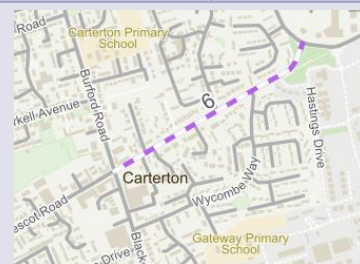
WRAT	62%	Attractiveness	Comfort	Directness	Safety	Coherence
Findings: <ul style="list-style-type: none"> ➤ There are clear trodden desire lines on the northern side of the carriageway beyond Wycombe Way, and on the approach to the junction with Upavon Way and Carterton Road on both sides of the carriageway. ➤ At present, there is a dropped kerb at the end of Wycombe Way directly over Brize Norton Road, indicating a crossing, however there are no pedestrian-controlled provisions. However, plans are in place to install a controlled crossing in this location. ➤ The crossing provisions at the junction with Upavon Way and Carterton Road are very poor, meaning pedestrians may not feel safe crossing the road. 						Constraint Categories: <ul style="list-style-type: none"> ➤ Inadequate infrastructure ➤ Narrow ➤ Maintenance issue

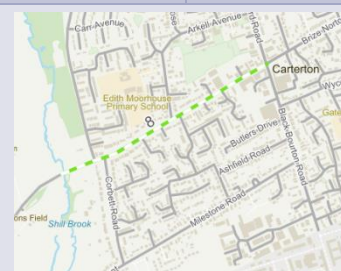
- There is very little crossing provision over Alvescot Road along the length of the road. There is need for crossings, especially at the end of the alley connecting Edith Moorhouse Primary School and Alvescot Road.
- Pedestrian priority is removed when crossing the side roads.
- Due to the width and visibility, vehicles were observed driving at excessive speeds at quiet periods endangering pedestrian safety.

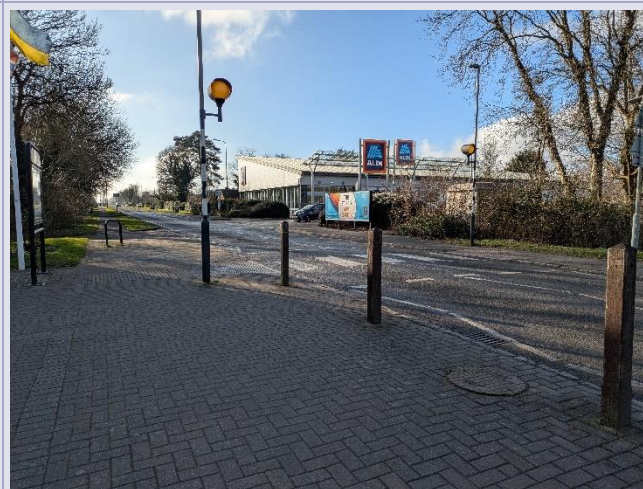
Figure 33: A pedestrian priority-controlled crossing connects the market square and the supermarket

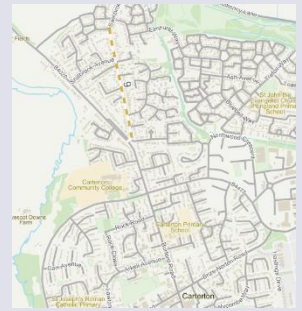
- Beyond Baldwin Mews, the footway on the eastern side of the carriageway stops, with no provisions to cross onto the opposite side.
- Dropped kerbs and tactile paving at side roads are not up to standard, with wide junction mouths at Glenmore Road.
- An existing modal filter north of Manor Road has been observed to be utilised as an area for parking (Figure 36) which restricts pedestrian and cycle movements through the filter.

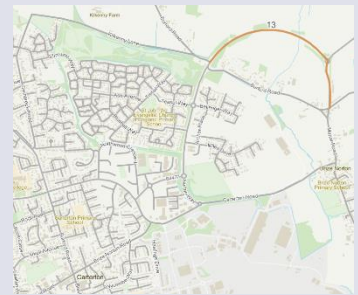
- Currently, cyclists have the option to cycle in a small verge, with vehicles passing at a very close distance.

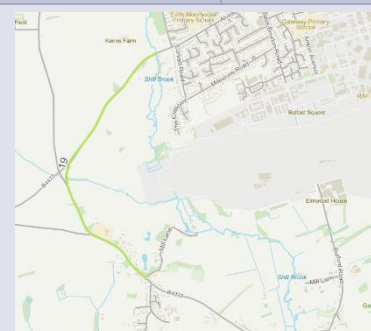
- When in Carterton, there are wide verges on either side of the wide carriageway. Some cars were observed driving at excessive speeds on this section.
- Within Alvescot, the carriageway and footways narrow due to width constraints from buildings and boundary walls, creating pinch points where no proposals could be made.

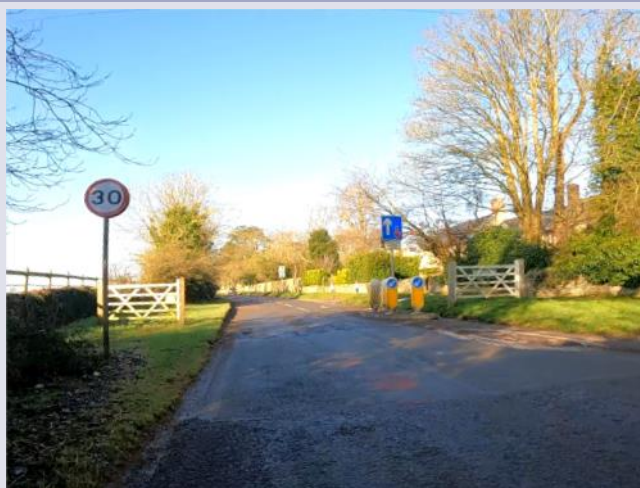
Figure 62: Gateway feature on entrance to Alvescot

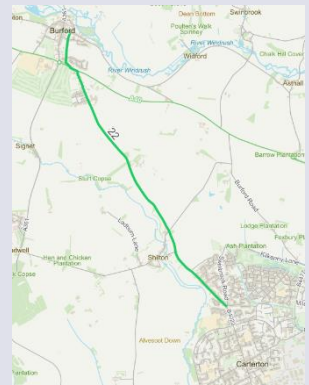
- The gradient of the road surface from one side of the carriageway to the other may limit what infrastructure can be proposed – some sections have sloping hills down away from the carriageway, meaning large amounts of earth may need to be moved to install anything.
- At some points, the carriageway is wide, with wide grass verges on either side of the carriageway. There are no footpaths, however this route would not be aimed at walking and wheeling due to its rural nature and high speeds.
